Master's Thesis

CHARACTERISATION OF THE
MORPHOLOGY OF INCLINED SCC
CRACKS IN AUSTRALIAN GAS
PIPELINES

LUKE ZADOW

The University of Adelaide

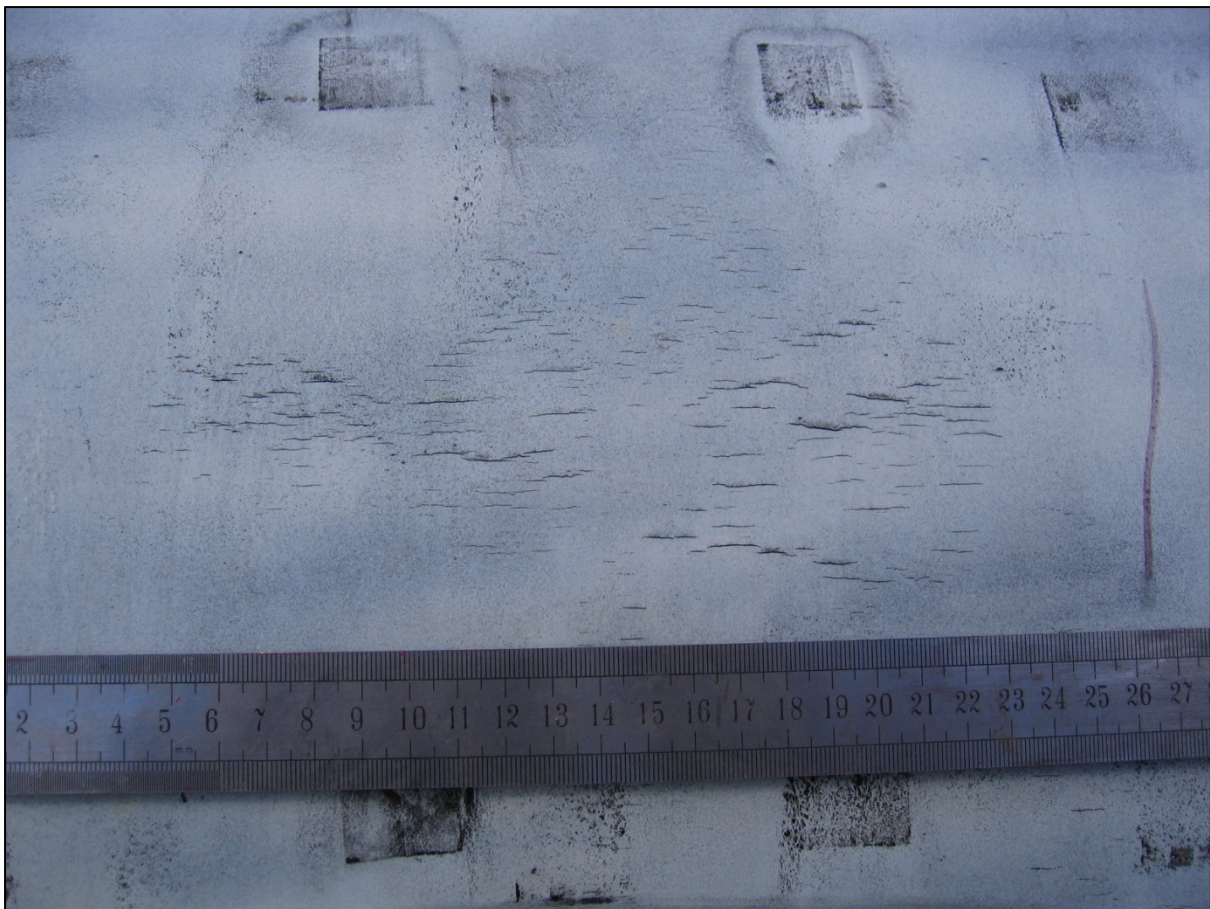
Figure 1-2: Presence of SCC on a pipeline surface as detected by MPI.

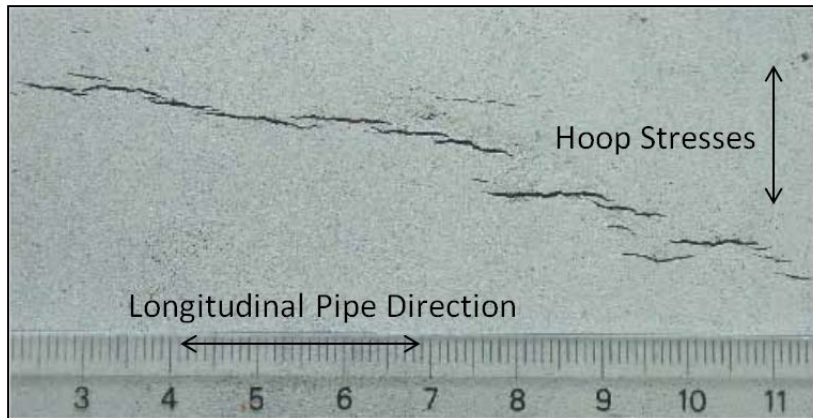
Figure 1-3: SCC colony as seen on an MPI treated pipe surface.

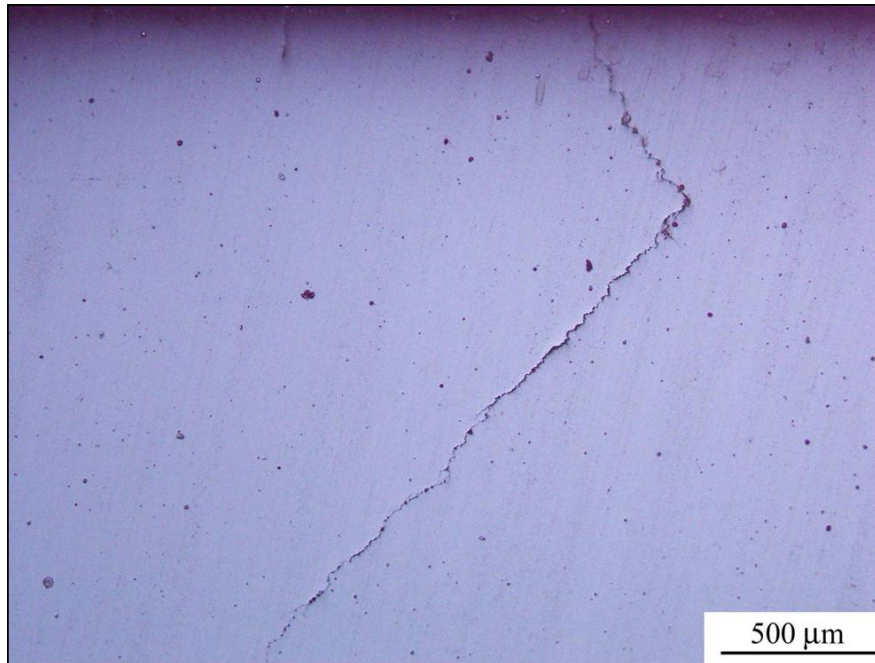
Figure 1-4: Typical inclined SCC

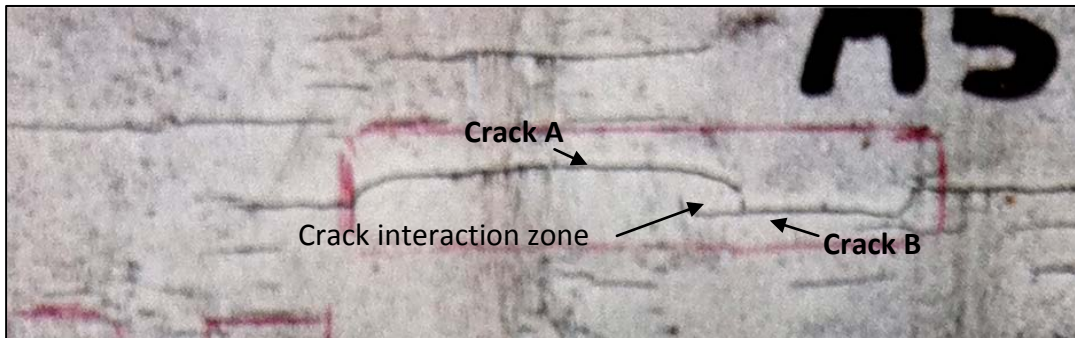
altered. This also means that the cracks will converge after the crack tips have passed one another at a certain distance (Wang et al. 1996). This can be seen in Figure 2-11 where the tips of Crack A and Crack B have passed one another and then grow towards each other. This also has the effect of leaving an 'island' of steel in the middle.

Figure 2-11: Visible crack interaction on the OD surface of the ex-service Australian pipe sample.

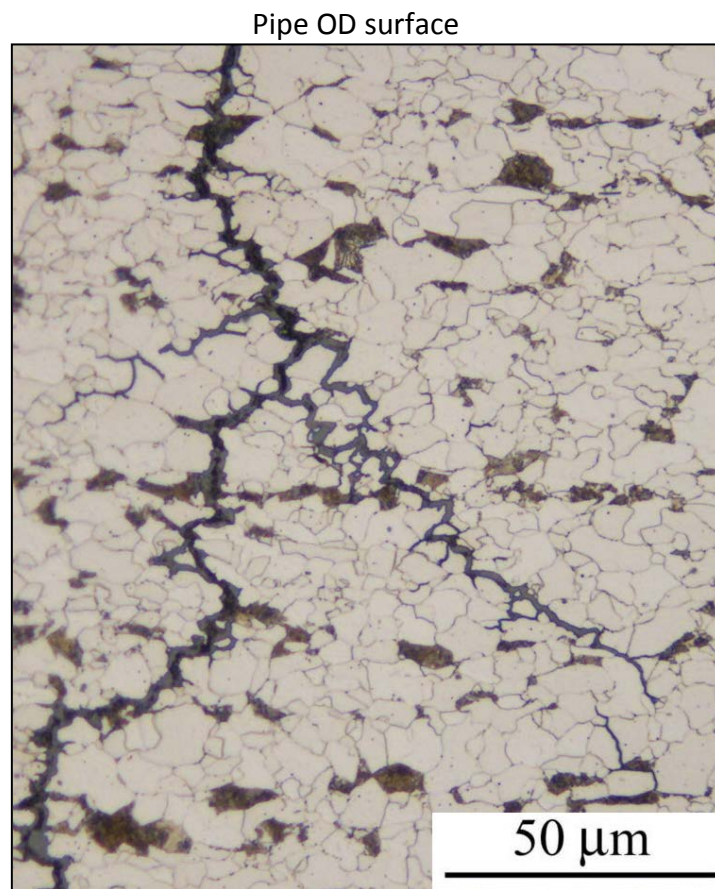
Figure 6-1 shows one example of an SCC crack examined at the highest magnification available after the polished surface was etched. In the micrograph, the microstructural grain boundaries are evident. The crack path shown is clearly IG as it follows the grain boundaries. The IG crack path (seen in Figure 6-1) is rough and messy as it follows the grain boundaries.

Figure 6-1: IG SCC crack path through the pipe wall.

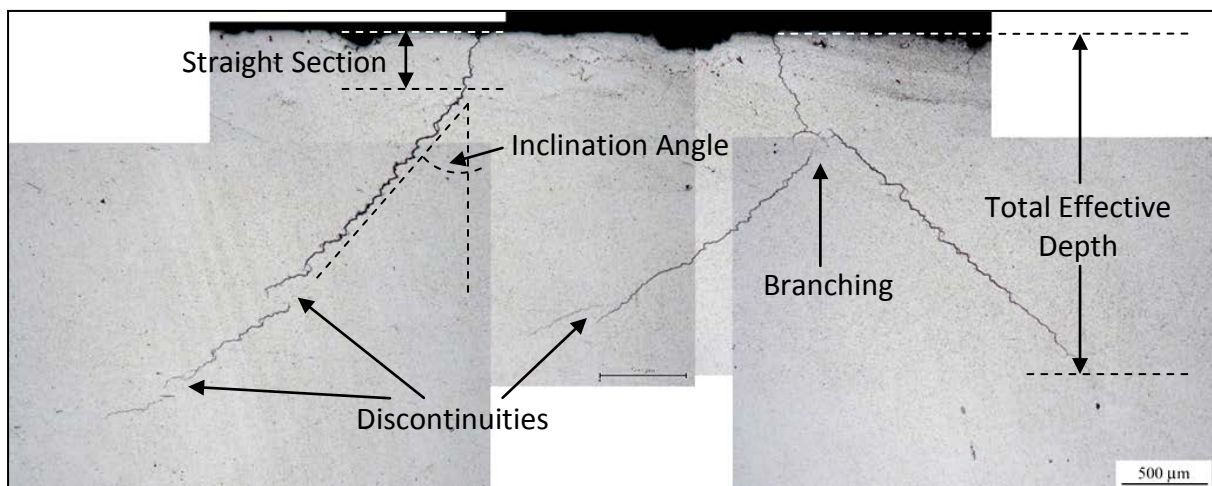
(Sutherby & Chen 2004; Xie et al. 2009). Figure 6-4 shows a transverse view of the wall thickness, revealing two cracks, one of which shows significant branching of the main crack path (illustrated). In the cross section, the 'straight section' can be seen on both cracks as the small perpendicular segment of crack from the initiation point before the crack deviates. The straight section is defined as the small segment of crack where the crack is travelling perpendicular to the pipe wall from the initiation point to the point of inclination. The method by which the morphological parameters of the cracks, in terms of the inclination angle and total effective depth, are measured is illustrated in Figure 6-4. Of interest is the very large distance that the cracks travel in the hoop direction underneath the surface (approx. 2.5 mm for the crack on the left and 1.8 mm for the crack on the right).

Figure 6-4: Transverse view illustrating SCC cracks with typical straight sections and defining the inclination angle.

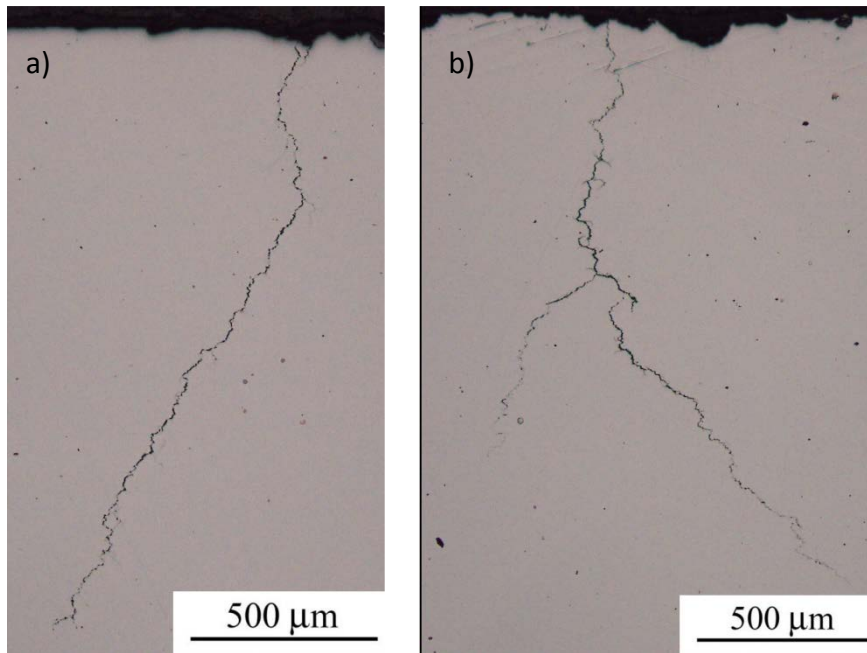
Figure 6-6: Unetched sections (a) and (b) 1 mm apart in the main axis direction. (MPI) of the surface appearance of this crack was straight in the longitudinal pipe direction.

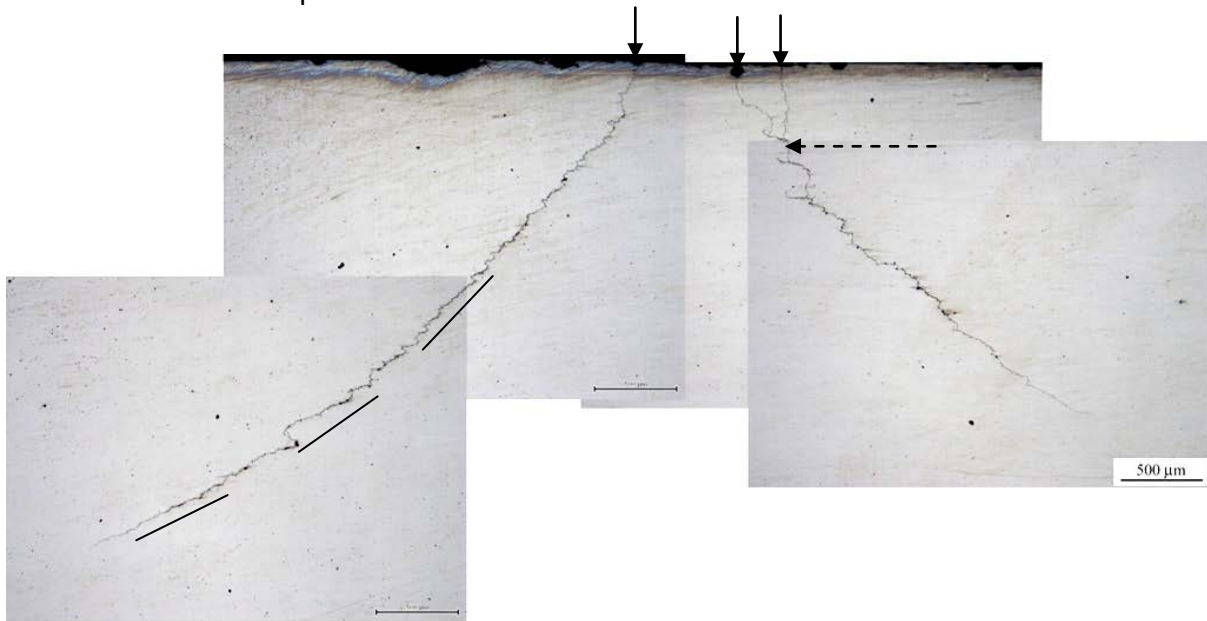
Figure 6-8: Angle changes as the crack grows in the through-wall direction (scale bar is 500 μm). The two cracks on the right have coalesced.

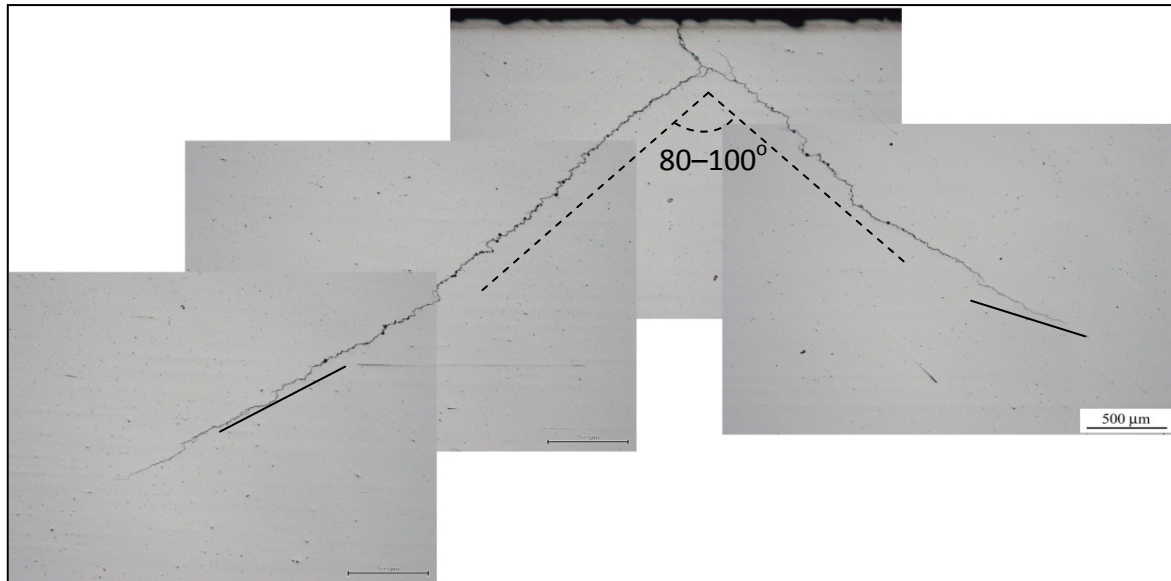
Figure 6-11: Inclined crack with significant branching at a perpendicular angle to the inclined crack path.

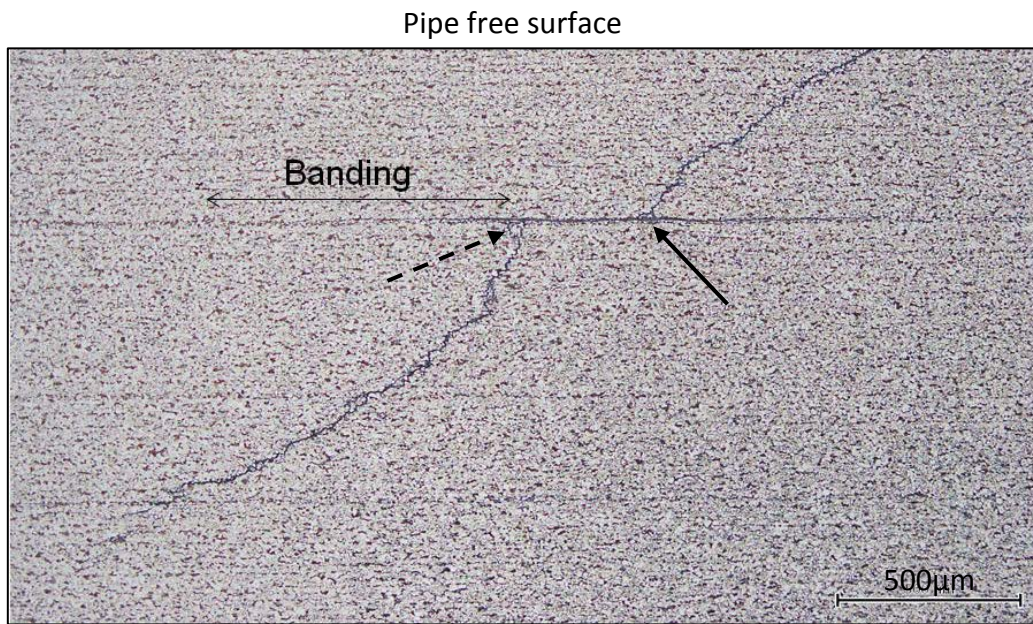
Figure 6-13: 2% Nital etched image of SCC crack interacting with an inclusion.

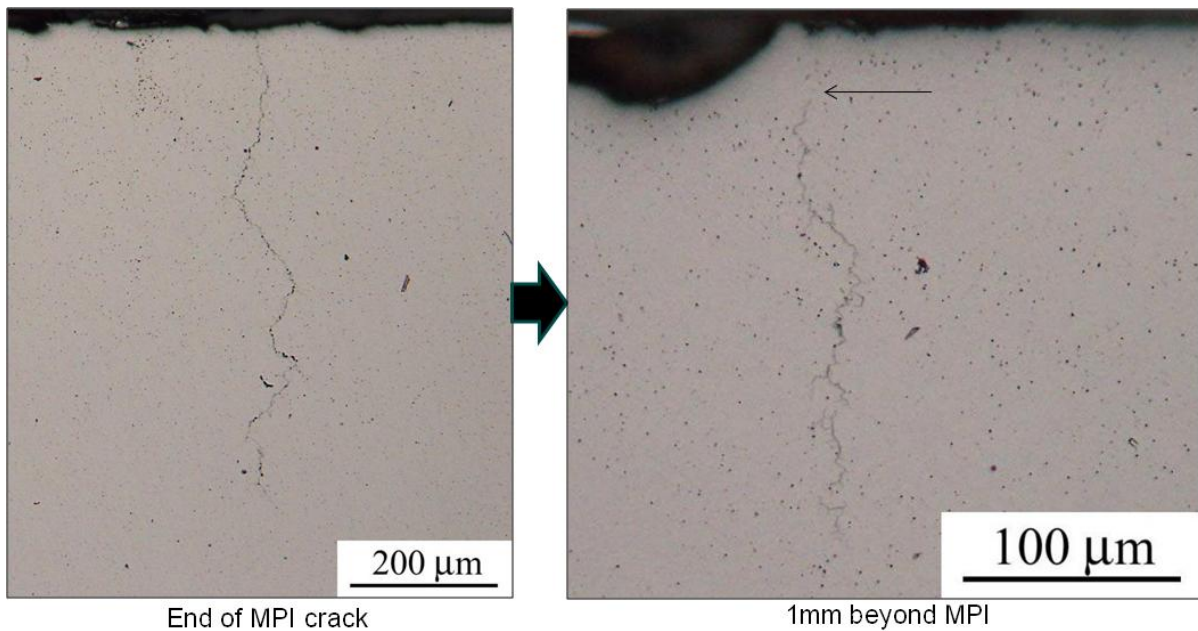
Figure 6-14: Longitudinal subsurface extension.

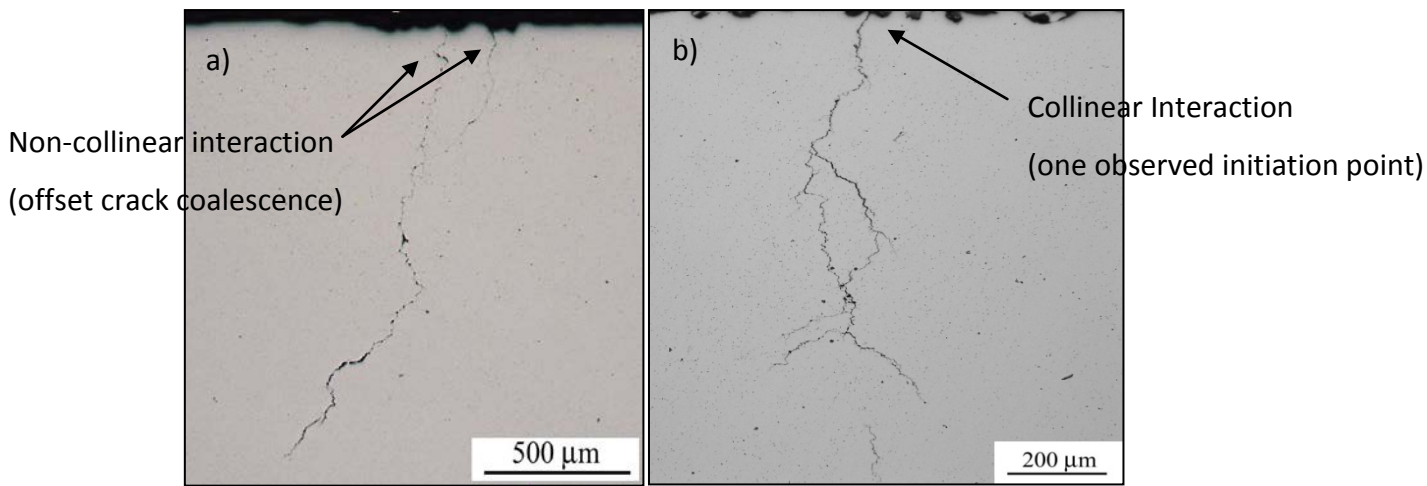
Figure 6-15: Cross sectional observations of a) non-collinear interaction and b) collinear interaction.

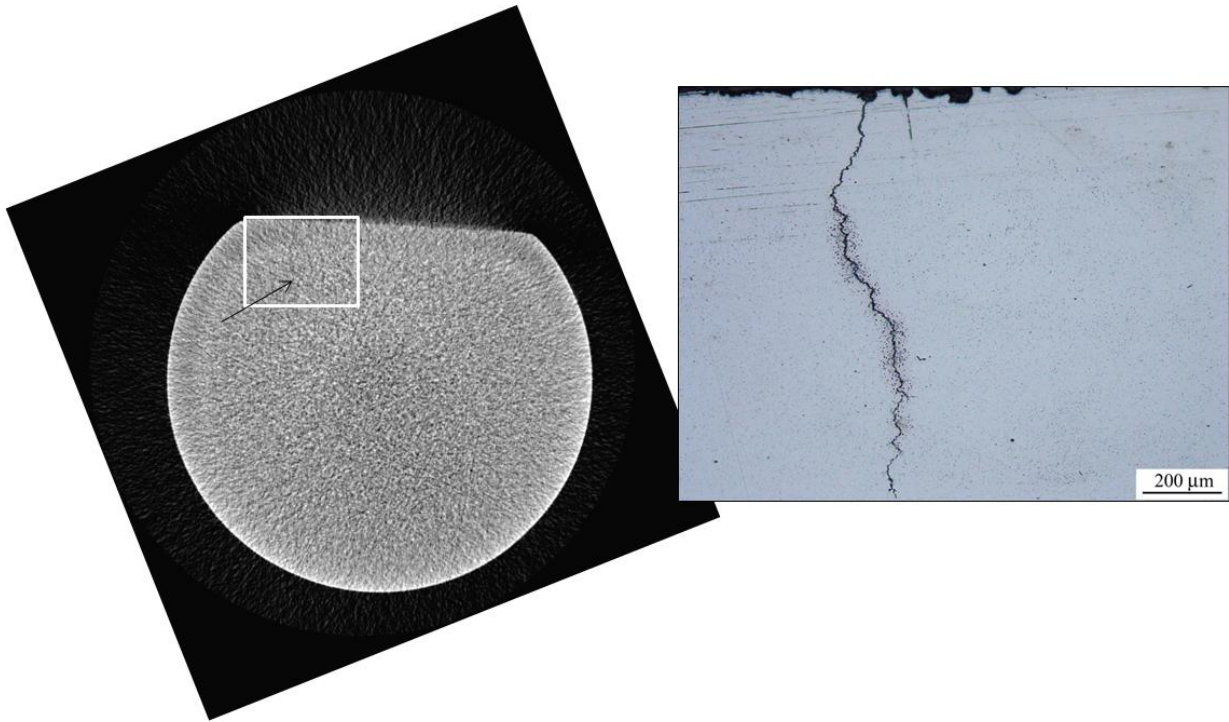
Figure 6-17: Cross section of SCC affected sample using X-ray scanning (left) and metallography (right).

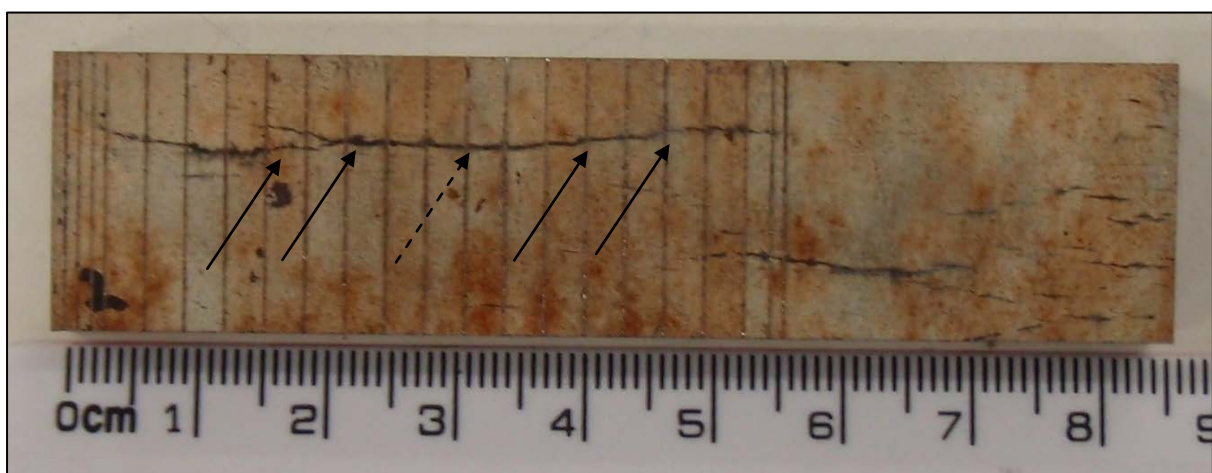
Figure 8-2: Sample CMI-2 as photographed before analysis.

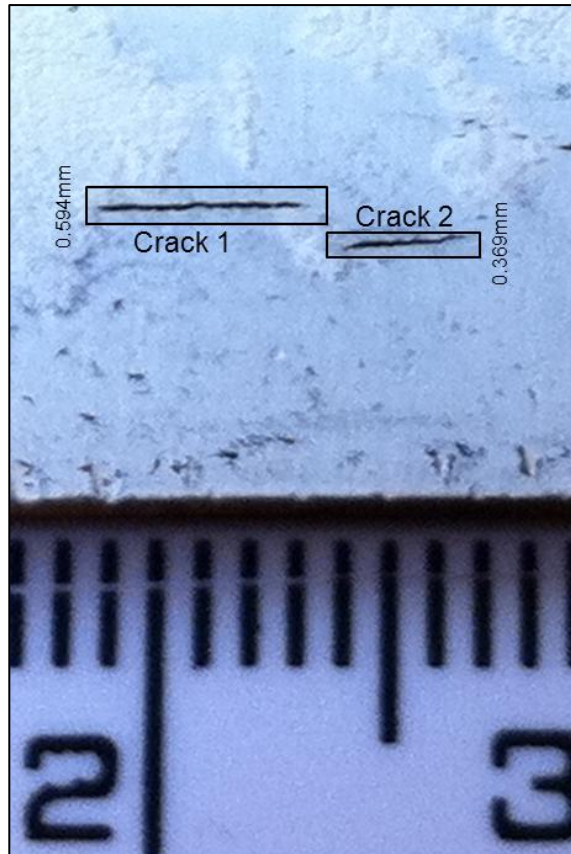
Figure 8-3: Two cracks in a sample not expected to interact (measured hoop travel).

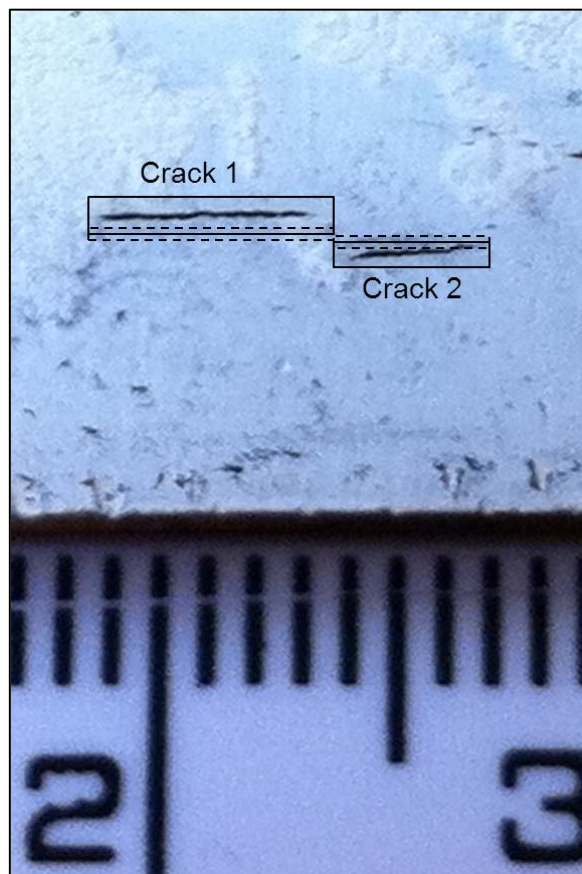
Figure 8-4: Two cracks that may be interacting when approaching the CEPA calculation from a 3D perspective.

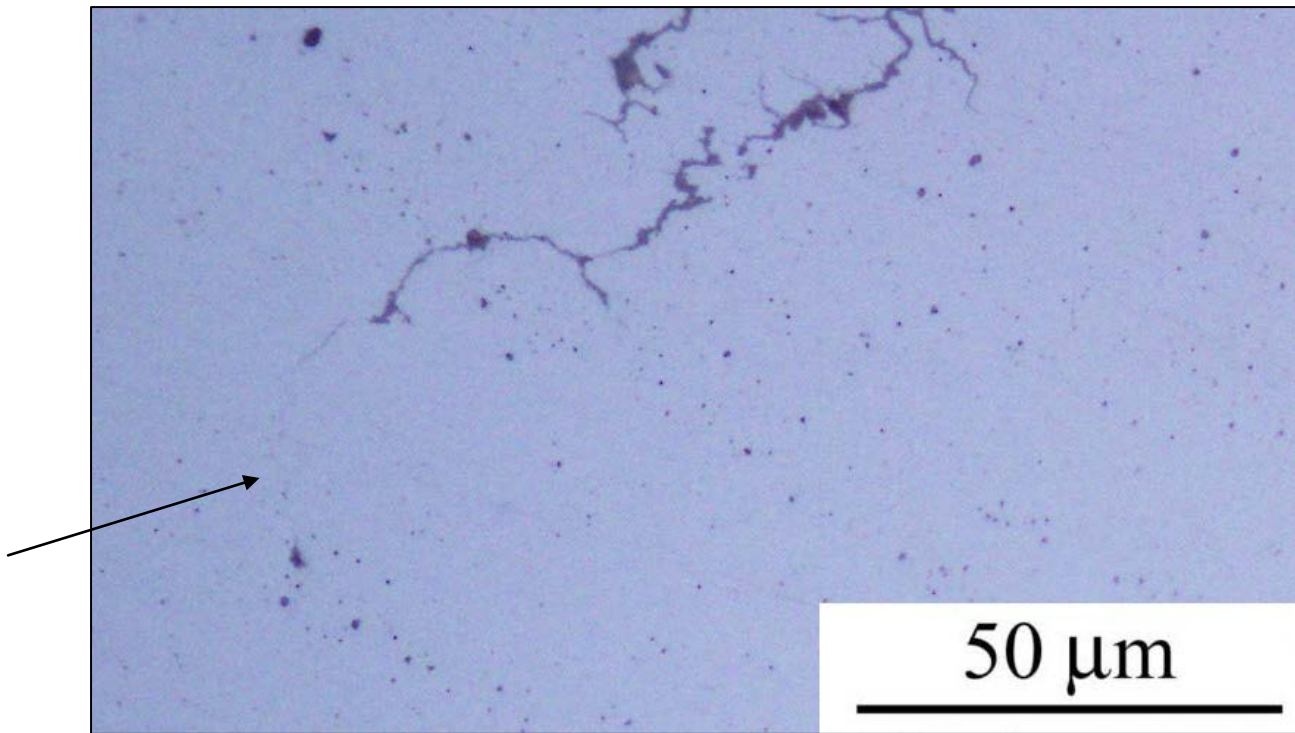
Figure 8-6: SCC crack tip taken from ex-service pipe sample showing a very fine structure near the tip.

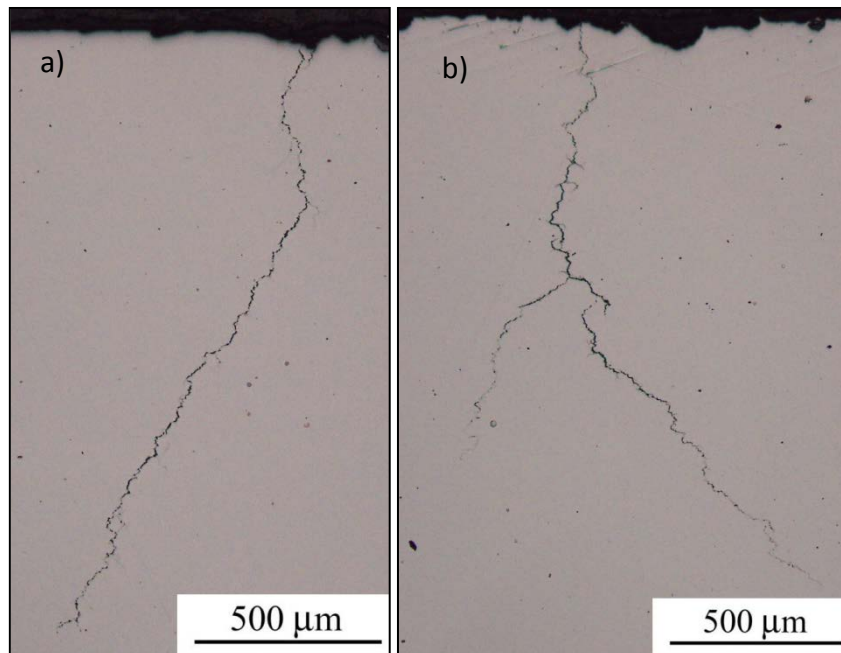
Figure 8-9: Observable change in inclination angle and direction of a single crack with a) and b) cross sectional slices 1 mm apart.
