THE EFFECT OF ACTIVE MASS THICKNESS ON THE
CYCLE LIFE OF LOW-ANTIMONY LEAD-ALLOY
SPINE EMPLOYED IN DEEP-CYCLE BATTERIES

A THESIS

MASTER OF ENGINEERING SCIENCE

THE UNIVERSITY OF ADELAIDE

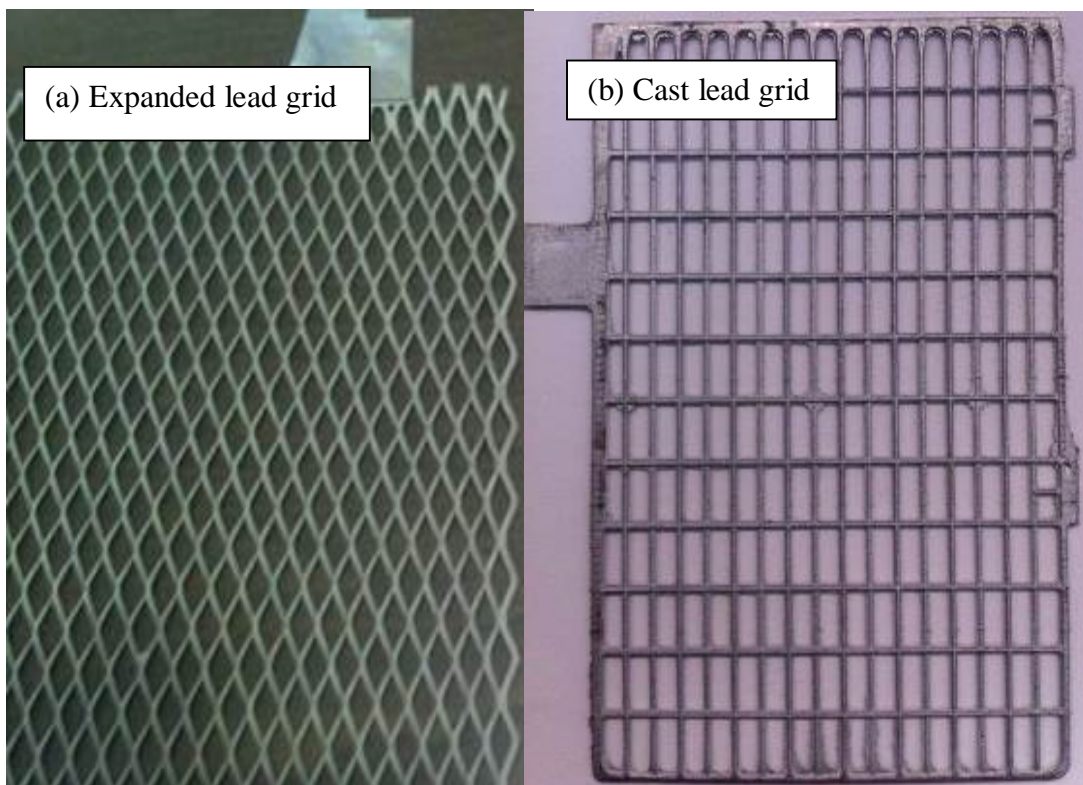
Figure 5 - (a) Expanded grid (Pacific Marine Batteries) (b) cast grid (Exide Technologies) illustrating modern lead grid designs compared to a thin flat sheet of lead used for grid in early development.

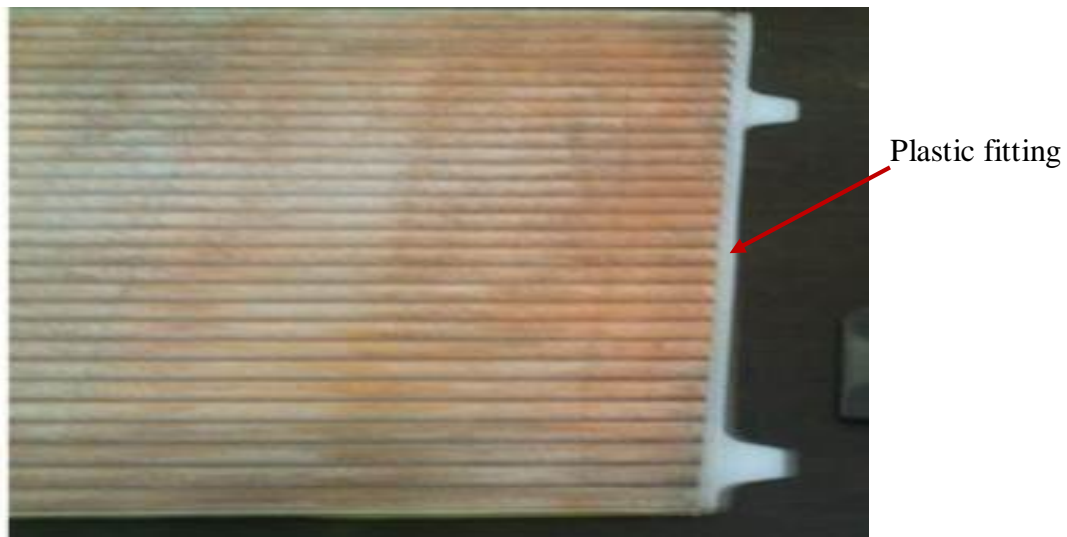
Figure 8 - Un-formed positive tubular-plate (Pacific Marine Batteries)

In this design of these plates, a central conducting ‘spine’ is surrounded by the active mass and the assembly is encased in a porous woven retainer tube known as the ‘gauntlet’. The tubular-plate’s design and manufacturing process are more complex than those for the flat pasted plate. First, a series of parallel lead spines are cast on to a bar composed of an antimonial lead alloy. Following casting, the gauntlet is fitted over the grid spines (Figure 7), and these tubes are then filled with a mixture of lead oxide and red lead powder by vibration. After the tubes are filled, the ends are sealed by knocking a plastic fitting onto the ends of the lead grid spines. The assembly is then “pickled” by soaking in a dilute sulfuric acid solution to convert the lead oxides into lead sulfate. The finished product contains a series of tubes filled with lead sulfate with a centre core of lead to carry the current (Figure 8).

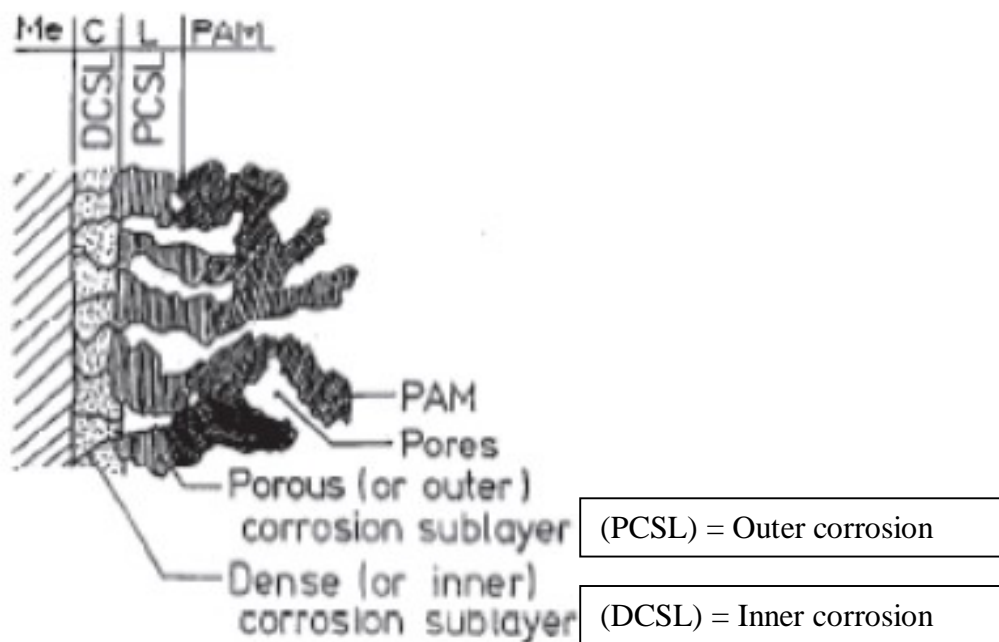
Figure 13 - Schematic representation of structure of corrosion layer (Pavlov 1994)

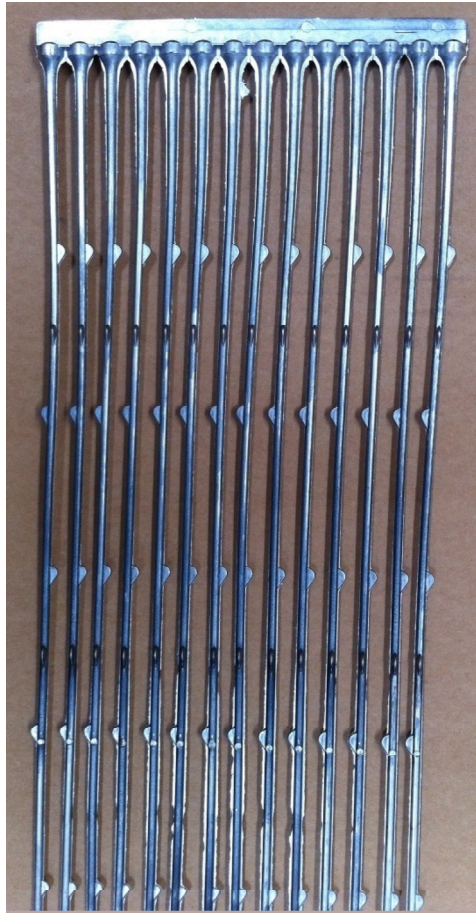
Figure 15 - Cast spines from HADI die casting machine

The spines used in this study were pressure cast using a HADI die casting machine. They were cast as long spines as shown in Figure 15. The spines were then cut into the required length as illustrated in Figure 16. A spine length of 140 mm (less than half of the normal length) was used for ease of handling and quality consistency: bowing; eccentric within the tube to avoid localized corrosion; and minimize density gradient during oxide filling. A minor modification to the boss (beneath the top bar that enters the top of the gauntlet be inserted into the gauntlet) of the lead spine was made prior to oxide filling. The boss of the spine was designed to fit into the 8.6 mm internal diameter gauntlet tube. The boss had to be filed down for it to inserted firmly into the gauntlets of the smaller sizes: 6.2 mm and 7.3 mm as shown in Figure 17

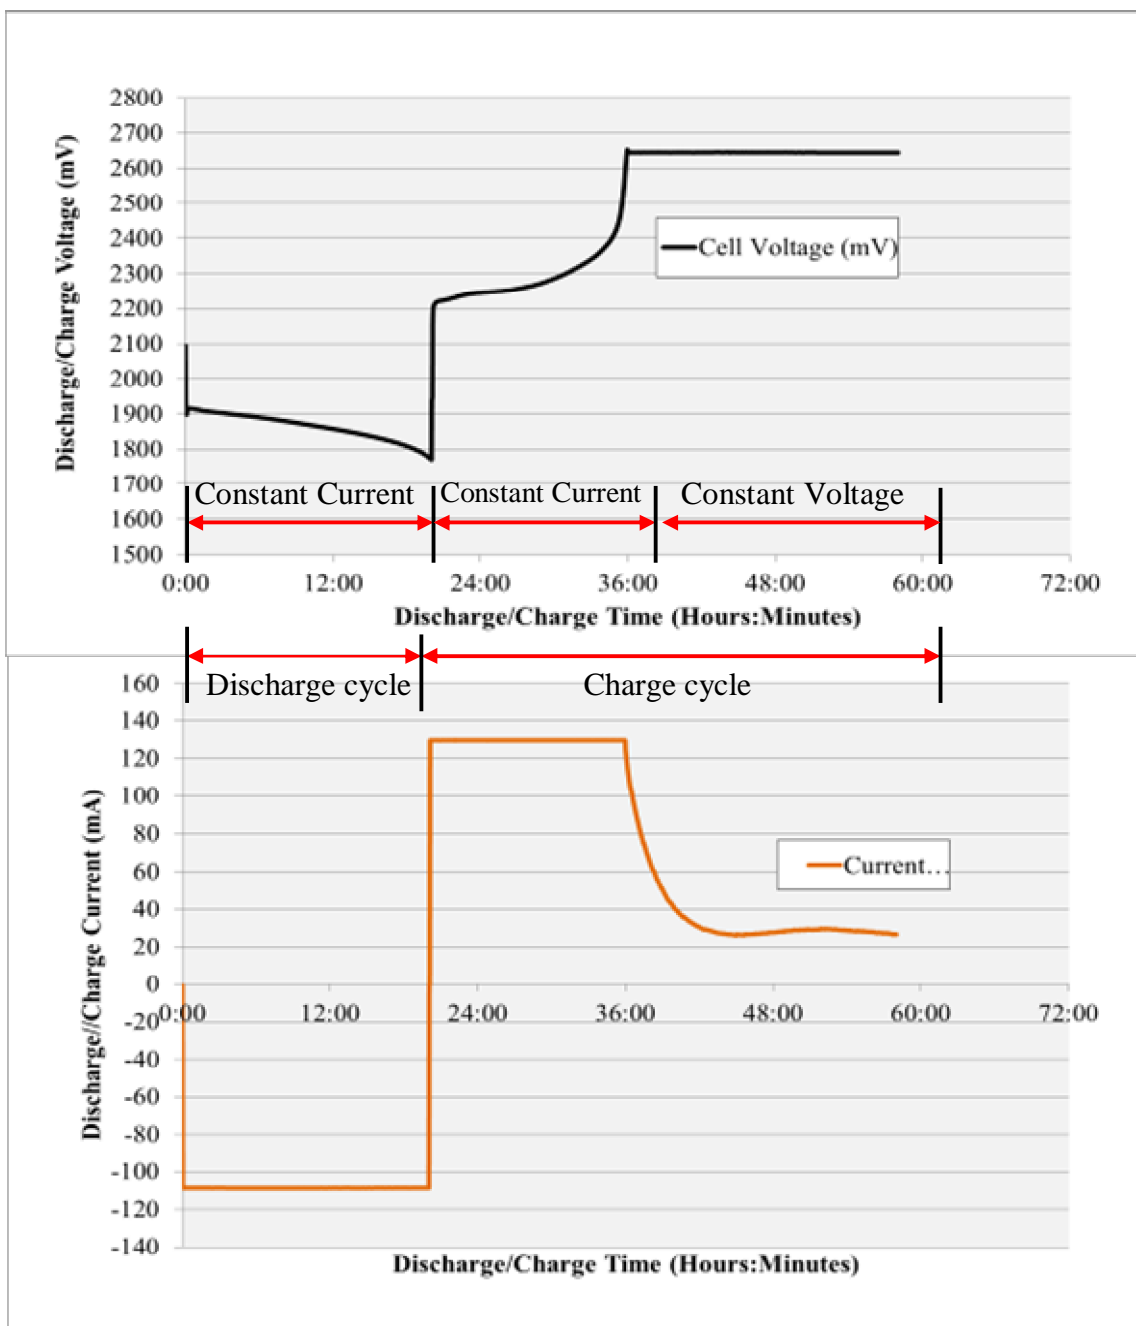
Figure 27 – An example of a typical completed discharge/charge cycle.

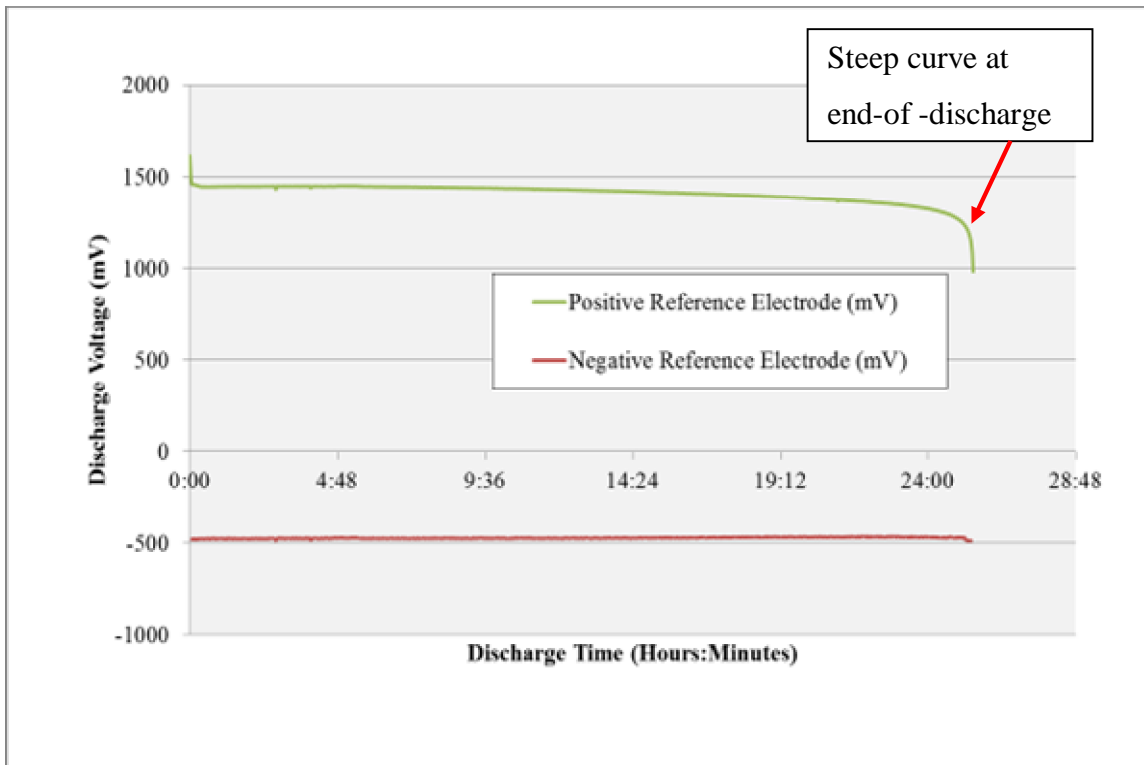
Figure 29 – The limited amount of PAM causes a steep positive potential curve at the end-of-discharge

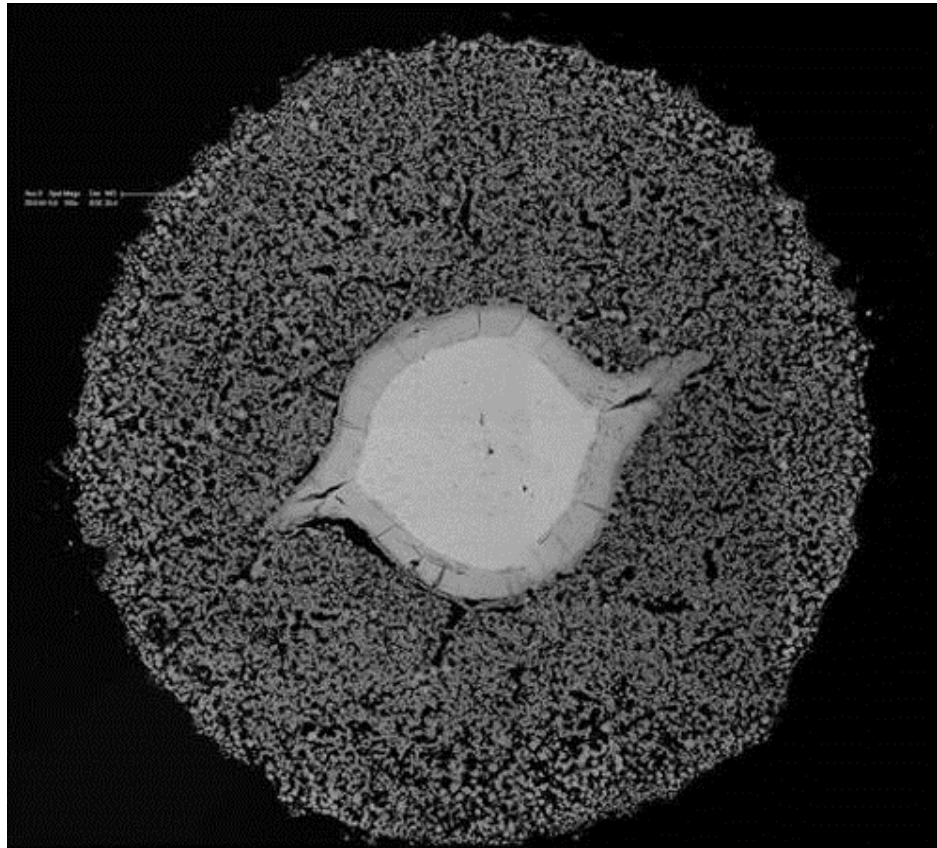
Figure 34 – BSC SEM image of a prepared cross section electrode captured on a Philips XL40 scanning electron microscope at an accelerating voltage of 15 kV

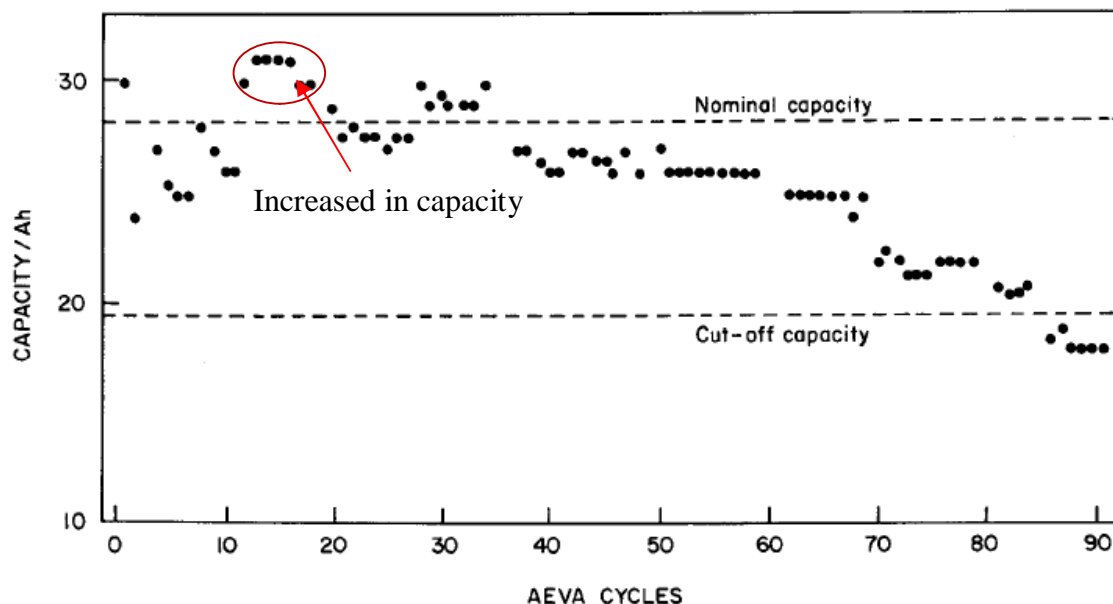
Figure 46 – Capacity of low-antimony lead-acid battery subjected to deep-discharge cycling (Barrett et al. 1981)

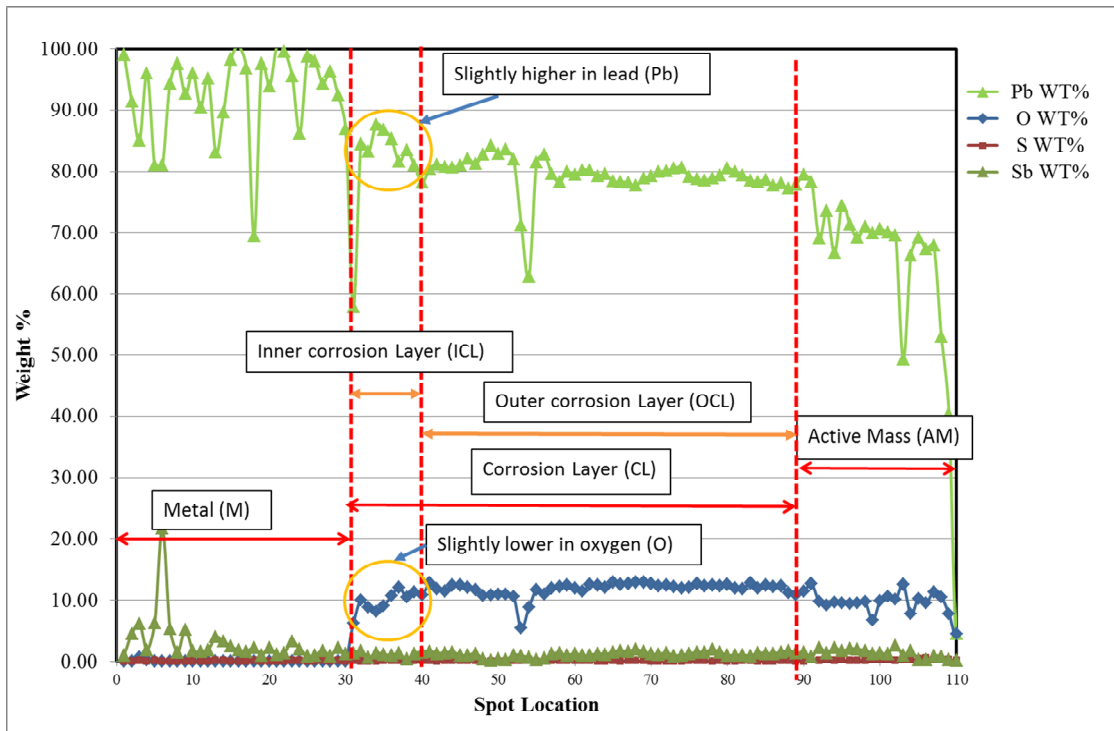
Figure 55 – Quantitative spot analysis of the lead (Pb), oxygen (O), antimony (Sb) and sulfur (S) composition

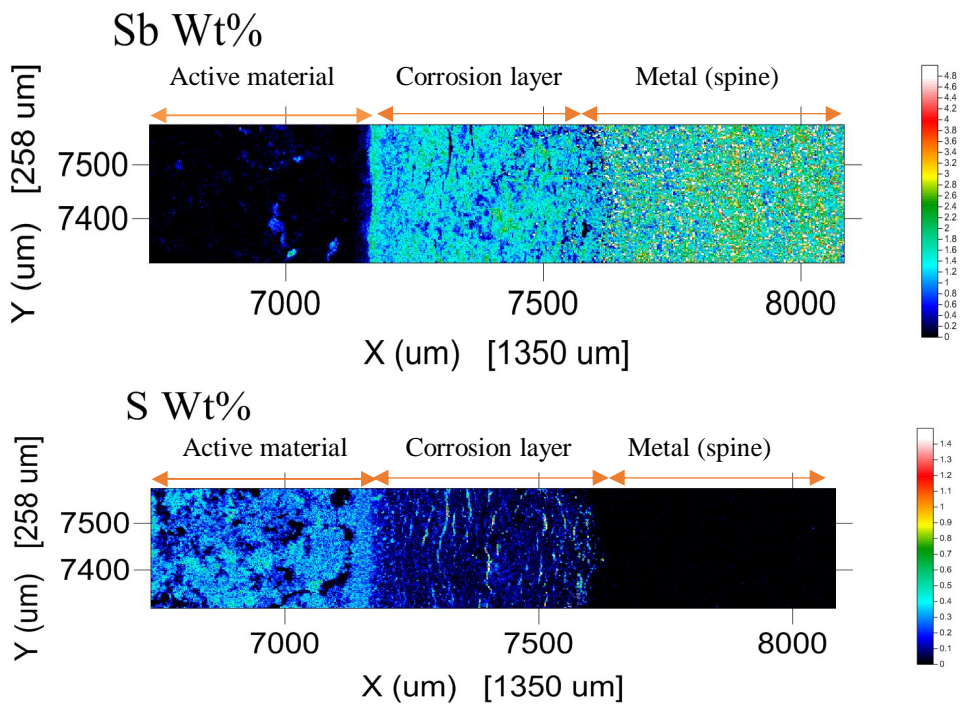
Figure 57 – Area maps for antimony and sulfur

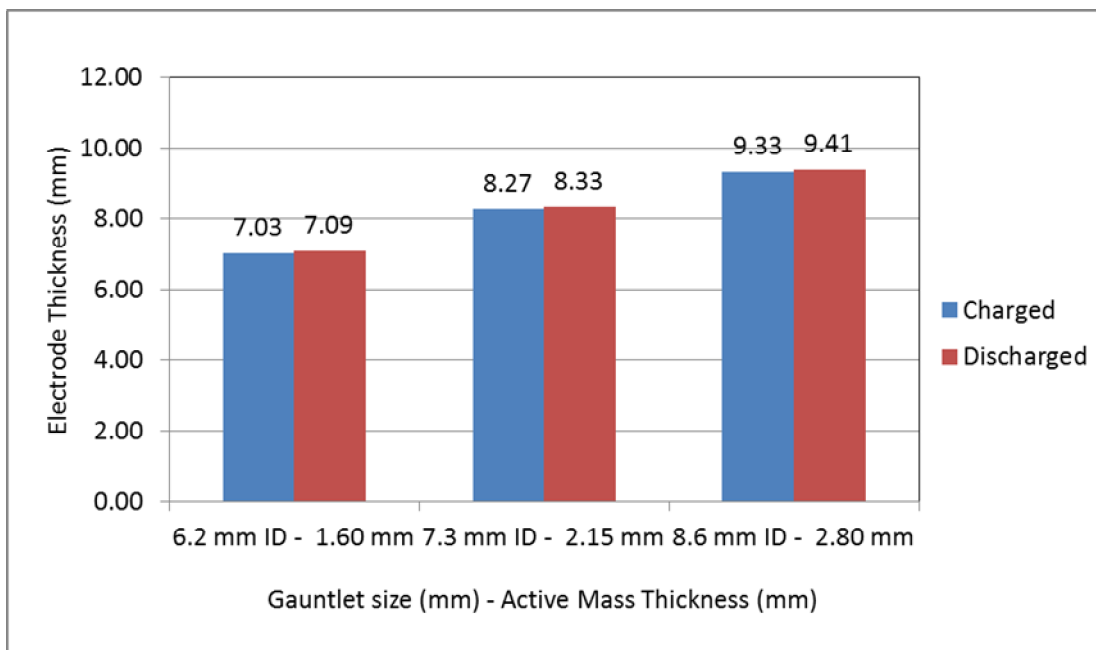
Figure 60 – Thickness of the electrode fully charged and in a discharged state for different active mass thicknesses (Gauntlet diameter)

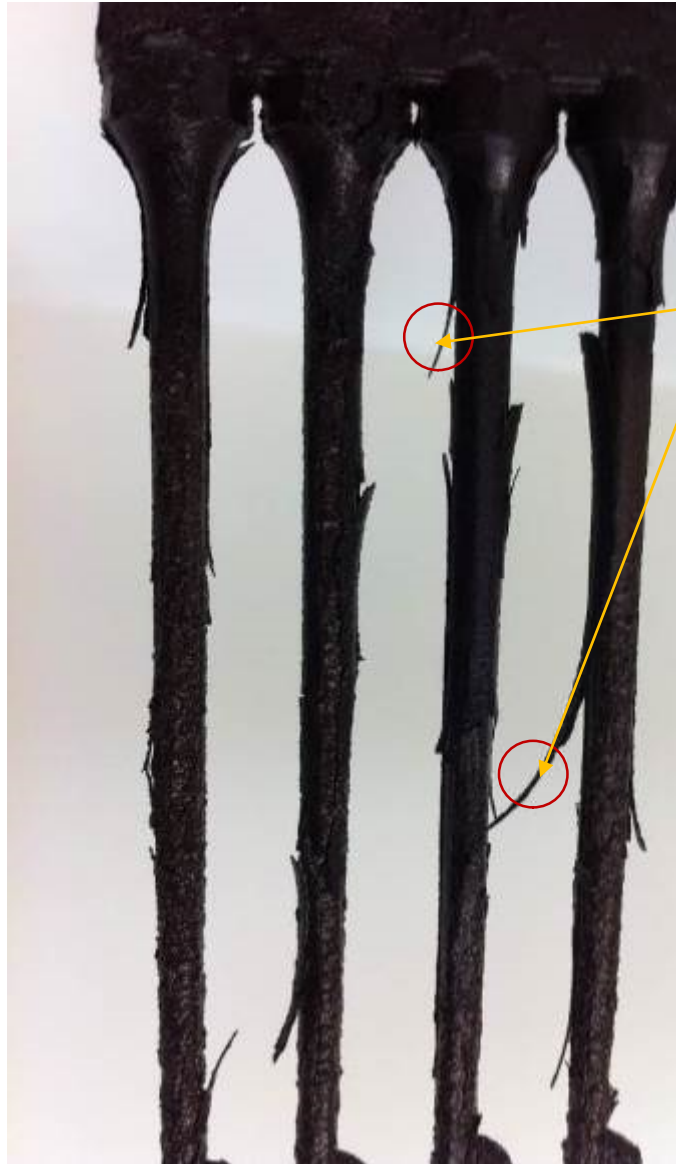
Shedding of the
outer corrosion
layer
