Failure Analysis of Corrosion Case Histories

Author: Sadeq Hooshmand Zaferani

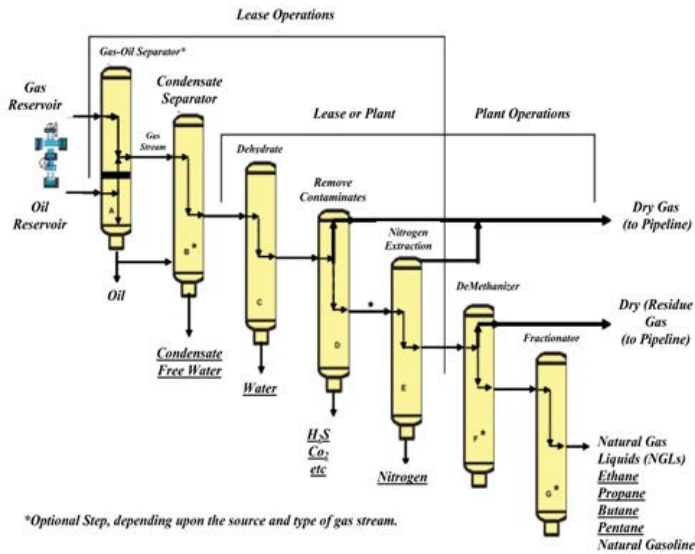
Figure 1: Generalized natural gas processing schematic [1]

Natural gas processing begins at the wellhead (Figure 1). The composition of the raw natural gas extracted from producing wells depends on the type, depth and location of the underground deposit and the geology of the area. Oil and natural gas are often found together in the same reservoir [1].

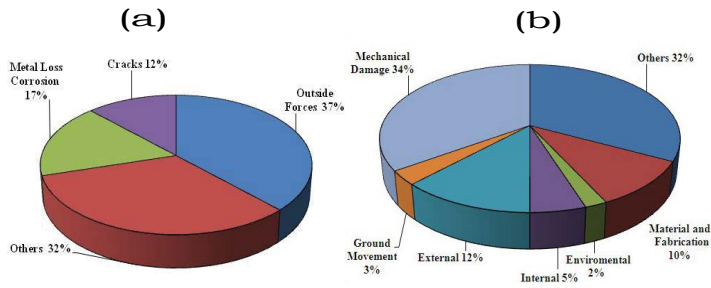
Figure 3: a) Relative frequency (%) of major causes of pipeline failures b) Relative frequency (%) of failure causes [11].

The figures show mechanical damage as the major cause of failure followed by metal loss corrosion. The frequency of corrosion leaks is low in the USA database because a large percentage of corrosion related failures involve small leaks, which are not reported in this particular database. The ratio of corrosion failures is significantly higher in databases that include incidents leading to small leaks [11].

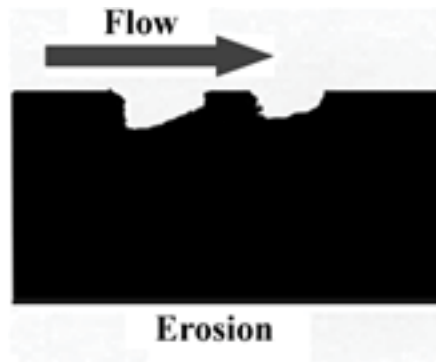
Figure 4: Schematic of erosion corrosion [13].

The term erosion applies to deterioration due to mechanical forces. When the factors contributing to erosion accelerate the rate of corrosion of a metal, the attack is called erosion corrosion. Erosion corrosion is usually caused by a corrodent, aqueous or gaseous, flowing over the metal surface or impinging on it. The mechanical deterioration may be aggravated by the presence of a corrodent, as in the case of fretting corrosion or corrosive wear. The attack takes the form of grooves, i.e., scooped-out rounded areas, horseshoe-shaped depressions, gullies, or waves, all of which often show directionality. At times the attack may be an assembly of pits. Ultimate perforation due to thinning or progression of pits, and rupture due to failure of the thinned wall to resist the internal fluid pressure are also common. All equipment exposed to flowing fluid is subject to erosion corrosion, but piping systems and heat exchangers are the most commonly affected [12].

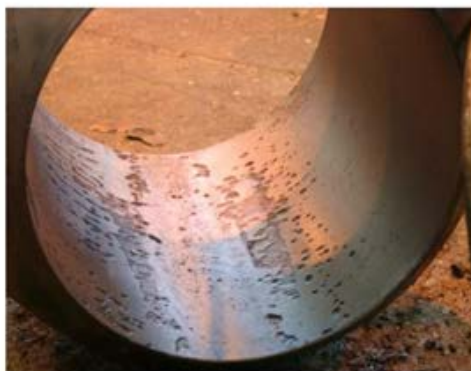
Phenomena: Gas Leakage**Illustration (Macro): Ball Valve****Phenomenon: Severe general
pitting****Illustration (Micro): Inner side of
Ball****Environment: Flow Line****Size: 14"****Material: Stainless Steel 316****Time in service: 29 years****Fluid: Sour Gas****Operating Pressure: 1440 Psig****Coating Type:-****Orientation of Specimen: 0°**

The mentioned ball had been used in a ball valve for 29 years. The flowing of sour gas and also corrosive liquid accumulation cause several pits on its internal surface. Because of pit distributions and also reaching to each other localized corrosion occurred.

- Routine periodic inspection to detect and control their structure variations.
- Use of stainless steel with grade of 254SMO (21% Cr, 18% Ni, 6% Mo, 0.2% N). The reason for this selection was the need for a material resistant to alternate exposure to seawater and sulfide-containing oil.

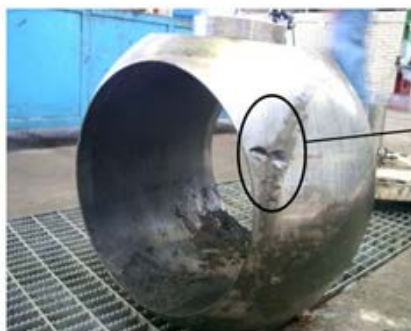
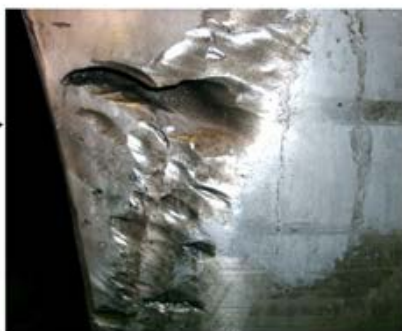
This ball eroded in form of wire drawing and leakage of high pressure fluids occurred. Being scratch or local depression in the ball surface allows constricted flow of the fluid as a leak, the high flow velocity in the leak zone causes erosion and development of a channel through the seal interface.

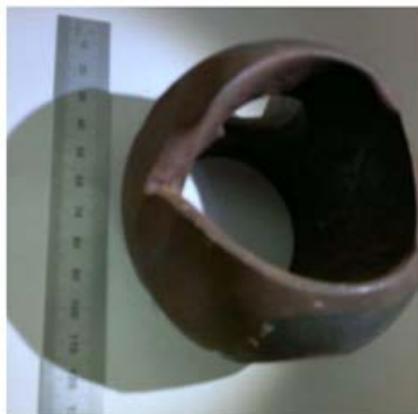
Phenomena: Gas Leakage**Illustration (Macro): Ball Valve****Phenomenon: Edge Severe
Erosion****Illustration (Micro): Ball****Environment: Flow Line****Size: 2"****Material: Carbon steel****Time in service: 5 years****Fluid: Sour Gas****Operating Pressure: 1440 Psig****Coating Type:-****Orientation of Specimen: 0°**

As shown in above figure, ball edges had been eroded by high rate flow. This erosion process had been done due to high speed of flowing fluid and also the presence of some liquid can intensify the erosion process.

Wall shear stress is one of the parameters that highly influence hydrodynamically induced corrosion such as erosion corrosion. Turbulent flow is frequently used in the gas industry to transport fluids in order to increase the transportation efficiency at a minimized cost. Also articles and other geometrical changes in the flow give rise to higher shear stress.

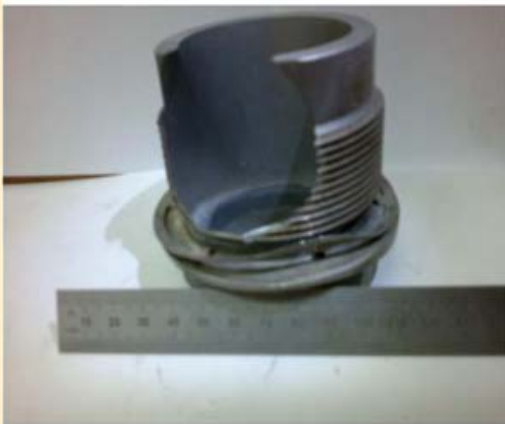
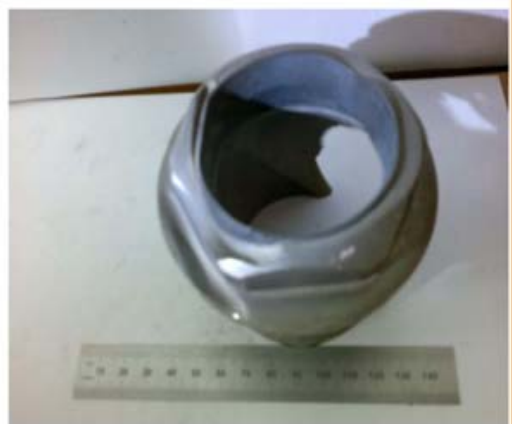
High gas flow and impingements of hard particles (eg: sands) carried by a fluid on a surface will cause additional mechanical damage.

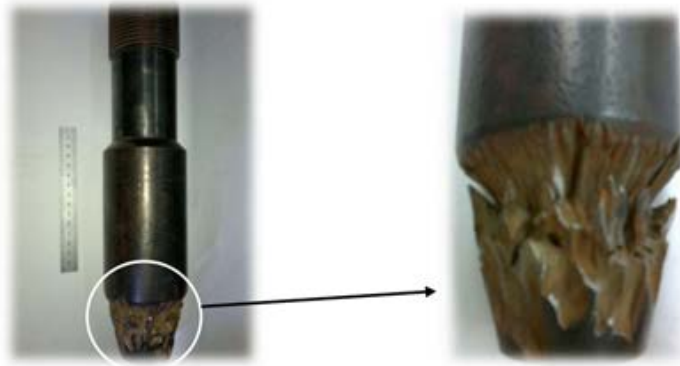
This erosion process had been done because of high speed of flowing fluid.

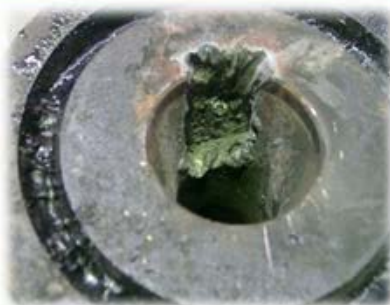
Phenomena: Gas Leakage**Illustration (Macro): Control Valve****Phenomenon: Flow Aberrations****Illustration (Micro): Outlet Flange****Environment: Flow Line****Size: 3"****Material: A216-WCC****Time in service: 5 years****Fluid: Sour Gas****Operating Pressure: 1440 Psig****Coating Type:-****Orientation of Specimen: 0°**

The mentioned control valve had been carried out in sour gas service. After 5 years of operation, severe erosion corrosion and also groove shape erosion observed in outlet flange. Over rate operation can be assumed as the main reason for this failure. In other words, out gassing is a very fast, hard-to-predict phenomenon that occurs when the pressure of a fluid drops below the saturation pressure of a dissolved gas. Once this point is reached, the gas separates from the solution and produces high velocity, erosive vapor droplets. This process is evident when the liquid and gas exiting the control valve have dissimilar molecular weights.

- Proper selection of control valve body and trim materials is the first step in combating erosion-related damage and could mean the difference between an unplanned shutdown and continued operation.
- Materials with high chromium and molybdenum content generally provide increased resistance to erosion and wear.
- Using the appropriate flow rate.

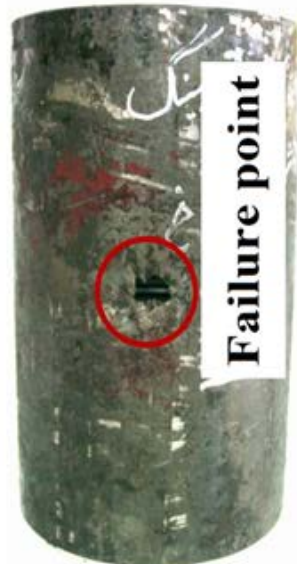
Leakage failure occurred as the mention hole in the coupling body. Creation of the perforation can be initiated via microstructure defect, therefore fluid rate and also its velocity intensifies the growth of the hole.

- It is recommended to use of this material with clearer microstructure and lower inclusions.

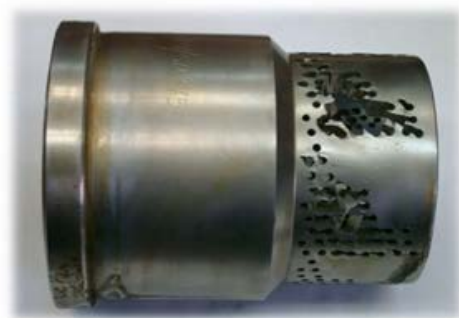
Phenomena: Valve Passing**Illustration (Macro): Control Valve****Phenomenon: Flow Erosion****Illustration (Micro): Cage****Environment: Flow Line****Size: 2"****Material: Stainless Steel 316****Time in service: 2 years****Fluid: Sour Gas****Operating Pressure: 4800 Psig****Coating Type:-****Orientation of Specimen: 90°**

Throttling process of control valve can be subjected to more severe conditions than other system components. The shock waves and pressure fluctuations resulting from these high velocity collapses can also cause vibrations, noise, accelerated corrosion, as well as limited valve capacity.

Furthermore the mentioned cage had been fabricated by Stainless steel 316 with hole diameter of 2 mm. Because of sensitization of SS 316 in chloride the selected material cannot act as a resistive body against of sour environment and also chloride, it had been destroyed by corrosive fluid with high rate.

- Increasing the hole diameter.
- Hardened stainless steels including S17400 and S41000 provide excellent hardness and durability against chloride sensitization for using as trim materials.
- Designing valves to resist the deleterious effects of the throttling process fluid is only as effective as the valve sizing and selection process itself.
- A control valve designed with hardened trim material could last almost indefinitely on low pressure drop service conditions.

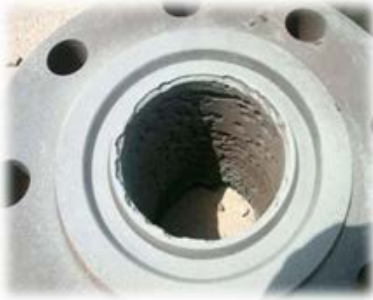
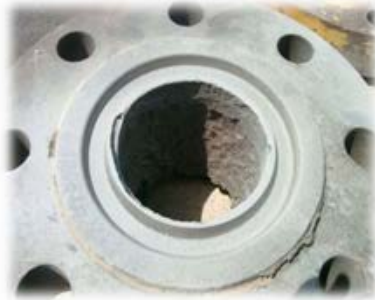
**Phenomena: Thickness
Dedagration****Illustration (Macro): Flange****Phenomenon: Intense,
widespread pitting on ID of steel****Illustration (Micro): Flange Inner
Side****Environment: Flow line****Size: 4 1/16"****Material: A 350 LF3****Time in service: 7 years****Fluid: Sour Gas****Operating Pressure: 4800 Psig****Coating Type:-****Orientation of Specimen: 0°**

The mentioned flange fabricated from material which is not appropriate for using in sour gas service according to NACE MR-01-75. Furthermore inclusions content affect on the quality therefore the unsuitable cleanliness of the selected alloy and also MnS containing reduce the resistance of the fabricated flange against the sour gas corrosion.

- Using of alloy with lower inclusion and clear microstructure.
- Using of suitable corrosion inhibitor.
- Clad the internal surface of flange with high resistance alloys (eg: Inconel 625 +Inconel 825, Duplex 22% and 25%)

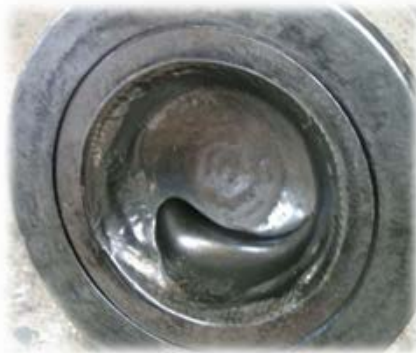
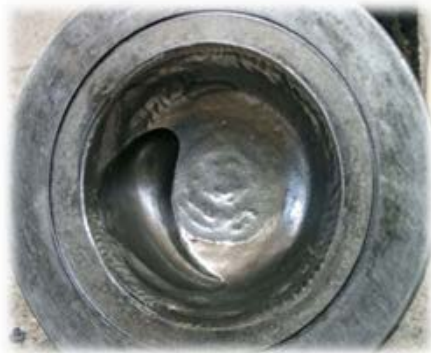
The severe erosion caused by high speed flow and finally the thickness thinning will be resulted.

The contacting of sands and also the disbanded tungsten parts of wellhead parts with high speed to grit trap cap cause the severe erosion.

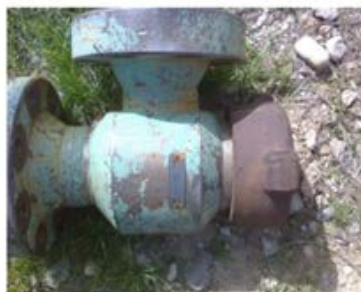
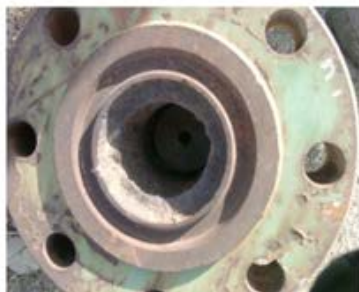
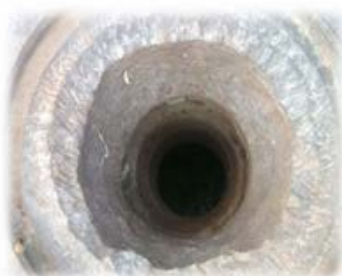
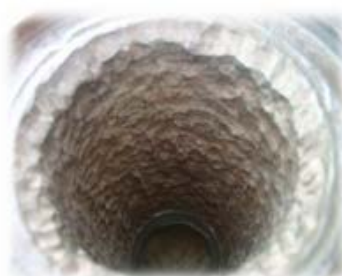
Phenomena: Desert sand dune appearance	Illustration (Macro): Choke Valve	Phenomenon: Cavitations, Severe general pitting
Illustration (Micro): Flange	Environment: X-Tree	Size: 2 1/16"
Material: SS 410	Time in service: 4 Years	Fluid: Sour Gas
Operating Pressure: 4800 Psig	Coating Type:-	Orientation of Specimen: 0°

Impingement of hard particles carried by a fluid on a surface will cause additional mechanical damage. When the fluid is corrosive, the particle impingement can remove protective films ordinary resistance to fluid shear, accelerating the corrosion. In this case, reducing the flow rate may not be sufficient to reduce the severity of attack.

- Using appropriate rate.
- Using of alloys with high corrosion resistance

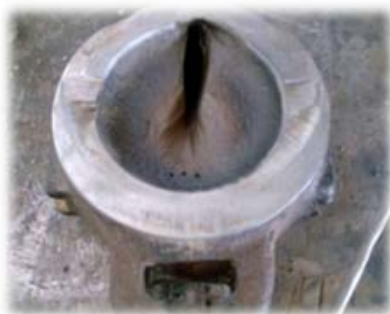
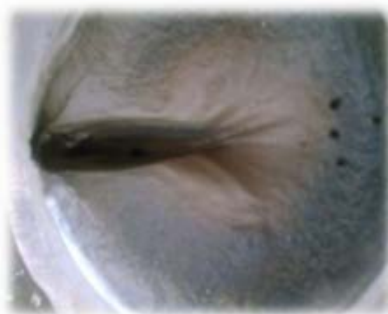
Over rating of gas flow is the main result of this phenomenon.

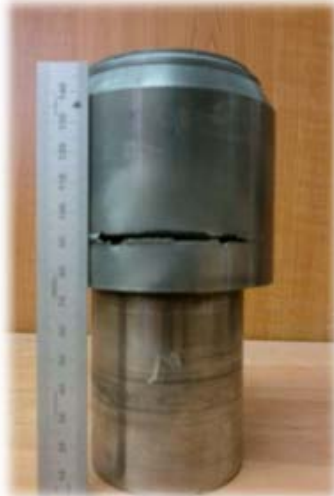
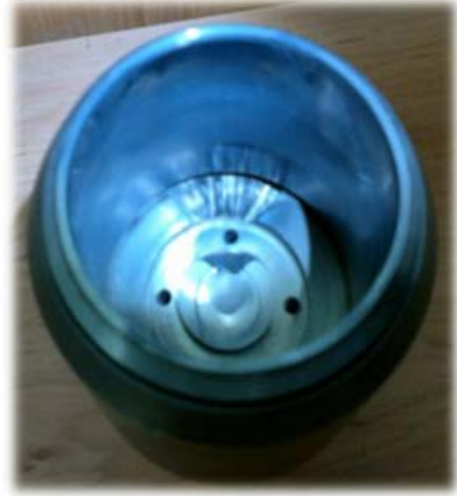
High, localized velocities, vortex flow, jet, and direct increase the rate of erosion-corrosion.

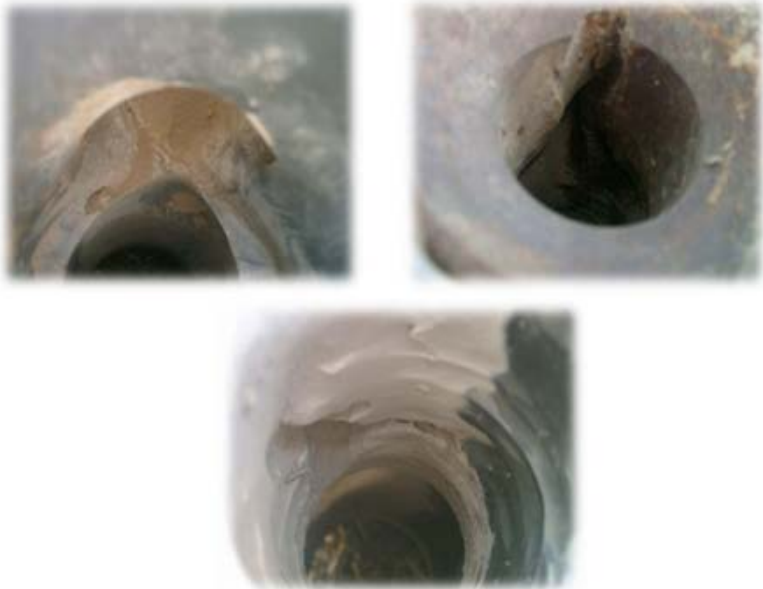
Phenomena: Gas Leakage	Illustration (Macro): Control Valve	Phenomenon: Jet Flow Erosion
Illustration (Micro): Outlet Flange	Environment: Flow line	Size: 3"
Material: A216 WCC	Time in service: 7 Years	Fluid: Sour Gas
Operating Pressure: 4800 Psig	Coating Type:-	Orientation of Specimen: 0°

The mentioned control valve had been carried out in sour gas service. After 7 years of operation, severe erosion corrosion and also groove shape erosion observed in the outlet flange. Over rate operation can be assumed as the main reason for this failure.

The fluid velocity plays a great role in corrosion rate. When the velocity is very high, the impact of the particles present in the fluid upon the inner wall of the equipment tends to remove the protective oxide layer and some of the metals under it causing erosion and thus lead to erosion-corrosion with time.

- Using appropriate rate.
- Using of alloys with high corrosion resistance.

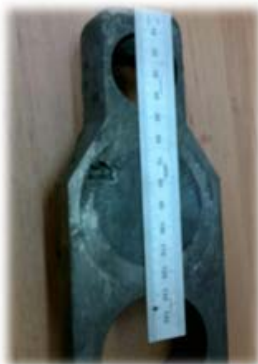
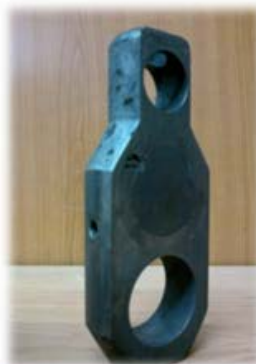
In service, high-pressures and flow rates are often encountered in the pipelines, which convey the fluid from the well-head and the ability of the valve to seal off these flows, when required, is of paramount importance. The Gate valve was used to open, or shut off, fluid flows and was not intended for regulating or throttling; any attempt to use it in this way will bring about a rapid deterioration in its ability to shut off flow.

The predominant wear processes on this gate is erosion, and two- and three-body abrasion caused by the presence of sand in the hydrocarbon fluid. Sand is often entrained in the fluid owing to the geology in which the reservoirs are located.

This damage can compromise the hard-faced sealing surfaces and thus containment of hydrocarbon fluids.

This damage occurs on opening and closing of the valves: when fully open or fully closed, damage is minimal. However, when partially open, swirling or jetting flow leading to low-angle erosive attack on the valve interior can occur. Abrasion can also be present, especially if sand becomes trapped between the gate and the sealing surfaces. The valve can also be subjected to other mechanisms such as sliding wear and galling.

It is assembled dry and adhesive wear can result when the valve enters service.

Damage of this type can significantly affect the performance and lead to its premature withdrawal from service. The most common manifestations of damage are leakage in the closed position, failure to open or close on demand, delayed operation and internal leakage.

- At present, the most widely used coating for seal faces in gate valves are tungsten carbide, with the balance being divided between bulk and sprayed Stellite, low-alloy steel and carbon steel.
- It has been found that the addition of Cr to WC-Co inhibits to a large extent the decomposition of WC-Co as well as having a beneficial effect on the erosion resistance.
- Of the various spraying processes, the high-velocity oxy-fuel (HVOF) method has been found to deposit coatings with significantly lower levels of carbide decomposition and phase transformation .

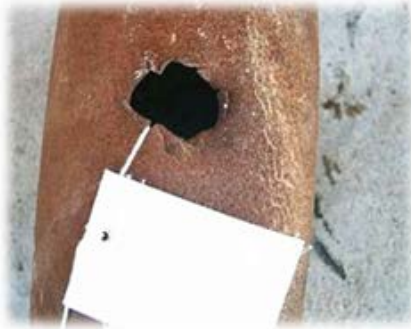
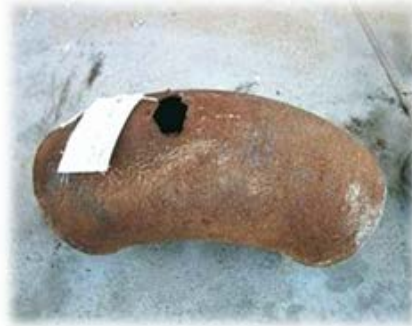
Presence of liquids and also sends intensify the erosion rate and also metal loss. Otherwise direction of flow is perpendicular to elbow wall.

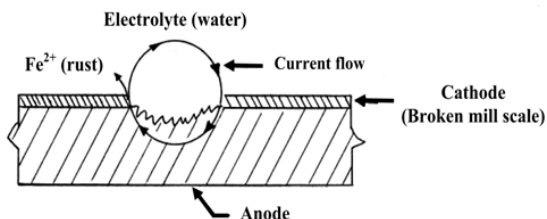
Figure 5: Formation of pit from break in mill scale [17].

If an appreciable attack is confined to a small area of metal acting as an anode, the developed pits are called shallow. The ratio of deepest metal penetration to average metal penetration, as determined by weight loss of the specimen, is known as the pitting factor. A pitting factor of 1 represents uniform corrosion [17].

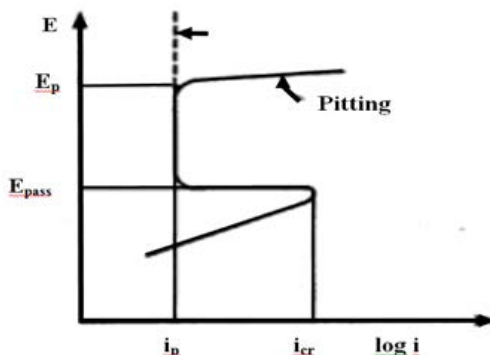
Figure 6: Anodic polarization curve for an active-passive metal in an environment causing pitting corrosion [17]. E_p = pitting potential; E_{pass} = passivation potential; i_{cr} = critical density and i_p = passive current density

Pitting corrosion (sometimes only called pitting) occurs on more or less passivated metals and alloys in environments containing chloride, bromide, iodide or perchlorate ions when the electrode potential exceeds a critical value, the pitting potential (Figure 6), which depends on various conditions. The pitting potential is not a thermodynamically defined potential and depends for one thing upon the rate of potential increase when the polarization curve is recorded. This form of corrosion is characterized by narrow pits with a radius of the same order of magnitude as, or less than, the depth. The pits may be of different shape, but a common feature is the sharp boundary (Figure 7). Pitting is a dangerous form of corrosion since the material in many cases may be penetrated without a clear warning (because the pits often are narrow and covered) and the pit growth is difficult to predict. This is connected to the fact that the extent and the intensity of pitting corrosion is difficult to measure because the number and size of pits (diameter and depth) vary from region to region and within each region. Short-term testing in the laboratory for determination of pit growth is also problematic because, under realistic conditions, it may take long time, e.g. many months, before the pits become visible. Another problem is that the critical size, i.e. the maximum pit depth, increases with increasing surface area [17].

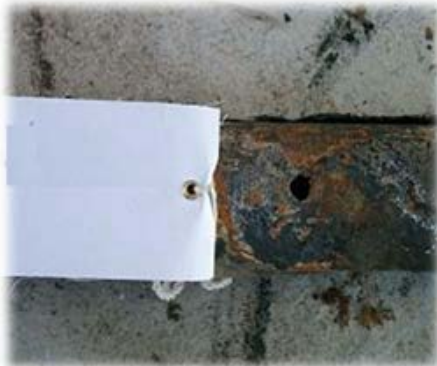
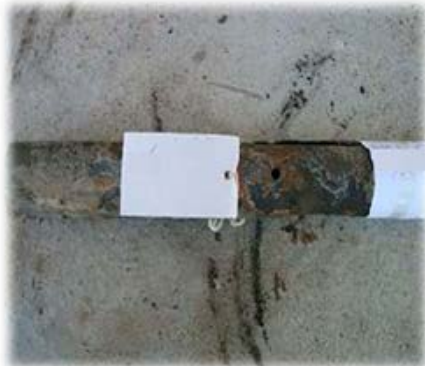
This localized corrosion exists as pitting corrosion because of lacking cathodic protection. This thickness thinning cause a failure in static test in 900 psig. Also metallic and nonmetallic inclusions often play a decisive role in the start of a corrosion pit.

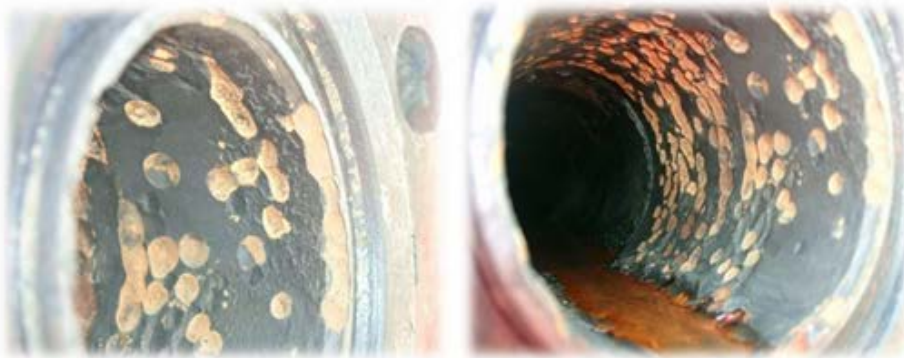
Phenomena: Gas Leakage**Illustration (Macro): Steel flange****Phenomenon: Intense,
widespread pitting****Illustration (Micro): Inner side****Environment: Flow line****Size: 4 1/16"****Material: A105N****Time in service: 5 months****Fluid: Sour Gas****Operating Pressure: 4800Psig****Coating Type:-****Orientation of Specimen: 0°**

Despite of suitable material of mentioned flange (A 105 N), non-metallic inclusions affect on this degradation.

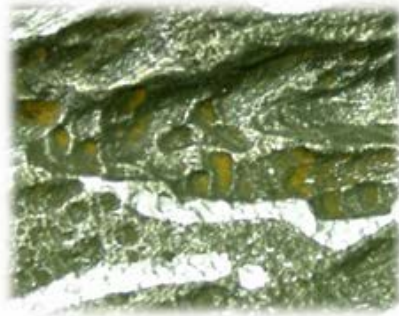
The main reason for this phenomenon is corrosive liquid accumulation. As observed the mentioned part of pipe shows thickness thinning, groove and root pass removing due to unsuitable material fabrication and also sand erosion. This observation provides localized erosion corrosion which exhaust as leakage. Presence of inclusions helps to increase the metal dedagration.

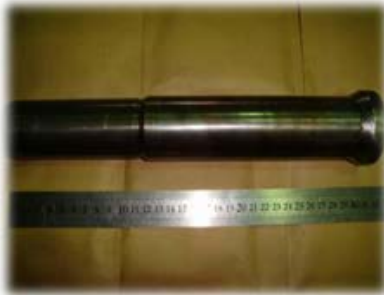
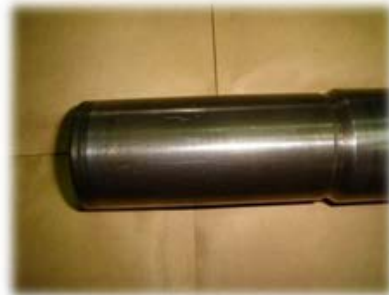
Pitting corrosion occurs at passivated metal surfaces of mentioned during the access of so-called aggressive anions. Halides very effectively attack passivating thin oxide layers, leading to an intense localized dissolution of the metal surface, which is otherwise protected by the passive layer against general dissolution. The restriction of the dissolution to pits within a large passivated metal surface, which may serve as a large cathode for the reduction of oxidants such as dissolved oxygen, leads to fast perforation of the metal, which weakens the construction and thus causes large economic losses and safety problems.

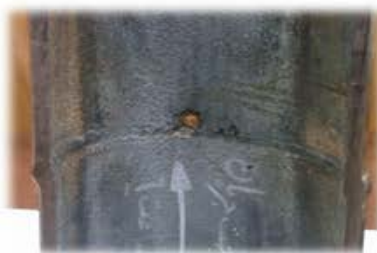
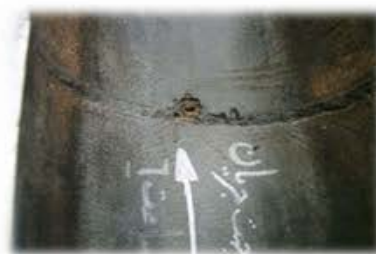
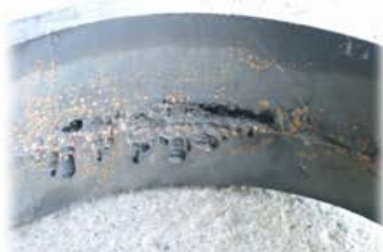
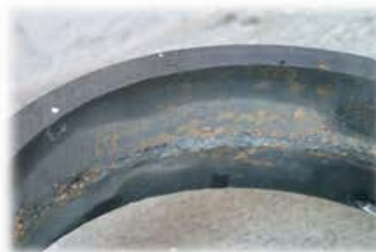
Phenomena: Large perforation**Illustration (Macro): Transition pipeline****Phenomenon: Preferential corrosion of weld****Illustration (Macro): Inside pipe wall****Environment: Under ground****Size: 8"****Material: API 5L-X42****Time in service: 1year****Fluid: Sweet Gas****Operating Pressure: 1440Psig****Coating Type:-****Orientation of Specimen: 0°**

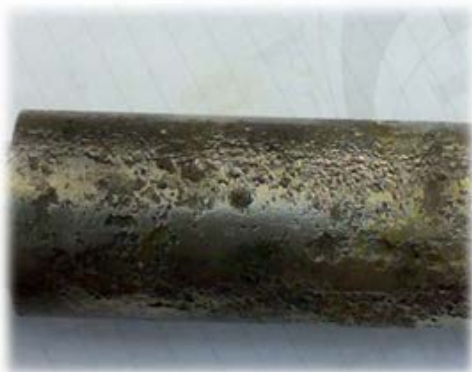
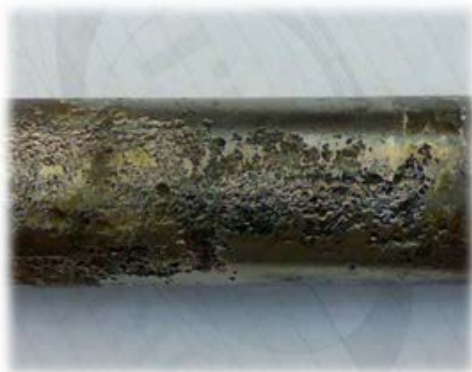
Phenomena: Gas Leakage**Illustration (Macro): Well head equipment****Phenomenon: Severe general pitting****Illustration (Micro): Upper Flow Tube****Environment: Sour gas well****Size: -****Material: Stainless Steel 410****Time in service: 1 year****Fluid: Sour Gas****Operating Pressure: 4500 Psig****Coating Type:-****Orientation of Specimen: 90°**

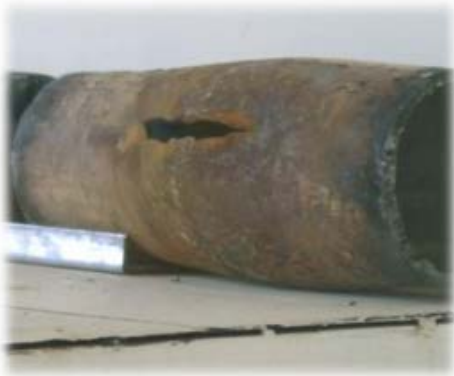
<u>CHAPTER 4</u>	CORROSION CASE HISTORY	<u>HYDROGEN INDUCED CRACKING</u>
Phenomena: Explosion	Illustration (Macro): Pipeline	Phenomenon: Freezing liquid crack
Illustration (Micro): -	Environment: Above ground pipe line	Size: 3"
Material: API 5L-X42	Time in service: 20 years	Fluid: Sweet gas and its liquid compounds
Operating Pressure: 1480 Psig	Coating Type:-	Orientation of Specimen: 0°

<p>History: The sudden reduction of temperature degree causes the freezing of inlet liquid and carries out a crack in the mentioned pipe.</p>		
<p>Solution:</p> <ul style="list-style-type: none"> It's recommended to used as underground pipeline or covered by a protective coating to protect against temperature degree changing.

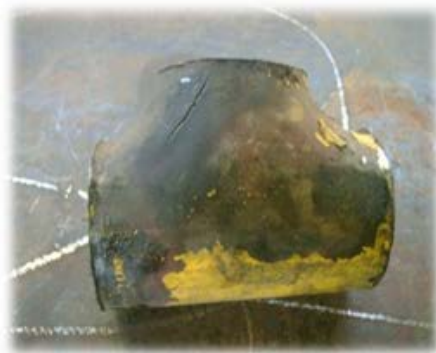
The sudden reduction of temperature degree causes the freezing of inlet liquid and carries out a crack in the TEE body. Also the wrong material selection (A234-WPB) can be assumed as another reason for this failure.

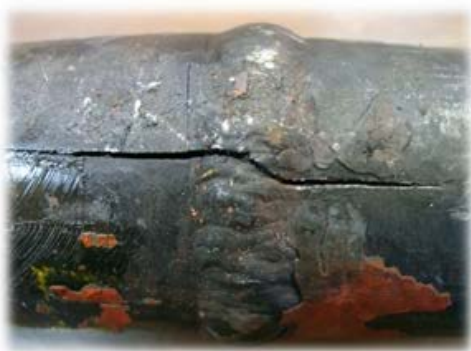
Basically the mentioned pipe was welded with residual stress, there the effect of low temperature in cold session and fluid accumulation cause a crack in the pipe body.

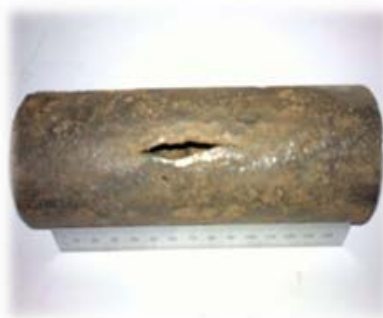
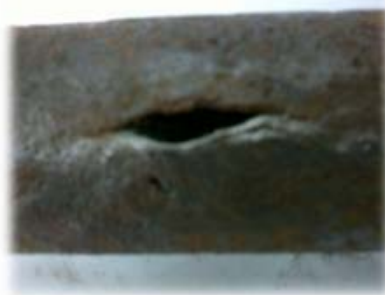
Phenomena: Explosion**Illustration (Macro): Line pipe****Phenomenon: Fish Eye Cracking****Illustration (Micro): Pilot pipe
line****Environment: Above ground****Size: 2"****Material: 5L-Gr B****Time in service: 8 years****Fluid: Sweet gas****Operating Pressure: 1200Psig****Coating Type:-****Orientation of Specimen: 0°**

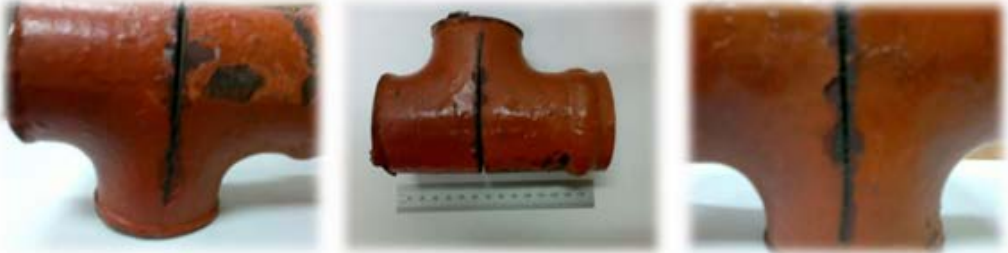
<u>CHAPTER 4</u>	CORROSION CASE HISTORY	<u>HYDROGEN INDUCED CRACKING</u>
Phenomena: Explosion	Illustration (Macro): Equal TEE	Phenomenon: Stress oriented HIC
Illustration (Micro): -	Environment: Above ground	Size: 2"
Material: A234 WPB	Time in service: 22 years	Fluid: Sour Gas
Operating Pressure: 1200Psig	Coating Type: Epoxy	Orientation of Specimen: 0°

<p>History: The hardness of the mentioned was more than accepted value for servicing in sour gas (22 HRC). Also presence of stress and H₂S gas causes stress oriented HIC.</p>		
<p>Solution:</p> <ul style="list-style-type: none"> • Reducing hardness value. • Removing stress.

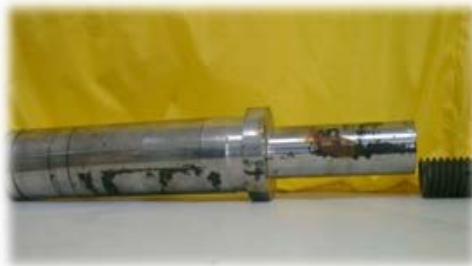
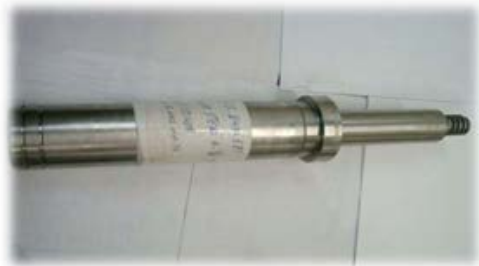
Fatigue was induced from the sharp corner of the keyway.

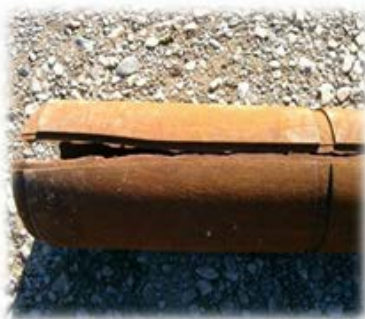
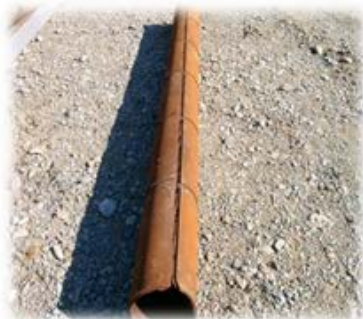
Presences of sour water with chloride make a longitudinal crack along the tube. The main reason is the low resistance of selected material against of HIC and SCC.

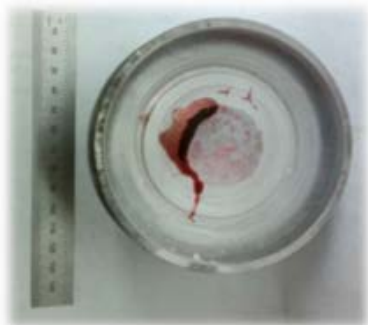
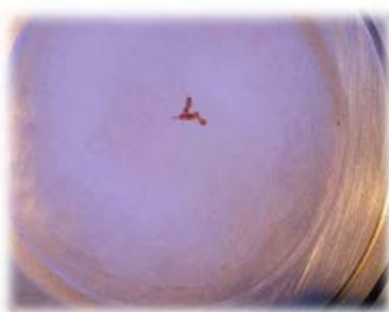
As observed in the photo, stress corrosion cracking (SCC) takes place within the material, where the cracks propagate through the structure. The crack tend to propagate in a direction that is perpendicular to the direction of applied stress(attacking the sands).

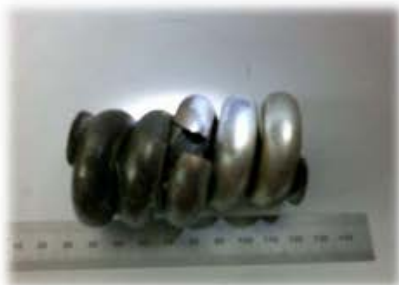
Stress-corrosion cracking occurred because of a corrosive sour gas (H_2S) and sufficient stresses coexist. This spring was used in a safety valve. This fatigue (above figure) occurred due to residual internal stress in the metal or external applied stress. Residual stresses were produced by deformation during fabrication, by unequal cooling from high temperature and by internal structural arrangements involving volume change.

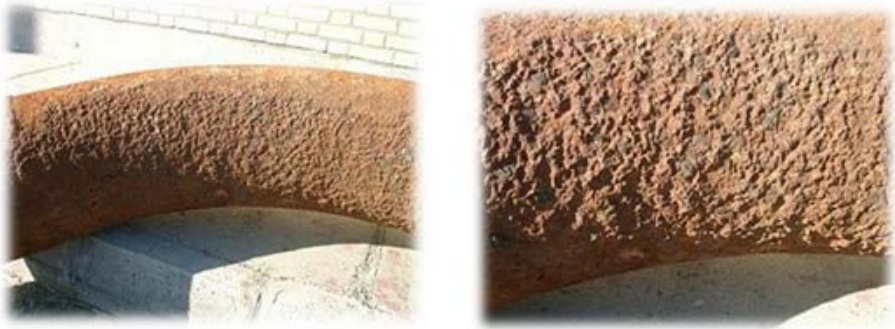
<u>CHAPTER 6</u>	CORROSION CASE HISTORY	<u>CORROSION UNDER INSULATION</u>
Phenomena: Thickness Thinning	Illustration (Macro): Elbow 90°	Phenomenon: Severe general pitting
Illustration (Micro):-	Environment: Underground pipeline	Size: 6"
Material: A 234 WPB	Time in service: 22 years	Fluid: Sour Gas
Operating Pressure: 1440 Psig	Coating: Calcium silicate	Orientation of Specimen: 0°

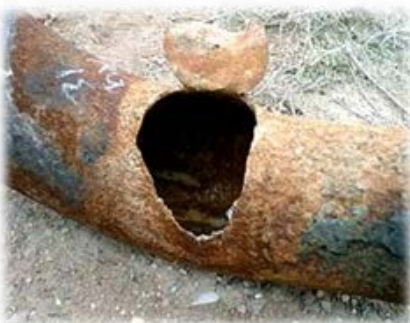
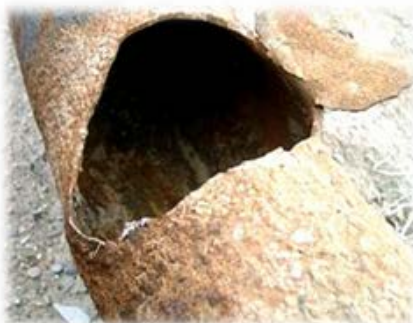
Phenomena: Explosion**Illustration (Macro): Elbow 90°****Phenomenon: Severe Pitting
Corrosion****Illustration (Micro): Transition
pipe line****Environment: Under ground****Size: 6"****Material: A860-WPHY42****Time in service: 2 years****Fluid: Sour Gas****Operating Pressure: 1440 Psig****Coating Type: CaSiO₃****Orientation of Specimen: 0°**

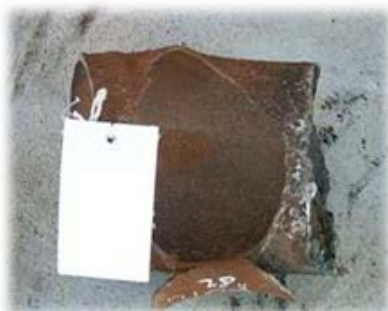
Phenomena: Rupture**Illustration (Macro): Elbow 90°****Phenomenon: Severe Pitting
Corrosion****Illustration (Micro): Transition
Flow Line****Environment: Under Ground
Flow Line****Size: 6"****Material: A860-WPHY 42****Time in service: 20 years****Fluid: Sour Gas****Operating Pressure: 1440 Psig****Coating Type:-****Orientation of Specimen: 90°**

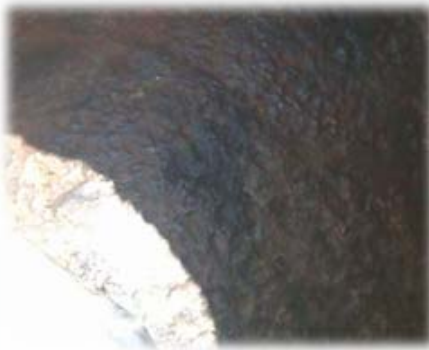
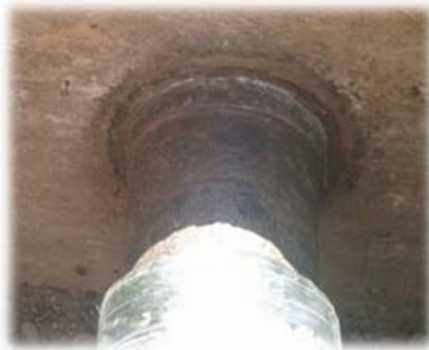
The coatings which used in welding parts were thermal coating of CaSiO_3 . This coating absorbs the corrosive electrolyte. Despite of using of appropriate cathodic protection system, because of corrosive electrolyte accumulation near the welding area. A galvanic cell creates and severe corrosion process starts. Finally corrosion under insulation occurs in shape of deep pits.

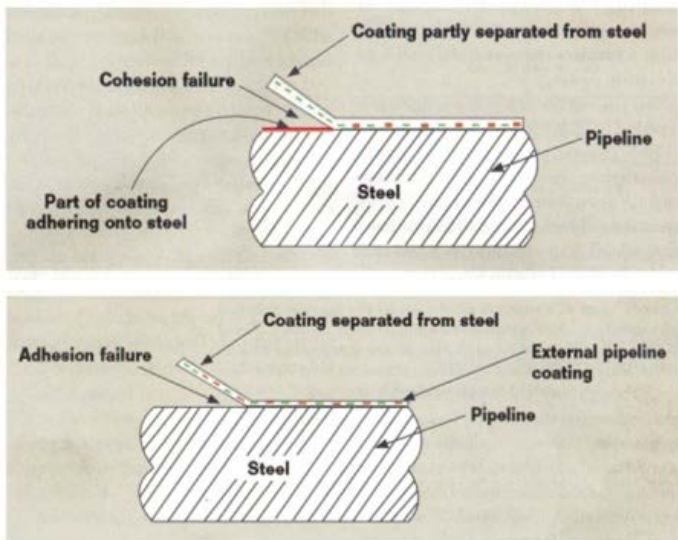
Figure 8: a) Adhesion failure, b) Cohesive coating failure [27].

The permeation of gases may break certain chemical bonds, but may have limited effect on the overall performance of the coating. This is the eighth-ranked failure mode [27].

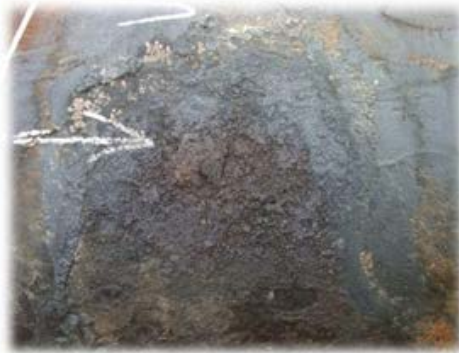
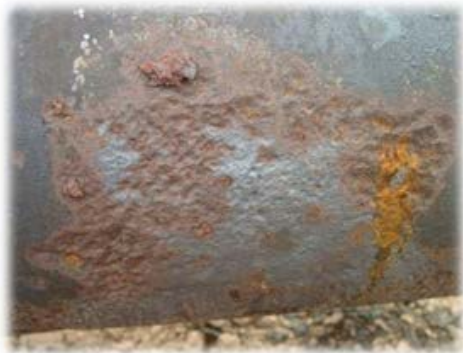
The mentioned flow line carried out for 20 years, but unfortunately the protective coating could not act as a good barrier for metal surface. Therefore corrosive media diffuse under it and corrosion under coating occurred.

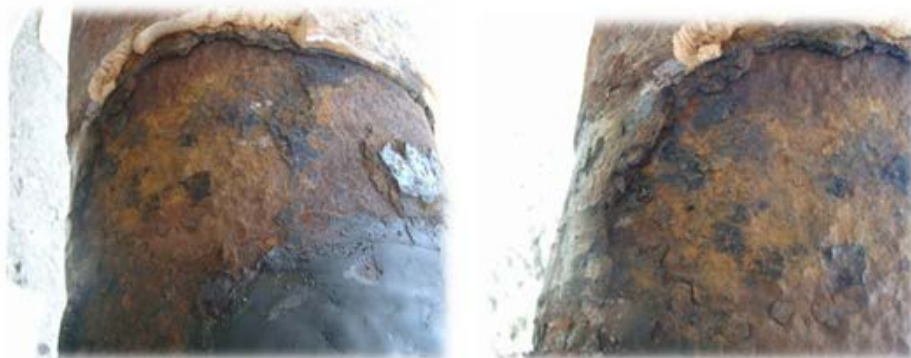
The mentioned flow line carried out for 29 years, but unfortunately the protective coating could not act as a good barrier for metal surface especially near the weld sections. Therefore corrosive media diffuse under it and corrosion under coating occurred.

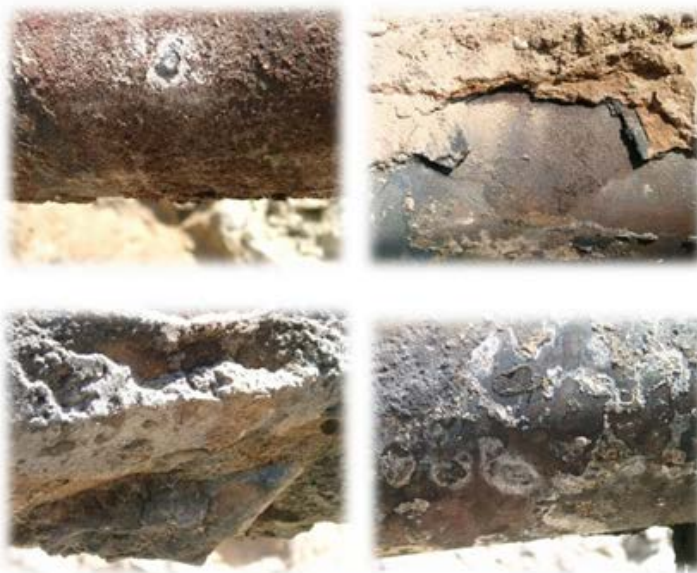
The mentioned pipeline had been used as transition pipeline at underground environment (under soil). After coating disbonding and diffusing of corrosive electrolyte the corrosion process occurs. This process causes thickness thinning and if it is not indicated, maybe an explosion will occur.

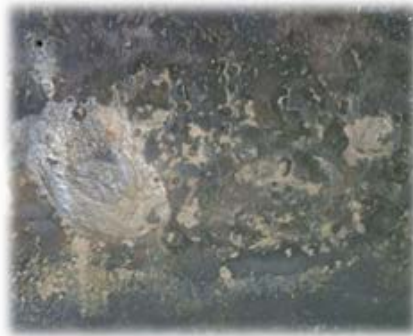
The deposition of impurities, as debris causes the formation of differential aeration cells, and allows the absorption of moisture from the air which leads to corrosion. Also presence of H₂O, H₂S, CO₂ accentuates the corrosion process. Furthermore the accumulation corrosion products prevent of contacting of corrosion inhibitors to metal surface and the protection process fails. This process results as thickness thinning which can be detected by Phased Array method.
