ADELAIDE IN-DEPTH ACCIDENT STUDY

1975-1979

PART 2: PEDESTRIAN ACCIDENTS

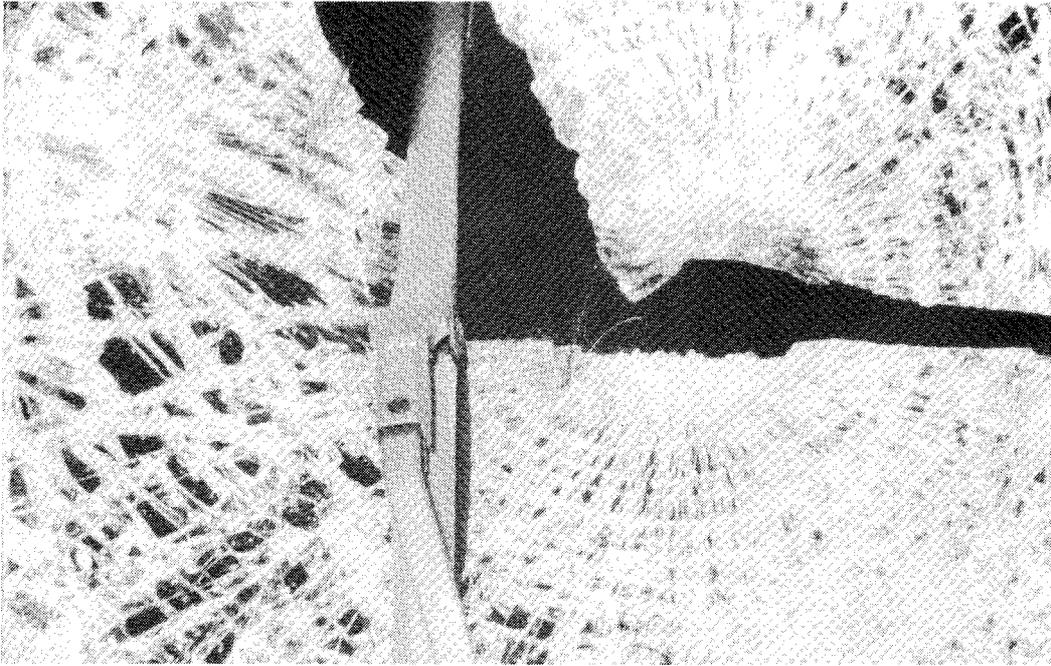
FIGURE 11: Head contact with windscreen. Note hairs caught in glass. See also Figures 16 and 26. Accident 144.

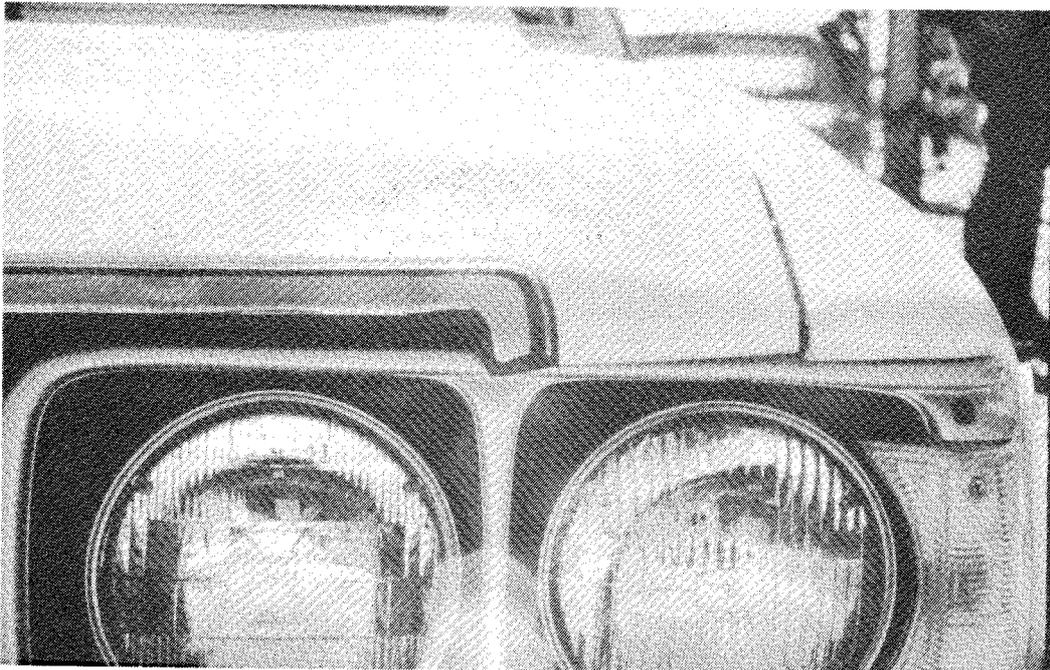
FIGURE 12: Damage to car resulting from impact with the head of a three year old child pedestrian. Accident 060.

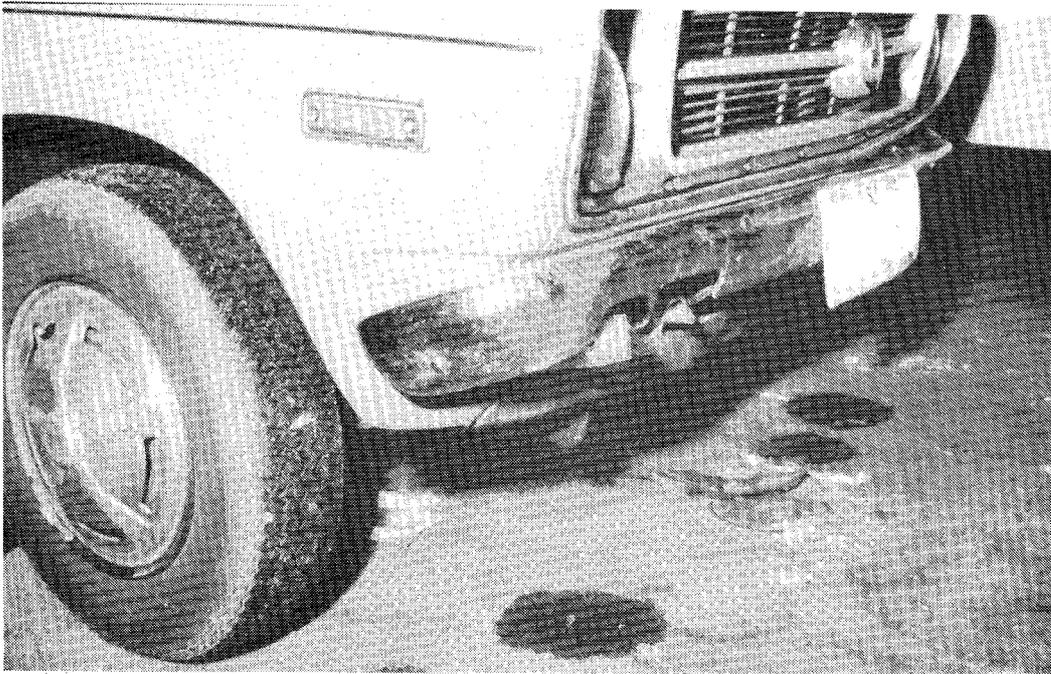
FIGURE 13: Distortion of bumper bar due to collision with an adult pedestrian. Accident 144.

Figure 13 shows the distortion of the front bumper bar of a Datsun 1200 which resulted from a collision with a pedestrian who was standing still in the centre of the road, side-on to the car (Accident 144). The pedestrian was one of the two noted above who sustained a severe knee injury.

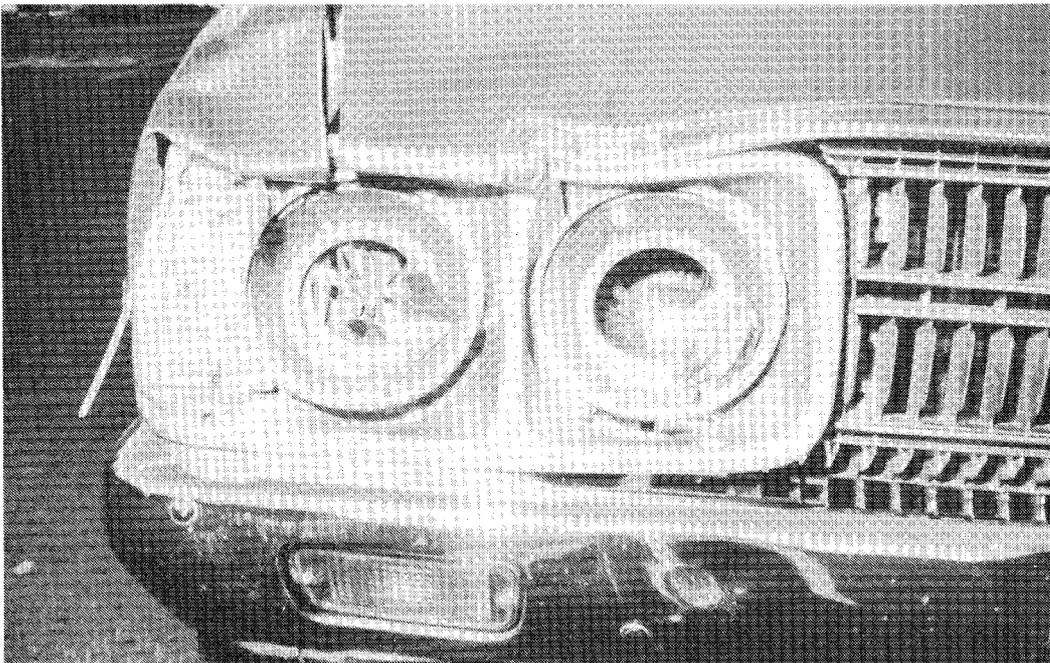
FIGURE 14: Damage resulting from a collision with an elderly female pedestrian. Accident 256.

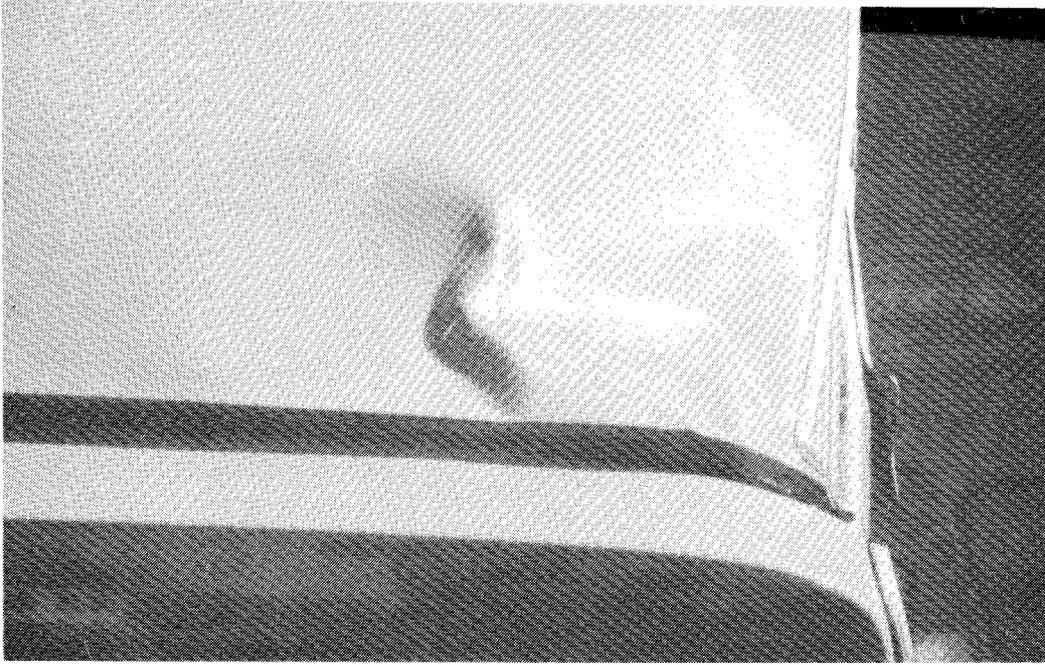
FIGURE 15: Damage to the bonnet of the car in Accident 144.

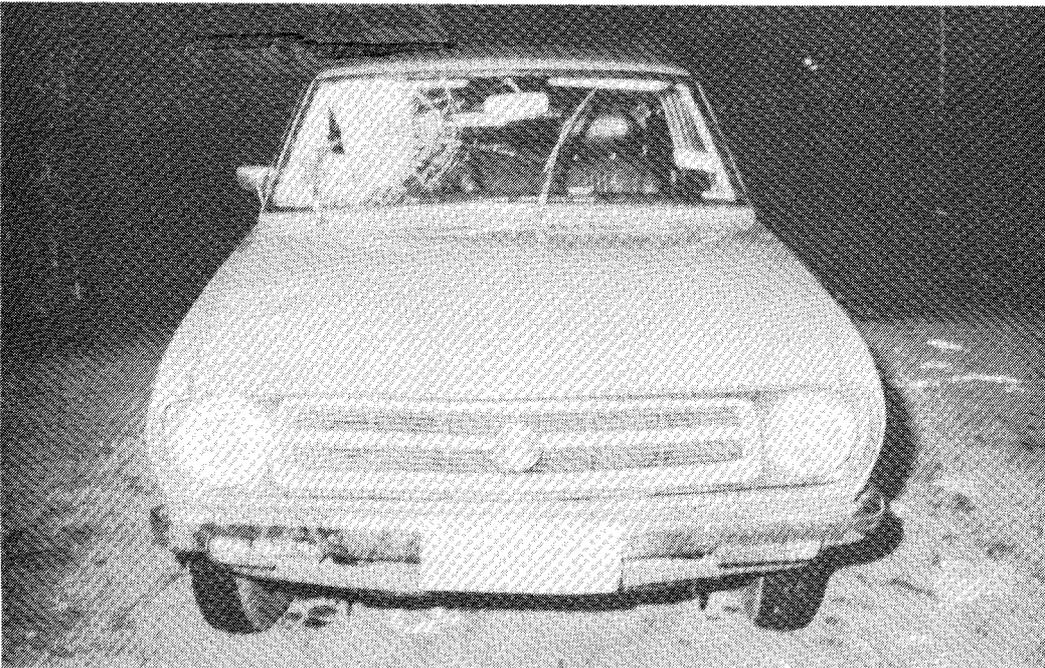
FIGURE 16: Bumper, bonnet and windscreen contact points in Accident 144.

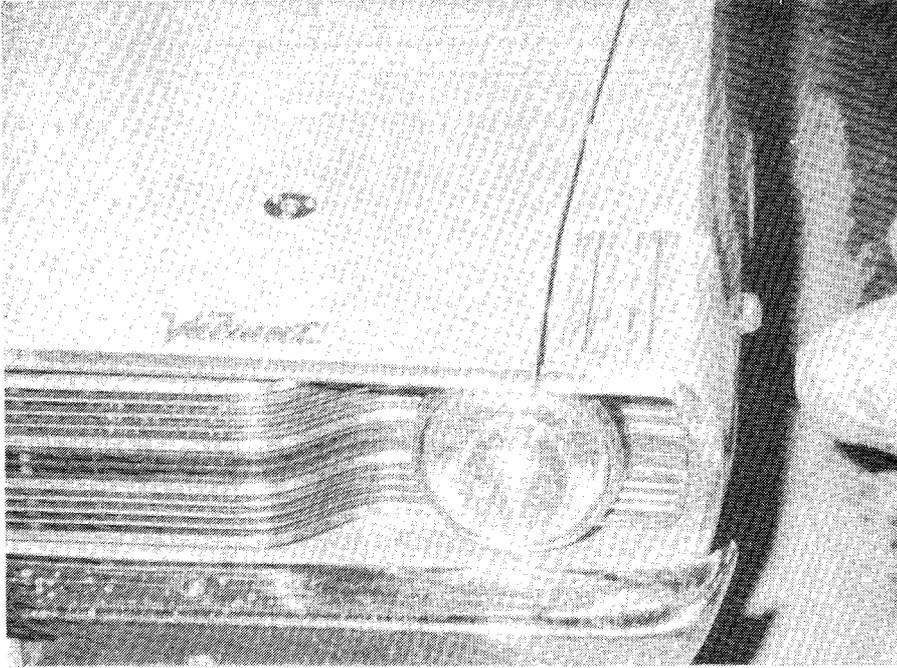
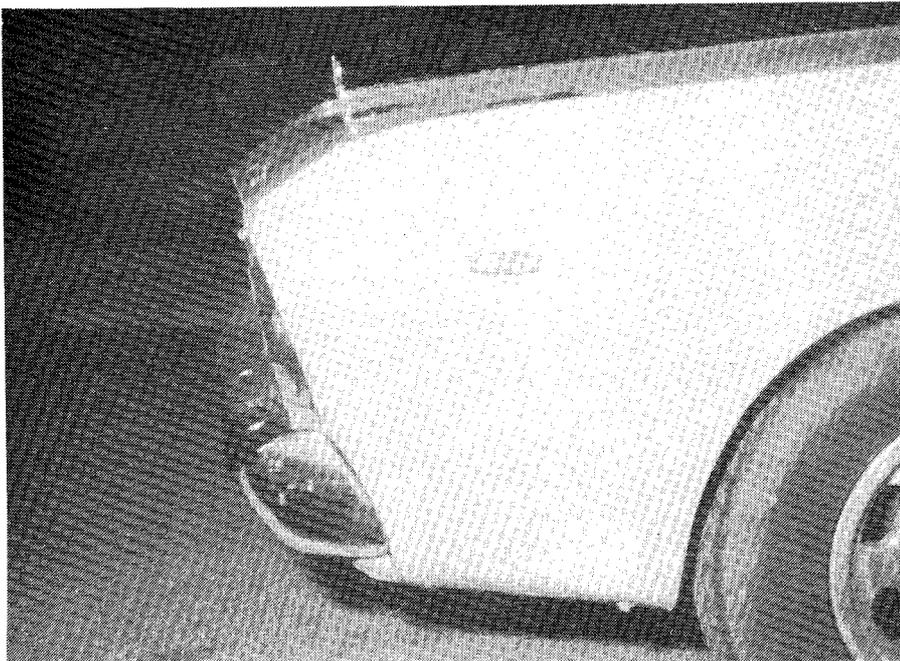
FIGURE 17: See caption to Figure 18.

FIGURE 18: An eight year old boy received a ruptured liver and a ruptured kidney when struck on the side by the front corner of this car. Accident 208.

An eight year old boy received a ruptured liver and a ruptured kidney when hit on the right side by a Chrysler Valiant (Accident 208, Figures 17 and 18).

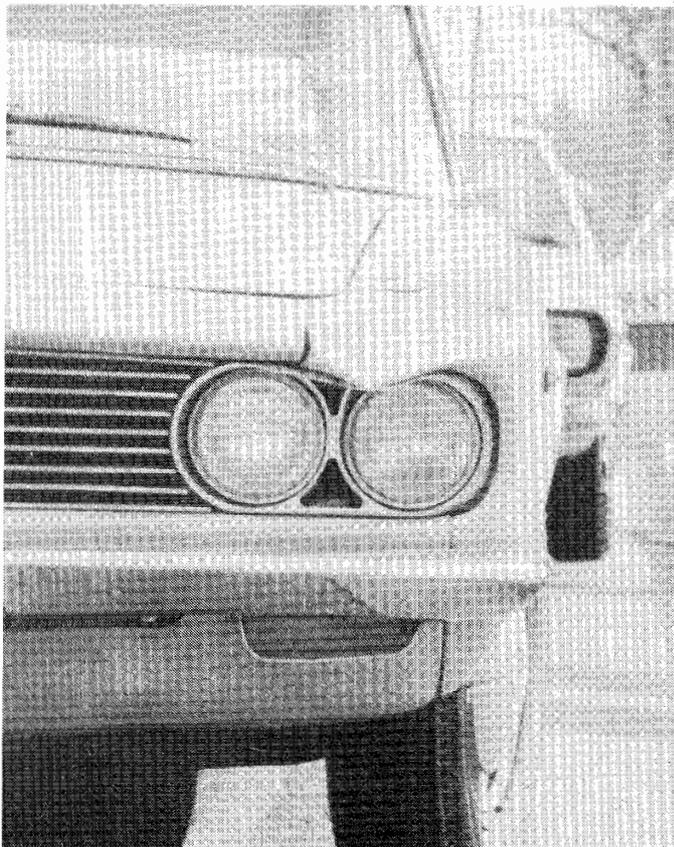
FIGURE 19.
Damage resulting from a collision with an elderly male pedestrian, who sustained a fractured pelvis. Accident 140 (see frontispiece).

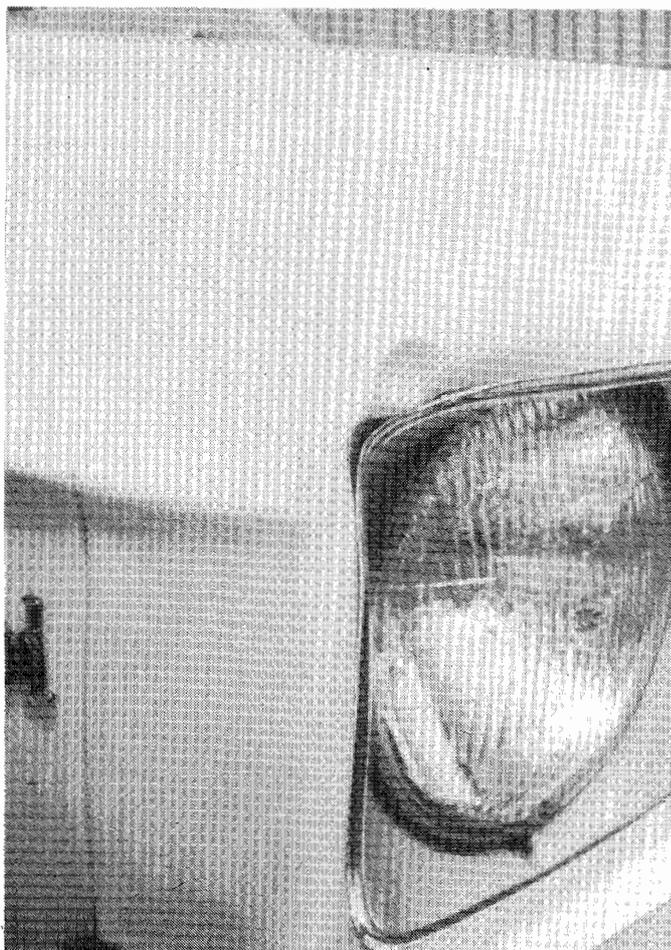
FIGURE 20:
This impact fractured the right femure and pelvis of a middle-aged male pedestrian. Note damage to pain work of car due to the fabric of the pedestrian's clothing sliding across the certical edge of the front corner of the car during the impact. Accident 191.

A pedestrian who was standing in the centre of the road (Accident 191), sustained a fractured right femur and a fractured pelvis when he was hit by the right front corner of a Holden sedan. Figure 20 shows the relatively minor damage to the car, which indicates the undesirable rigidity of this part of the vehicle rather than the force of the impact.

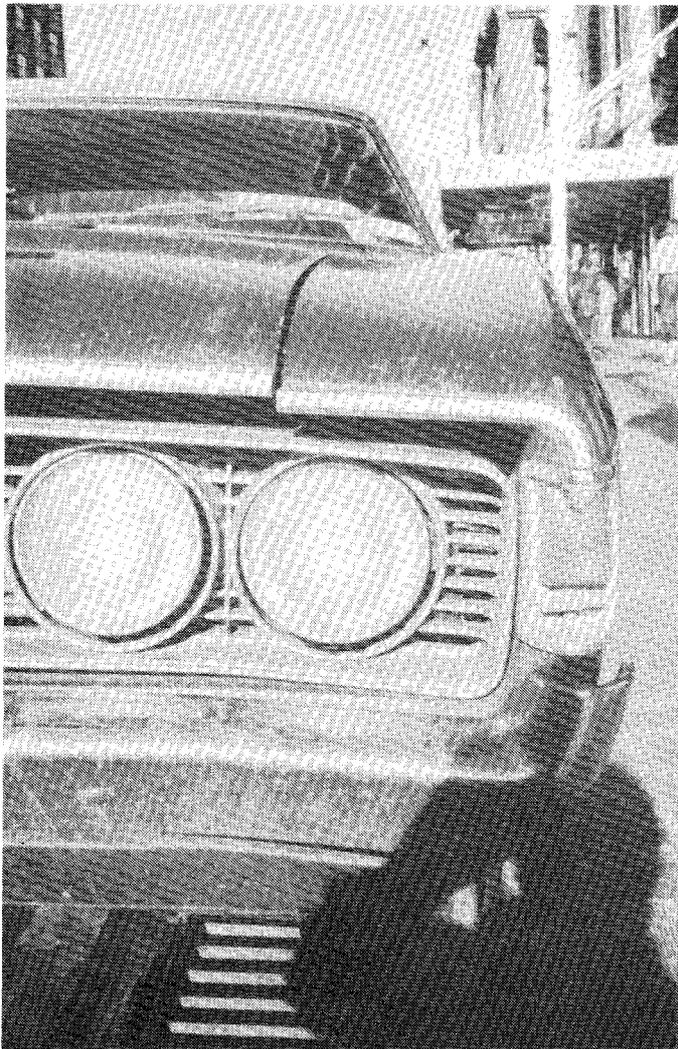
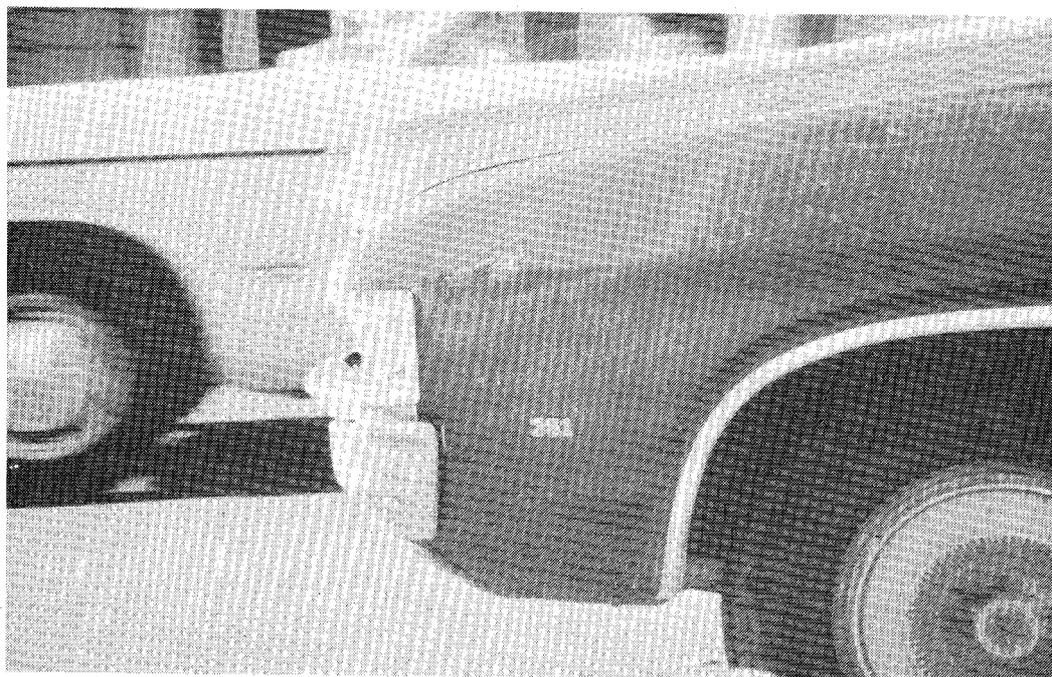
FIGURE 21:
See caption to Figure 22.

FIGURE 22: The front corner of this car fractured the right femure of a thirty year old female pedestrian (see also Figures 21 and 23). Accident 190.

The fourth pedestrian in this group, a 30 year old female, had her right femur fractured by an impact from the left front

corner of a Ford Fairlane sedan (Accident 190, Figures 21 to 23). Her right arm was also broken, near the shoulder, and she was hospitalized for 10 weeks.

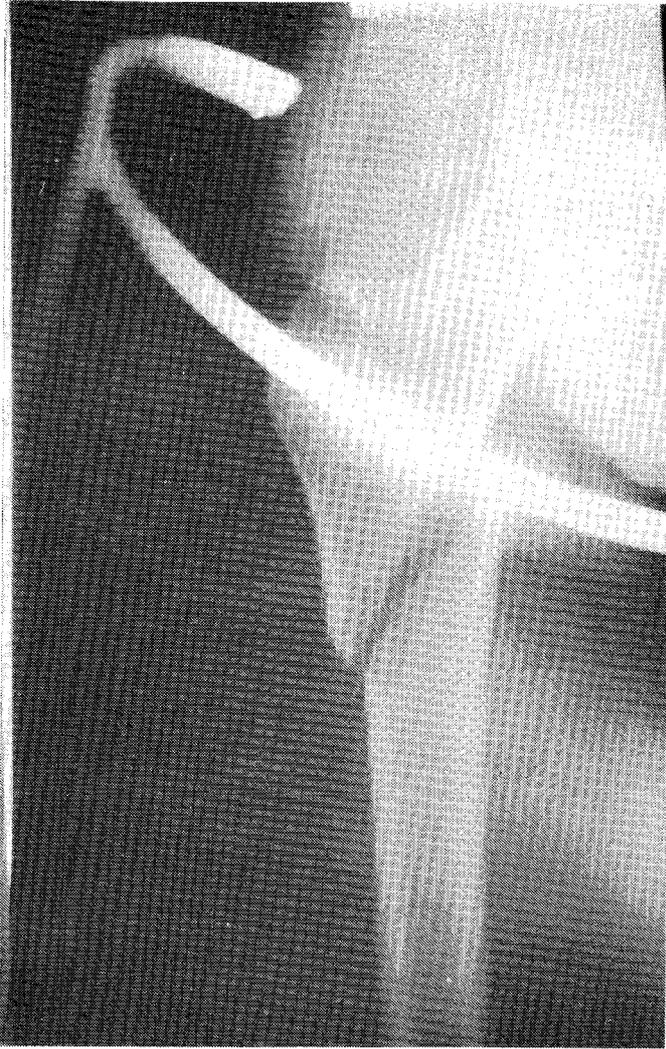
FIGURE 23:
Fracture of the right femur
of the pedestrian struck by
the car shown in Figures 21
and 22.

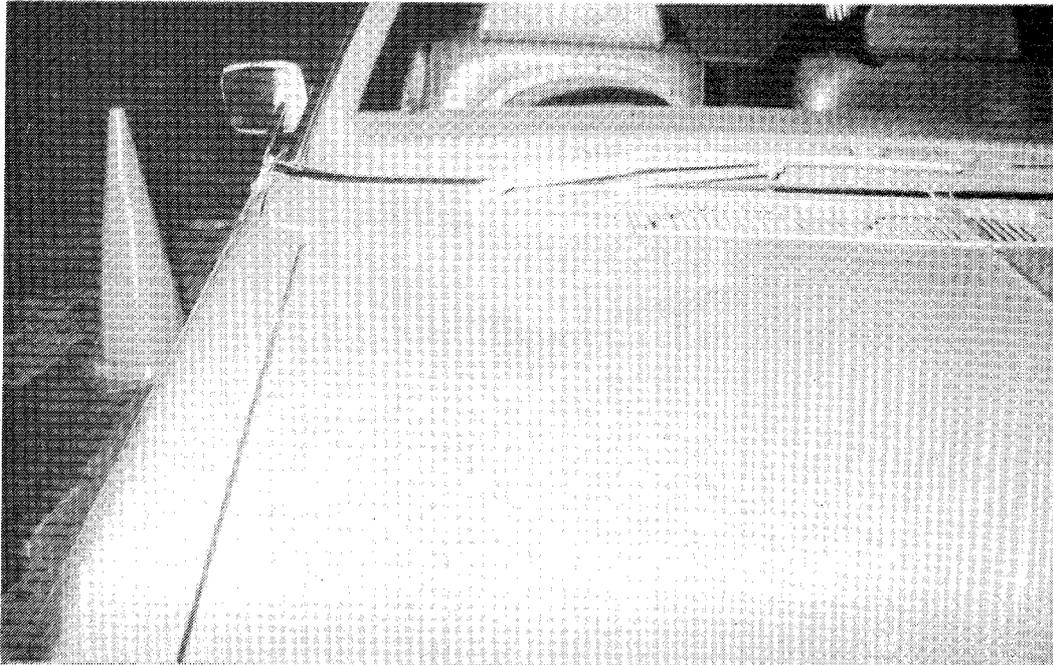
FIGURE 24: Damage to bonnet of car due to impact by
pedestrian's head. Accident 135.

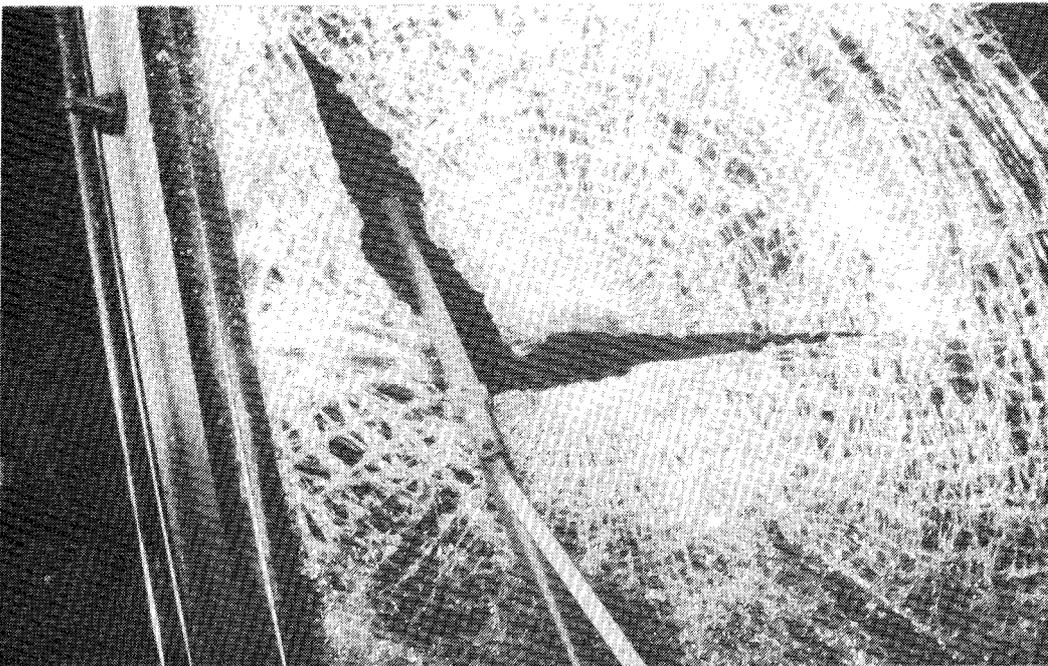
FIGURE 26: Damage to windscreen of car due to impact by pedestrian's head. Accident 144. See also Figures 11 and 16.

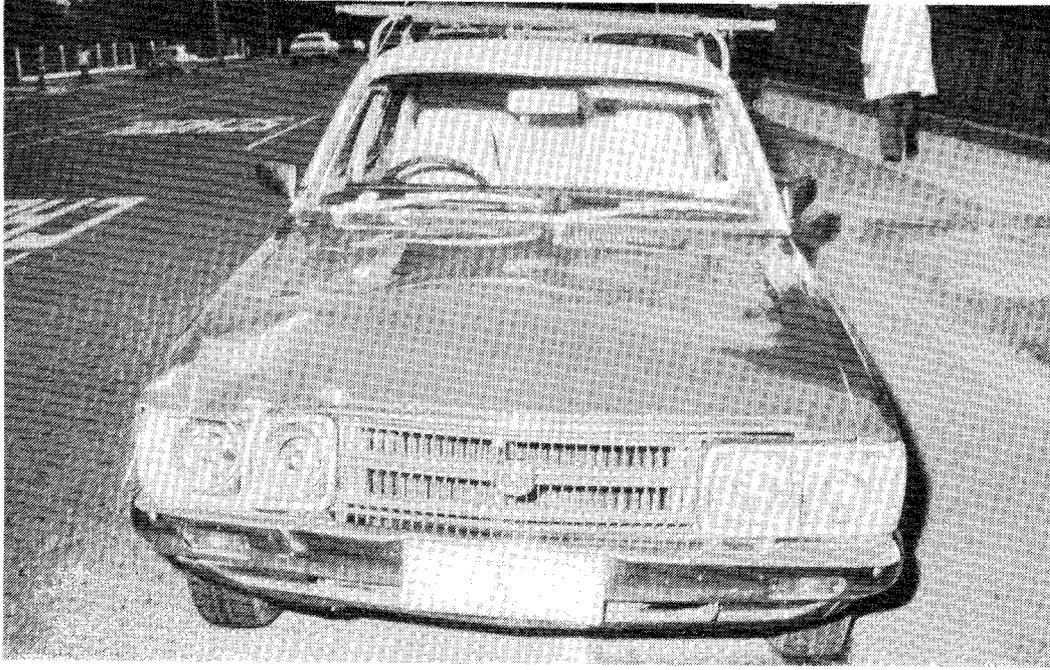
FIGURE 27: See caption to Figure 28, and Figure 14.

FIGURE 28: Accident 256. Pedestrian contact points are visible at the right front corner of the car, the right rear corner of the bonnet and, arrowed, as a scratch mark across the left side of the boot lid.
