**Spatial Simulation Based Riverbank Slope
Instability and Susceptibility Assessment in the
Lower River Murray**

Thesis submitted in fulfilment of the requirements for the degree
of Doctor of Philosophy

The University of Adelaide
Faculty of Engineering, Computer and Mathematical Sciences
School of Civil, Environmental and Mining Engineering

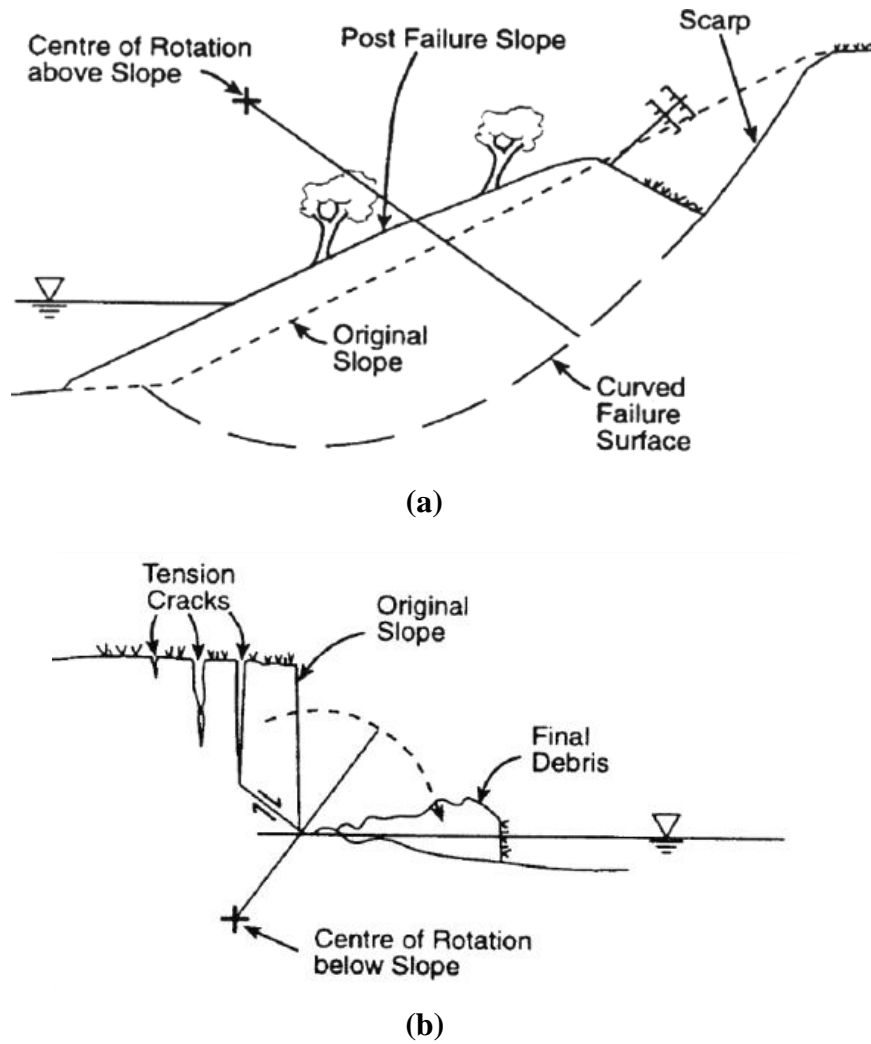
Figure 1.3 Slope failure on riverbanks (a) rotational slip on over-steepened riverbanks, (b) slab failure on over-heightened riverbanks (Source: Thorne, 1999).

Riverbank slope failures, as shown in Figure 1.3, are influenced by several factors:

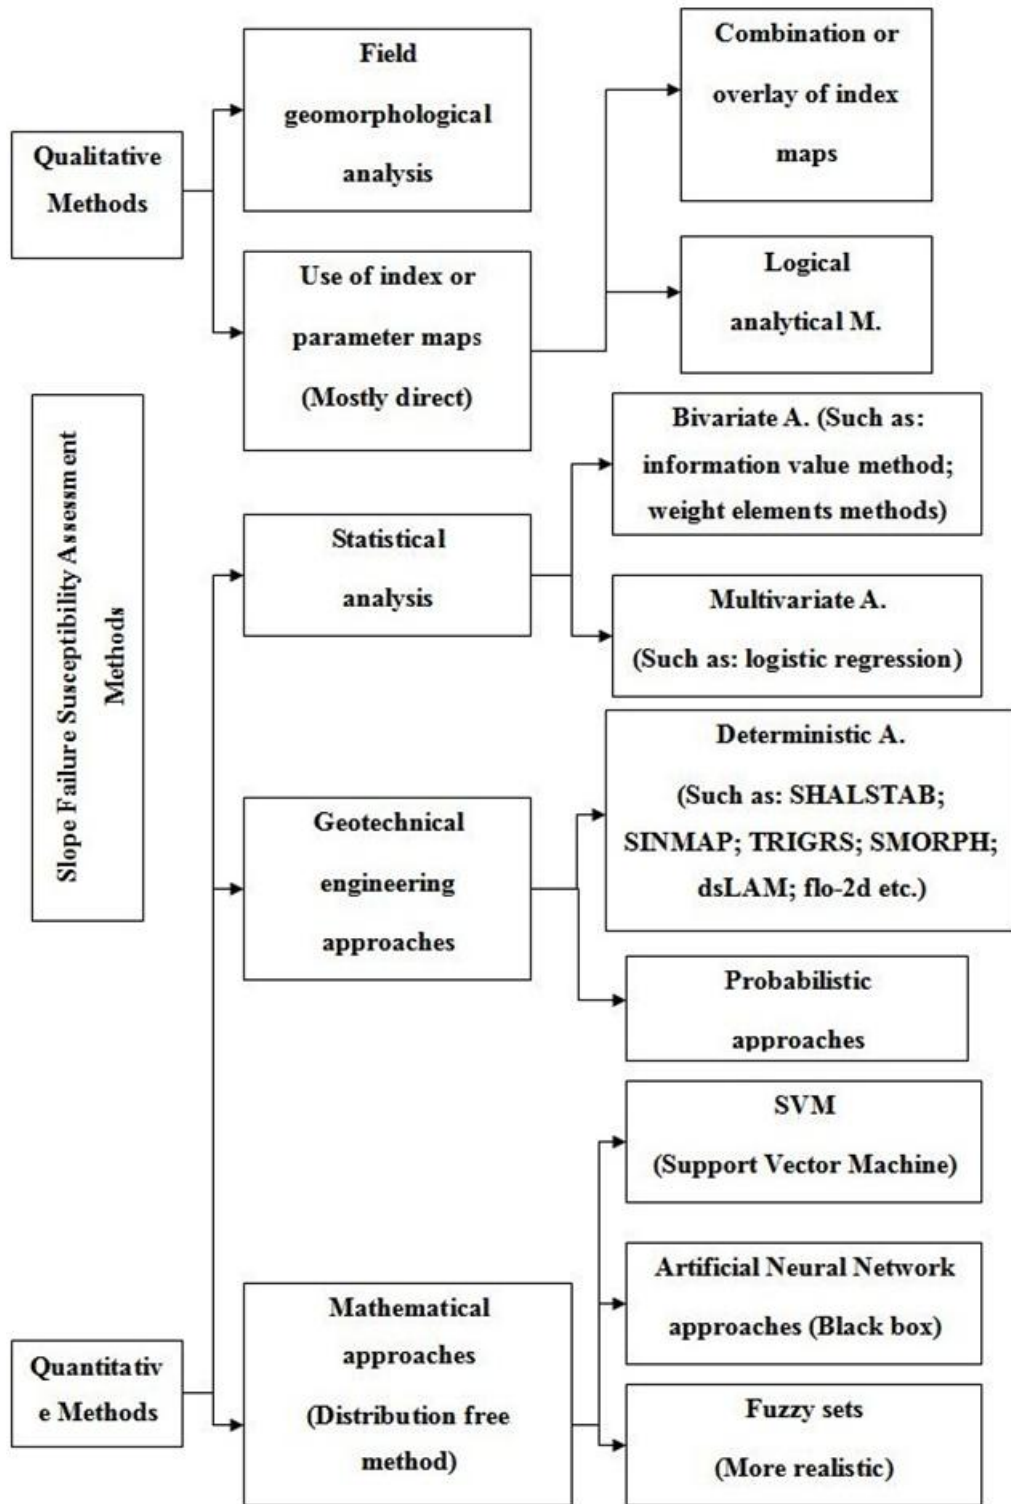
Figure 2.1 Proposed classification of slope failure susceptibility assessment methods

with empirical experiences to help identify sites susceptible to landslides, accompanied by the predictions made from analysis of landslide inventories; (2) multivariate analysis of physical influencing factors; (3) stability ranking with statistical analysis based on criteria such as slope, lithology, land use form, or geology structure and (4) probability analysis of slope failure based on slope stability models with hydrologic simulations. The more detailed categories of assessment methodologies are shown in Figure 2.1.

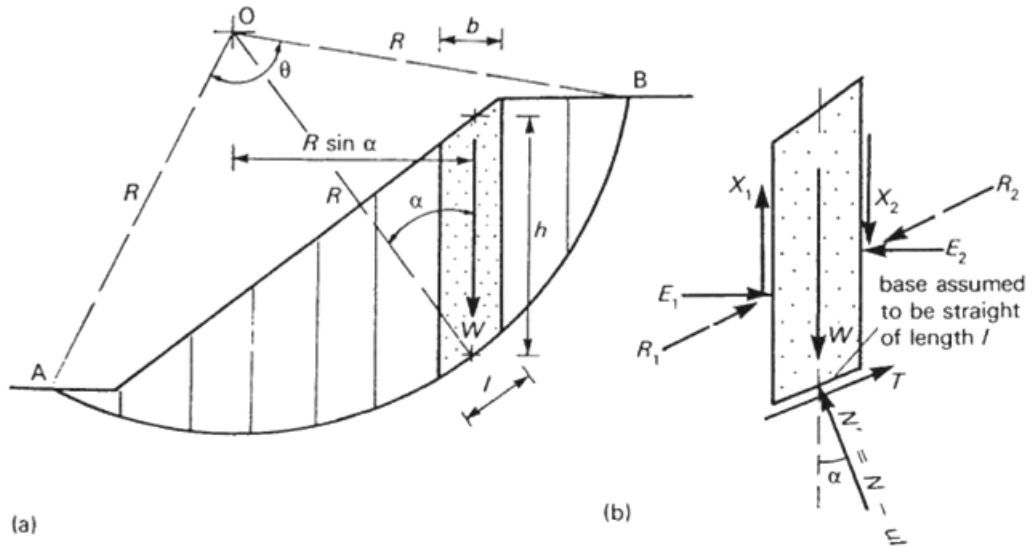
Figure 2.2 Method of slices: (a) division of slip mass; (b) forces on a slice
(Source: Whitlow, 1990).

In most common use in geotechnical engineering is the limit equilibrium method (LEM) and several commercial software packages are available which utilise this approach. The majority of stability analyses are carried out in terms of effective stresses in problems where changes in porewater pressures take place. Because of the variations in these stresses along a trial slip surface, the slip mass is considered as a series of slices, as shown in Figure 2.2, where W = the body weight of the slice; N' = the effective normal reacting force at the base of the slice; T = the shearing force induced along the base = $W \sin \alpha$; R_1 and R_2 = forces imposed on the sides from adjacent slices, which may be resolved into: E_1 and E_2 = normal interslice forces; and X_1 and X_2 = tangential interslice forces (Whitlow, 1990). A trial slip circle is selected having a centre, O , and a radius, R , and the horizontal distance between the two ends A and B divided into slices of equal breadth, b (Whitlow, 1990).

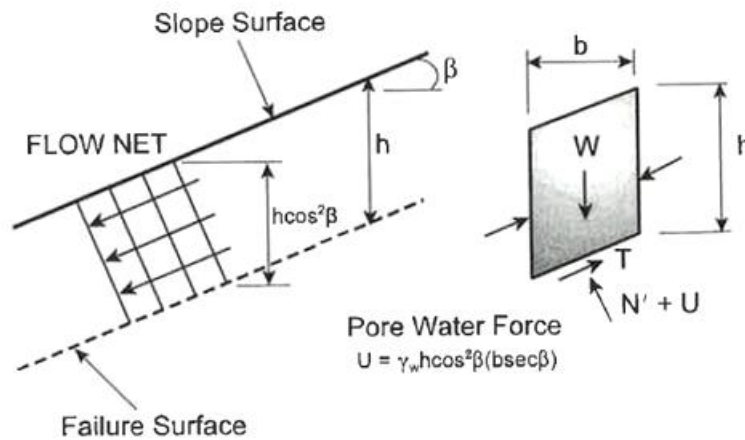
Figure 2.3 Infinite slope failure in $c-\phi$ soil with parallel seepage (Source: Abramson et al., 2002).

For cohesive-frictional ($c-\phi$) soil in a fully saturated condition, the same limit equilibrium concept can also be applied to determine FS , as shown in Figure 2.3. As depicted in Figure 2.3, U represents the porewater force; and S is the effective normal force, determined as follows:

From Equation (2.9), it is clear that FS is independent of the slope height and depth, h , but is reduced by the parameter $\frac{\gamma'}{\gamma_{sat}}$. For typical soils, this reduction will be 50% for fully saturated conditions when compared to dry conditions (Abramson et al., 2002).

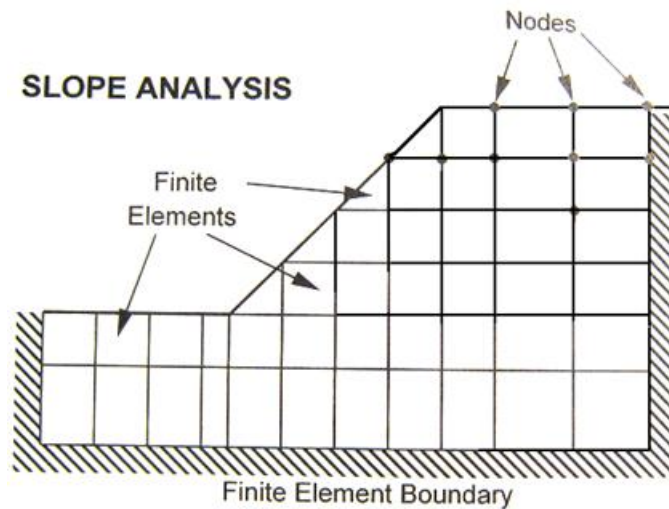
Figure 2.4 Definitions of terms used for finite element method (FEM)
(Source: Abramson et al., 2002).

As shown in Figure 2.4, the FEM essentially divides the slope surface into discrete units called elements. Each node and predefined boundaries of the continuum, as shown in Figure 2.4, connects the neighbouring elements. The displacement method formulation of the FEM is typically used for geotechnical applications and presents results in the form of displacement, stresses and strains at node points (Abramson et al., 2002). In the FEM, the soil on the failure surface is modelled as numerous discrete elements, and the failure mechanism of these discrete elements is considered as a progressive

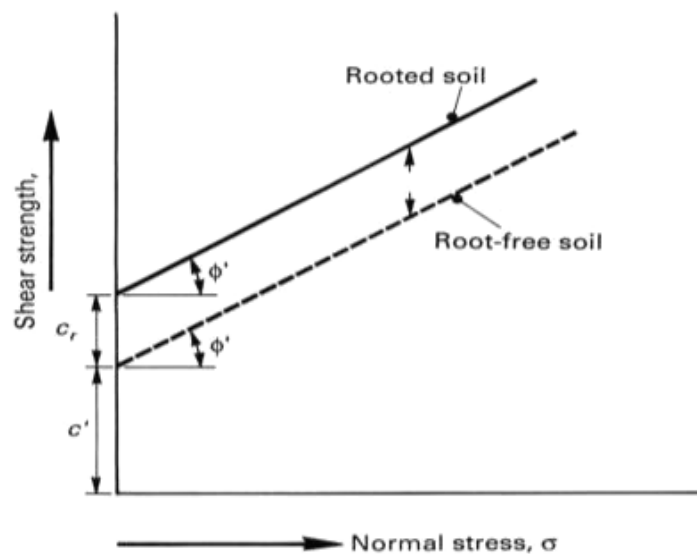
Figure 2.7 Effect of root reinforcement on shear strength of soil
(Source: Coppin and Richards, 1990).

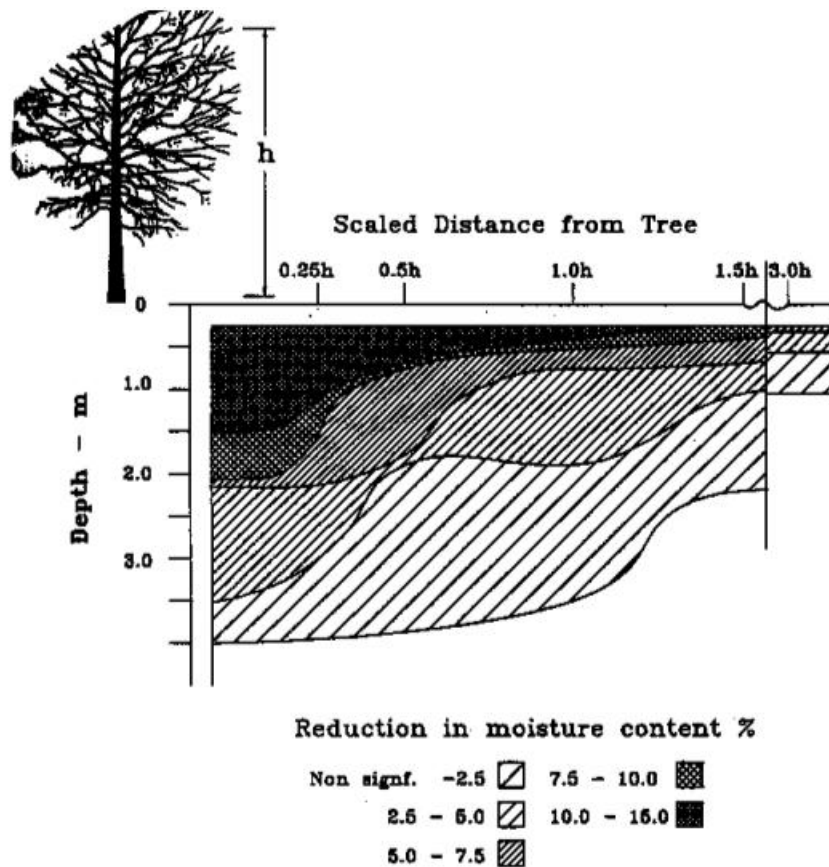
Figure 2.8 Reduction in soil moisture content near a Poplar tree growing in boulder clay (Source: Biddle, 1983).

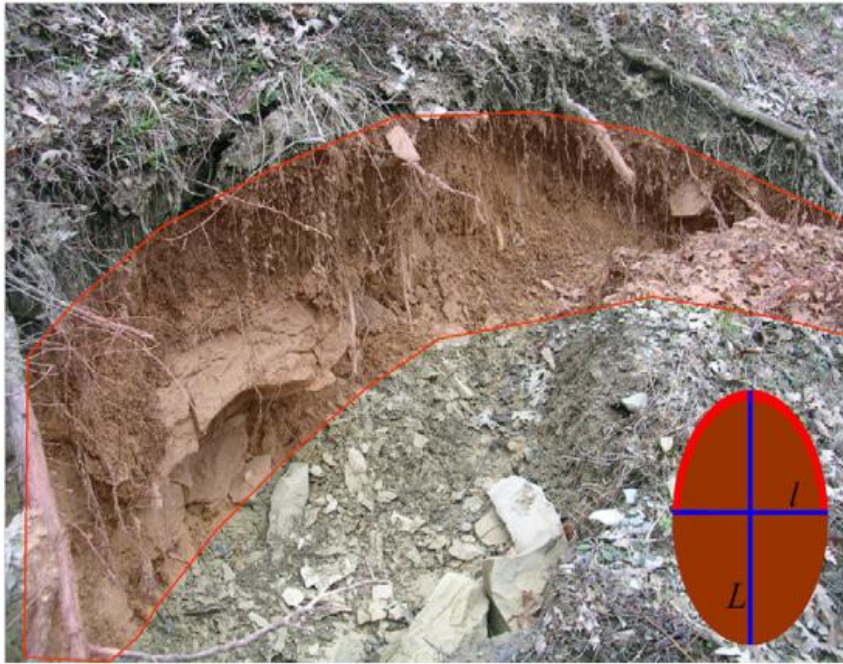
Figure 2.9 Illustration of the root matrix system of vegetation on riverbank
 (Source: Schwarz et al., 2010).

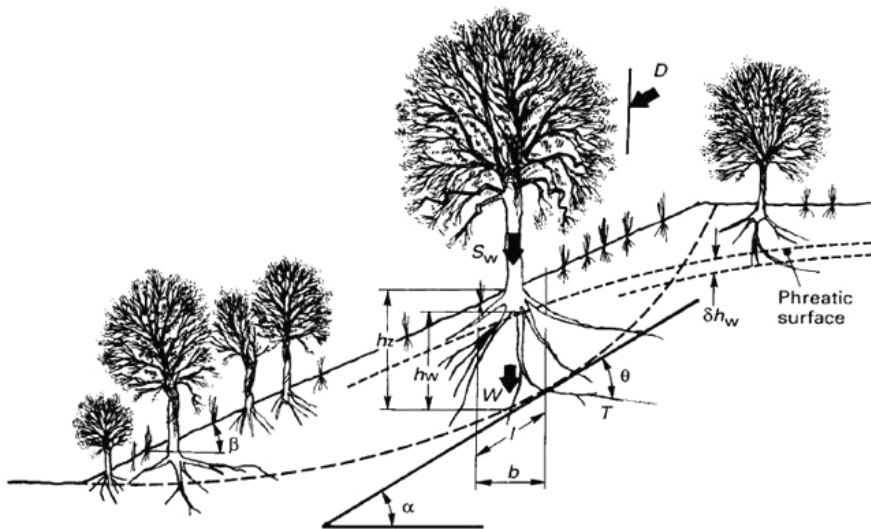
Figure 2.10 Influence of vegetation on riverbank (Source: Coppin and Richards, 1990).

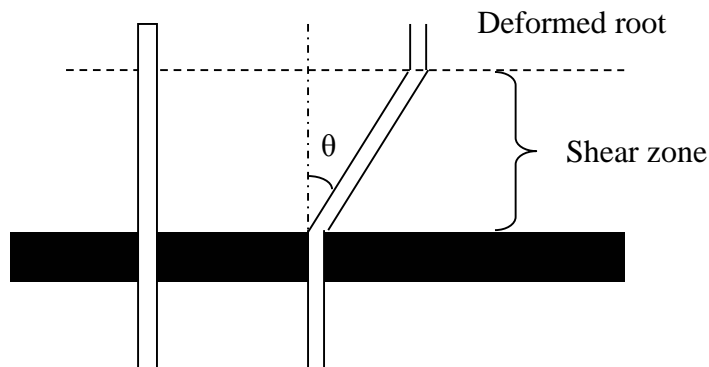
Figure 2.11 Angle of angle of shear distortion in the shear zone.

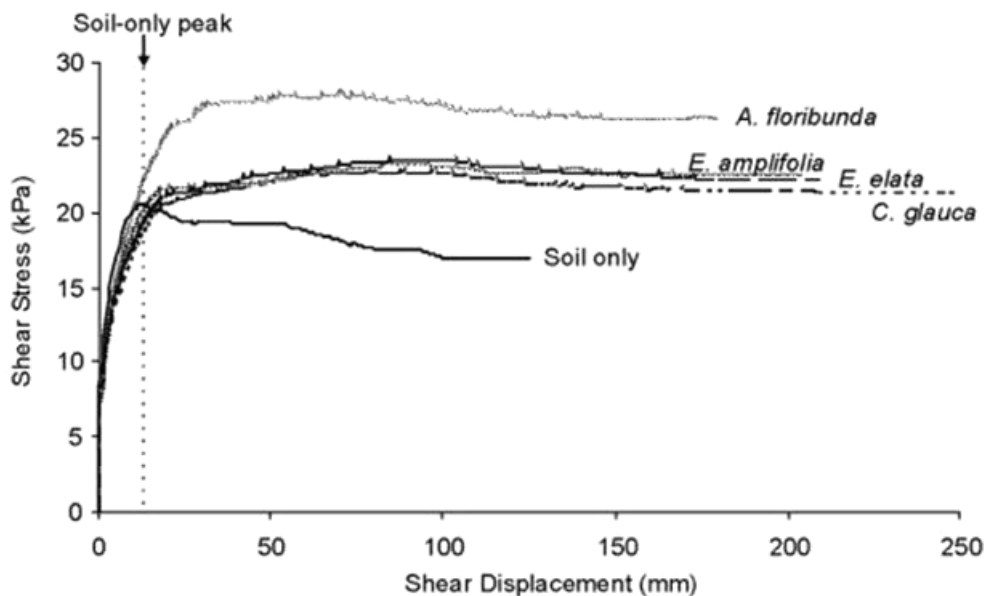
Figure 2.12 Average shear stress versus displacement plots for the four tree species and the soil-only tests (Source: Docker and Hubble, 2008).

respectively (Robert and Natasha, 2010). The field testing carried out by Docker and Hubble (2008) to study the increased shear resistance of soil due to root-reinforcement by four common Australian riparian trees, *Casuarina glauca*, *Eucalyptus amplifolia*, *Eucalyptus elata* and *Acacia floribunda* with a large-scale shear box, suggested that the tree root failed progressively rather than simultaneously, which is proposed by Wu et al. (1979). Docker and Hubble (2008) also showed that the calculated shear strength of the root-reinforced soil, assuming simultaneous root failure, yielded values 50% and 215% higher than directly measured shear strengths. The shear stress versus displacement plots for the four aforementioned tree species and soil only tests by Docker and Hubble (2008) is presented in Figure 2.12.

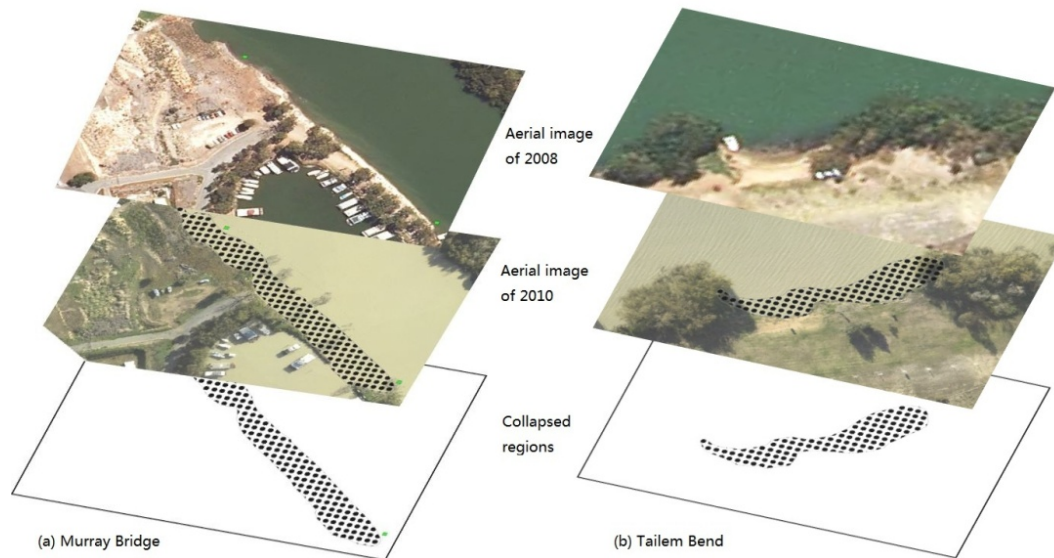
Figure 3.2 Examples of visual interpretation on 2008 and 2010 aerial images under ArcGIS in (a) Murray Bridge and; (b) Tailem Bend.

collapse region. Based on the visual comparison of aerial images of 2008 with 5m resolution and 2010 with 0.5m resolution, the collapsed region were vectorized as dotted area as shown in Figure 3.2.

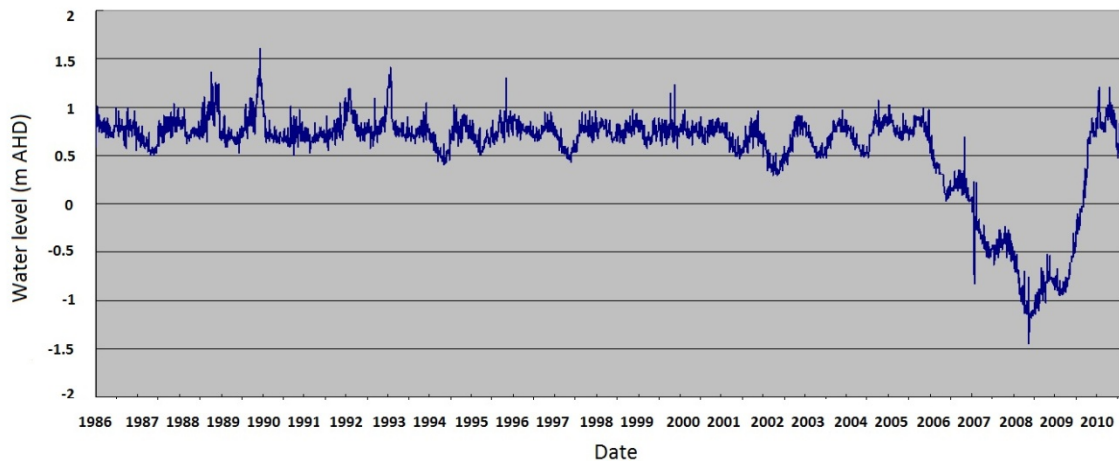
Figure 3.4 River Murray water at Murray Bridge 1/12/1986 to 11/07/2011
(DFW 2010).

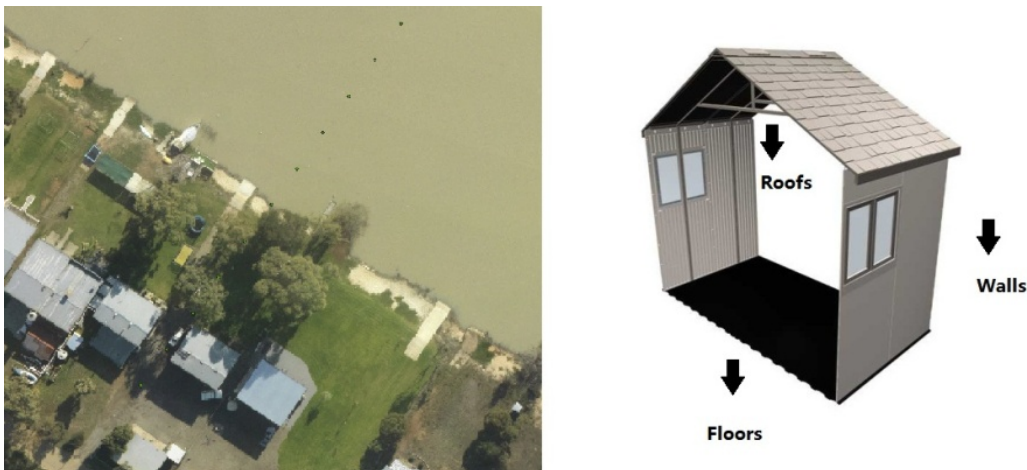
Figure 3.5 Schematic of the locations and the deadweight of the external loads
on the riverbank.

As shown in Figure 3.5, based on the aerial images of 2008 and 2010, the locations of riparian residential regions were identified using visual interpretation under ArcMap. Under SVSlope (SVOoffice, 2012), the load exerted by a house to the foundation is roughly 20 kPa, which comprise the weight of the roof, walls, floor and the live loads.

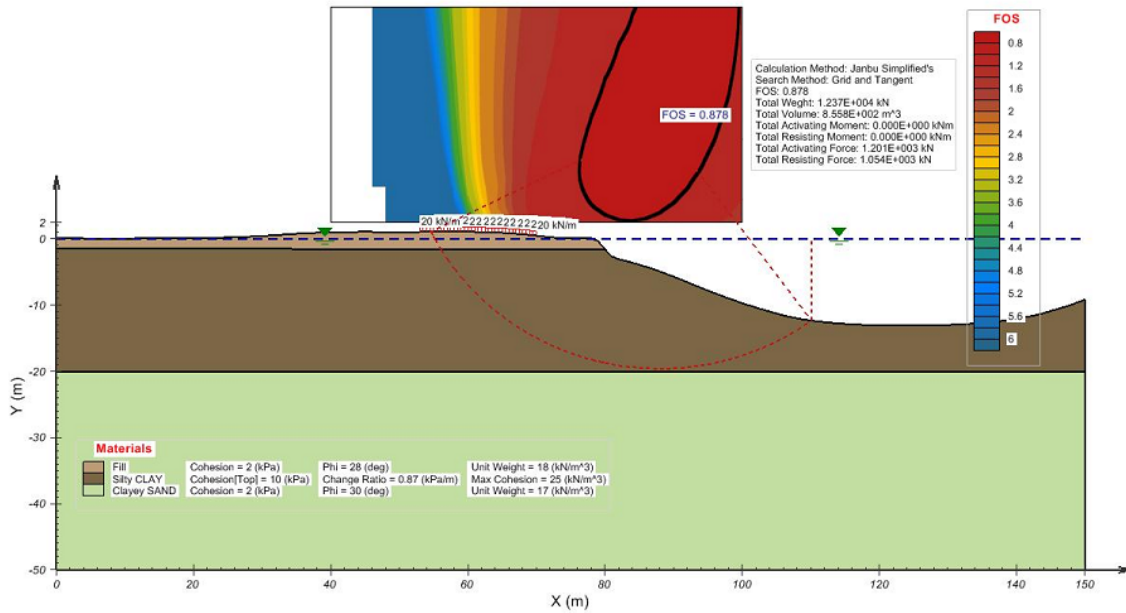
Figure 3.6 Minimum FOS and potential slip surface of deep-seated rotational failure at No. 21 model when water level was 0 m AHD.

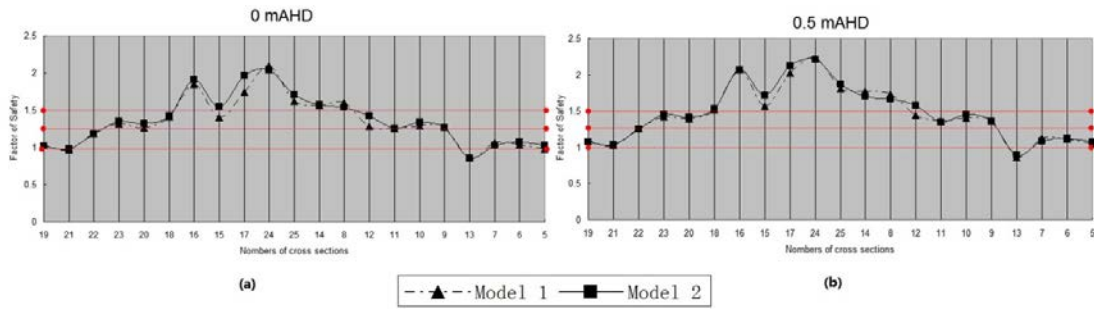
Figure 3.8 Factors of Safety of neighbouring cross sections (0 and 0.5 m AHD).

With reference to the River Murray, a long term FOS of 1.5 has been adopted as the minimum acceptable accounting for human safety and protection of assets (DFW 2010). In addition, $FOS \leq 1$ is adopted as “Unstable”, which indicates additional stabilisation is needed for stability; $1 < FOS \leq 1.25$ was assumed to be “Quasi stable”, indicating that minor destabilising factors can cause instability, such as additional surface loading, severe boat wash, river drawdown and high winds affecting trees; $1.25 < FOS \leq 1.5$ was adopted as “Moderately stable”, implying that moderate destabilising factors can cause instability, such as construction and extensive river drawdown; and $FOS > 1.5$ was adopted as “Stable”, denoting that only major destabilising factors will cause instability.

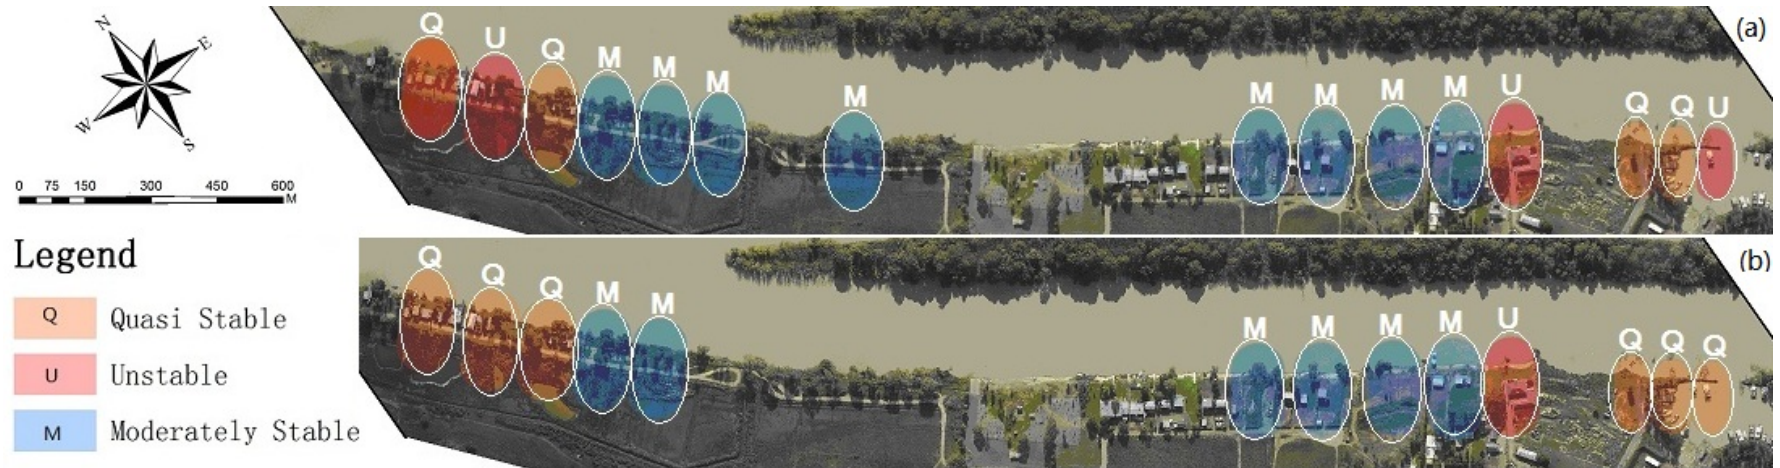
Figure 3.9 Predictions of riverbank susceptibility with river levels at (a) 0 m AHD and (b) 0.5 m AHD.

As shown in Figure 3.9, risk of riverbank instability is, in general, reduced by increasing river levels. Hence, when the river level is restore to 0.5 m AHD, a relatively large proportion of the banks examined present as quasi stable rather than moderately stable.

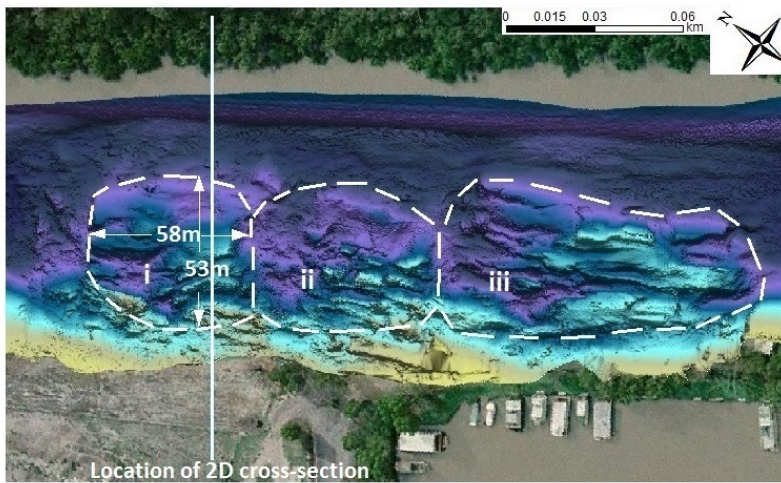
(b) Aerial bathymetry image at Long Island Marina, Murray Bridge showing the contours of the riverbed and the collapse of 70,000 m³ of material into the River Murray (Beal et al., 2010).

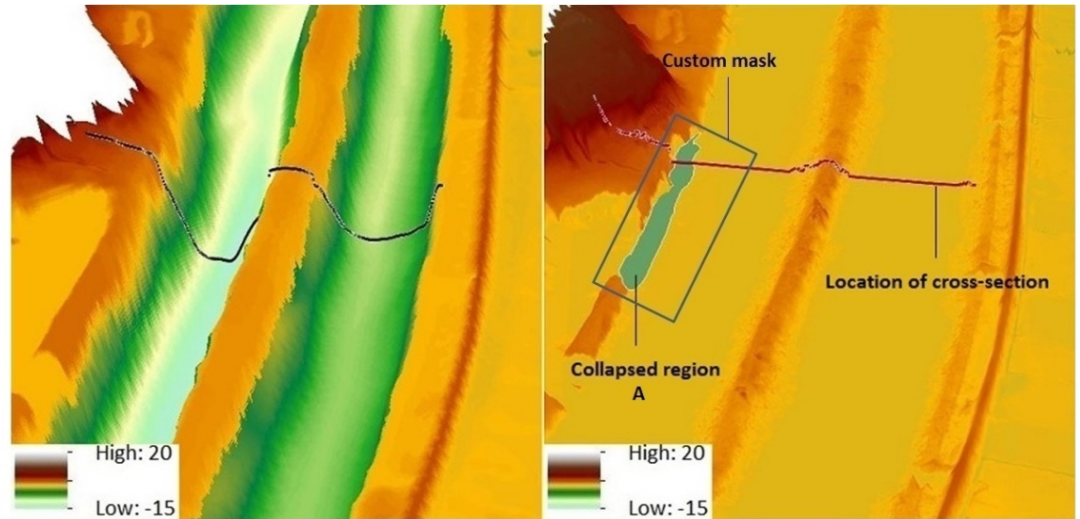
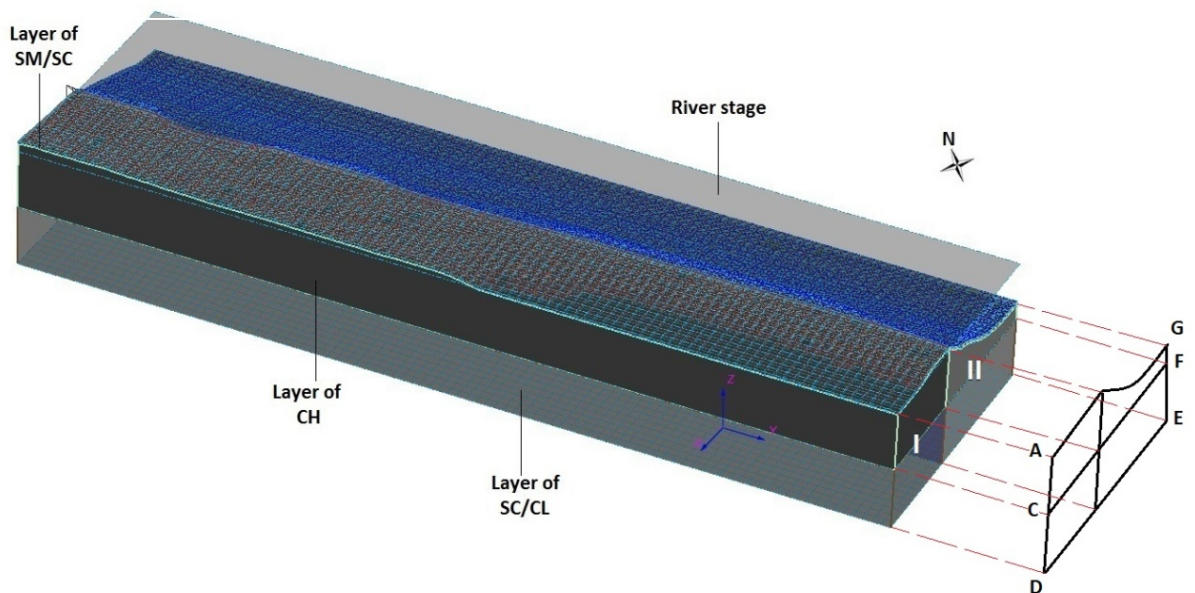
(a) Elevation extraction from the 2008 LIDAR DEM.

(b) Elevation extraction from the 2010 LIDAR DEM, with river level

(c) 3D topographical model.

Figure 4.2. Riverbank geometry definition.

elevation of the riverbank prior to the collapse with river levels at the same location subsequent to the collapse. For example, location A', where the riverbank was at 1.25 m AHD prior to the collapse, is compared with the river level at location B', which is at -0.57 m AHD subsequent to the failure. By adopting this comparative process, the identified region A is confirmed as having collapsed rather than simply having been submerged.

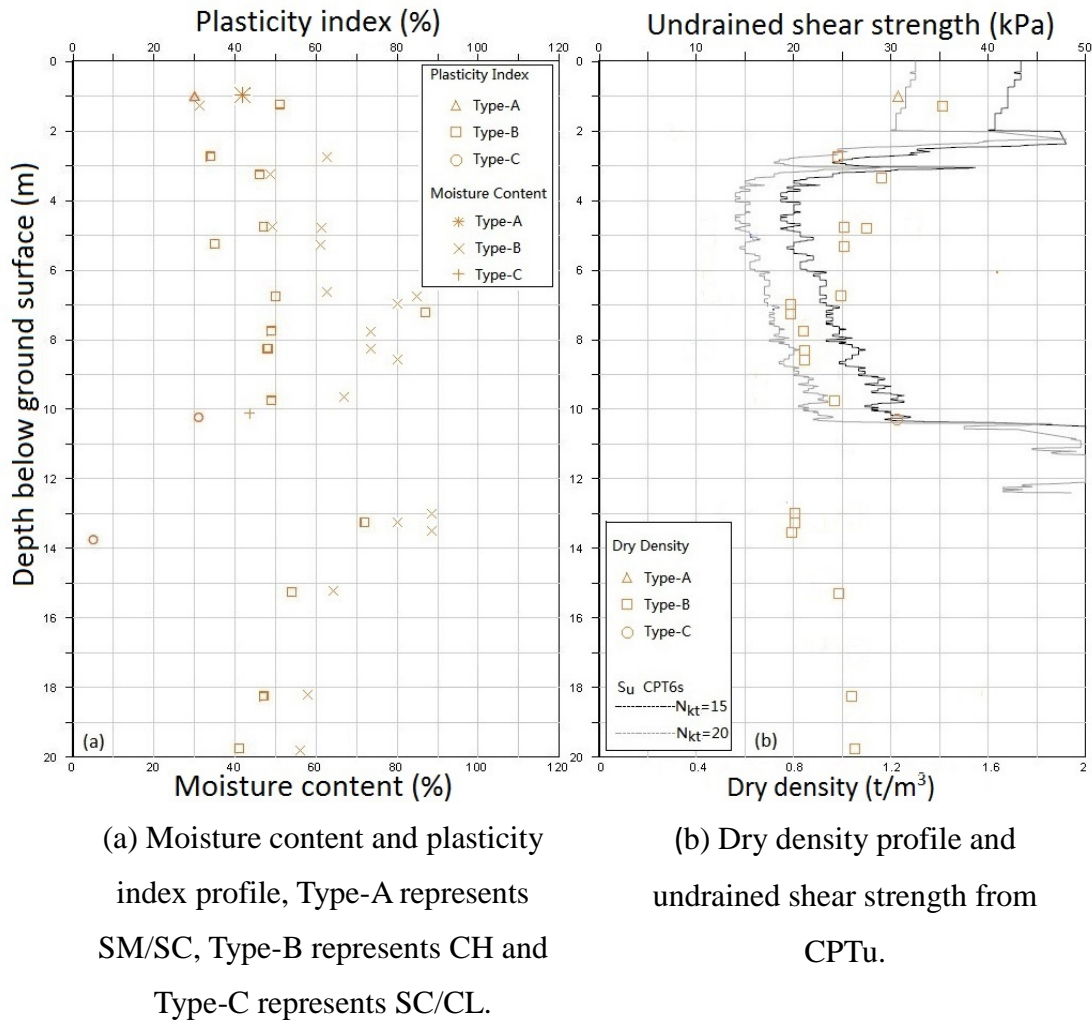
Figure 4.4 Geotechnical profiles based on soil samples taken from SR-BH1 and SR-CPTu6s at Long Island Marina.

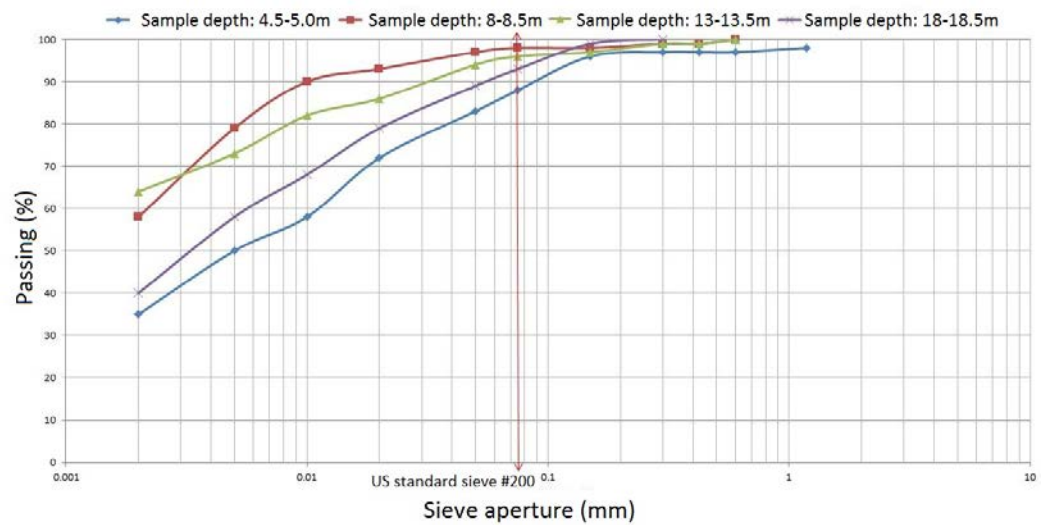
Figure 4.5 Particle size distributions based on the soil samples from four different depths in borehole SR-BH1.

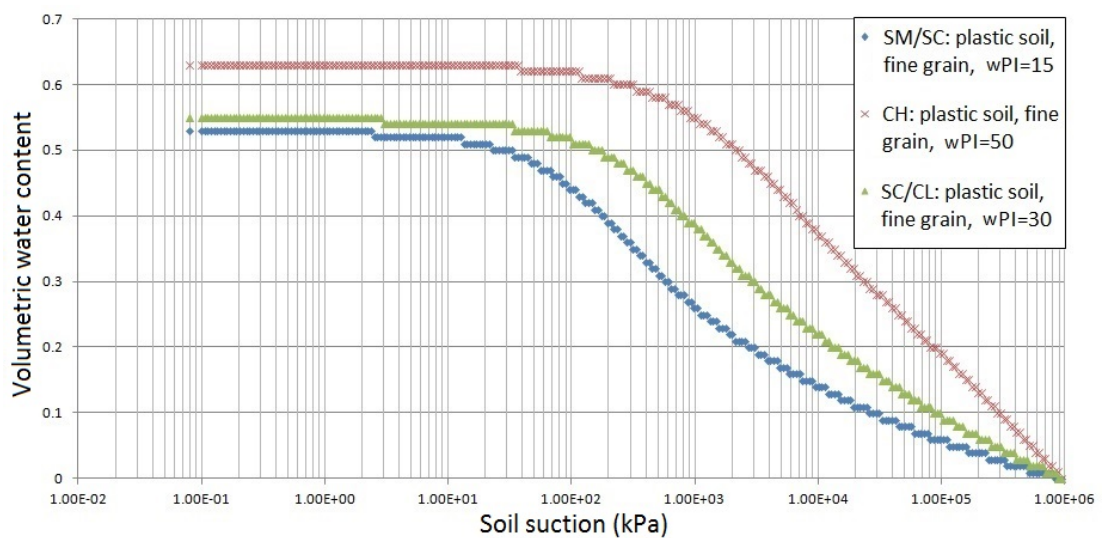
Figure 4.6 Estimated SWCCs for the three soil layers at Long Island Marina using the Fredlund and Xing fit estimation method.

layers (Figure 4.6). In contrast, for granular soils with $wPI = 0$ (i.e. non-plastic soils), the parameter D_{60} , which represents the grain diameter corresponding to 60% passing by weight from the PSD, is employed.

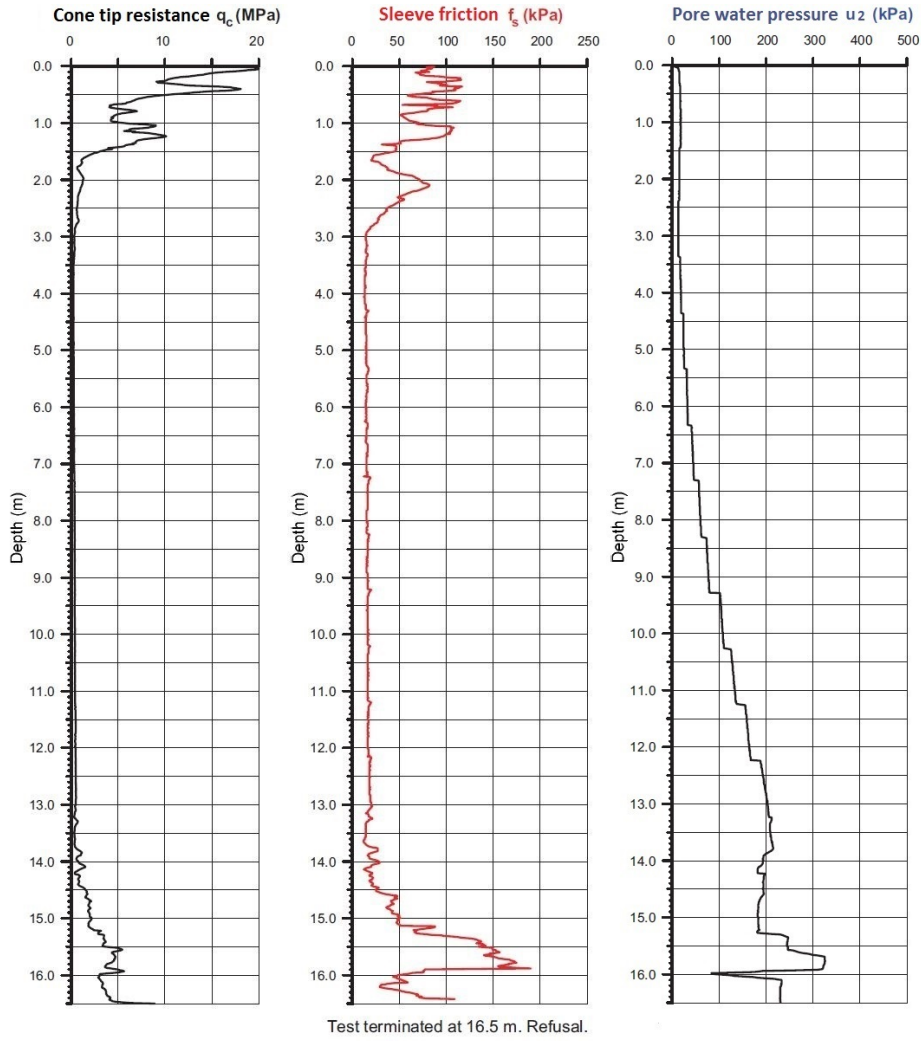
(a) CPTu profile at Murray Bridge.

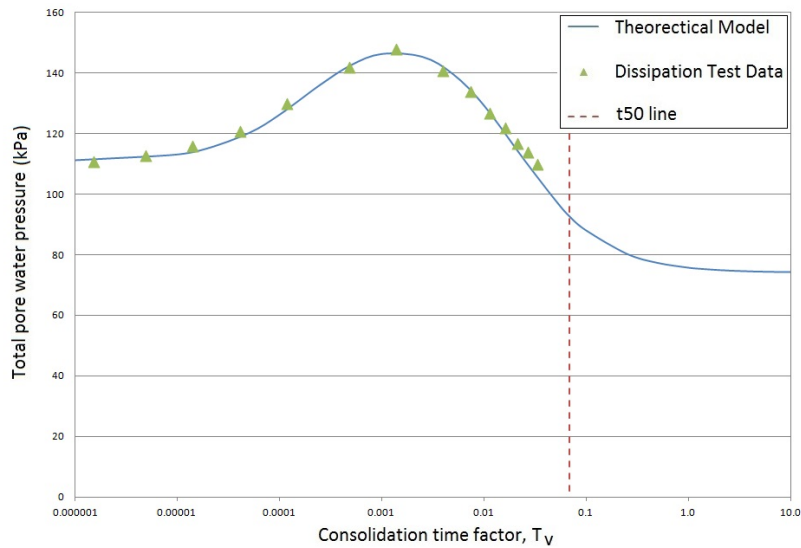
(b) Dissipation test data.

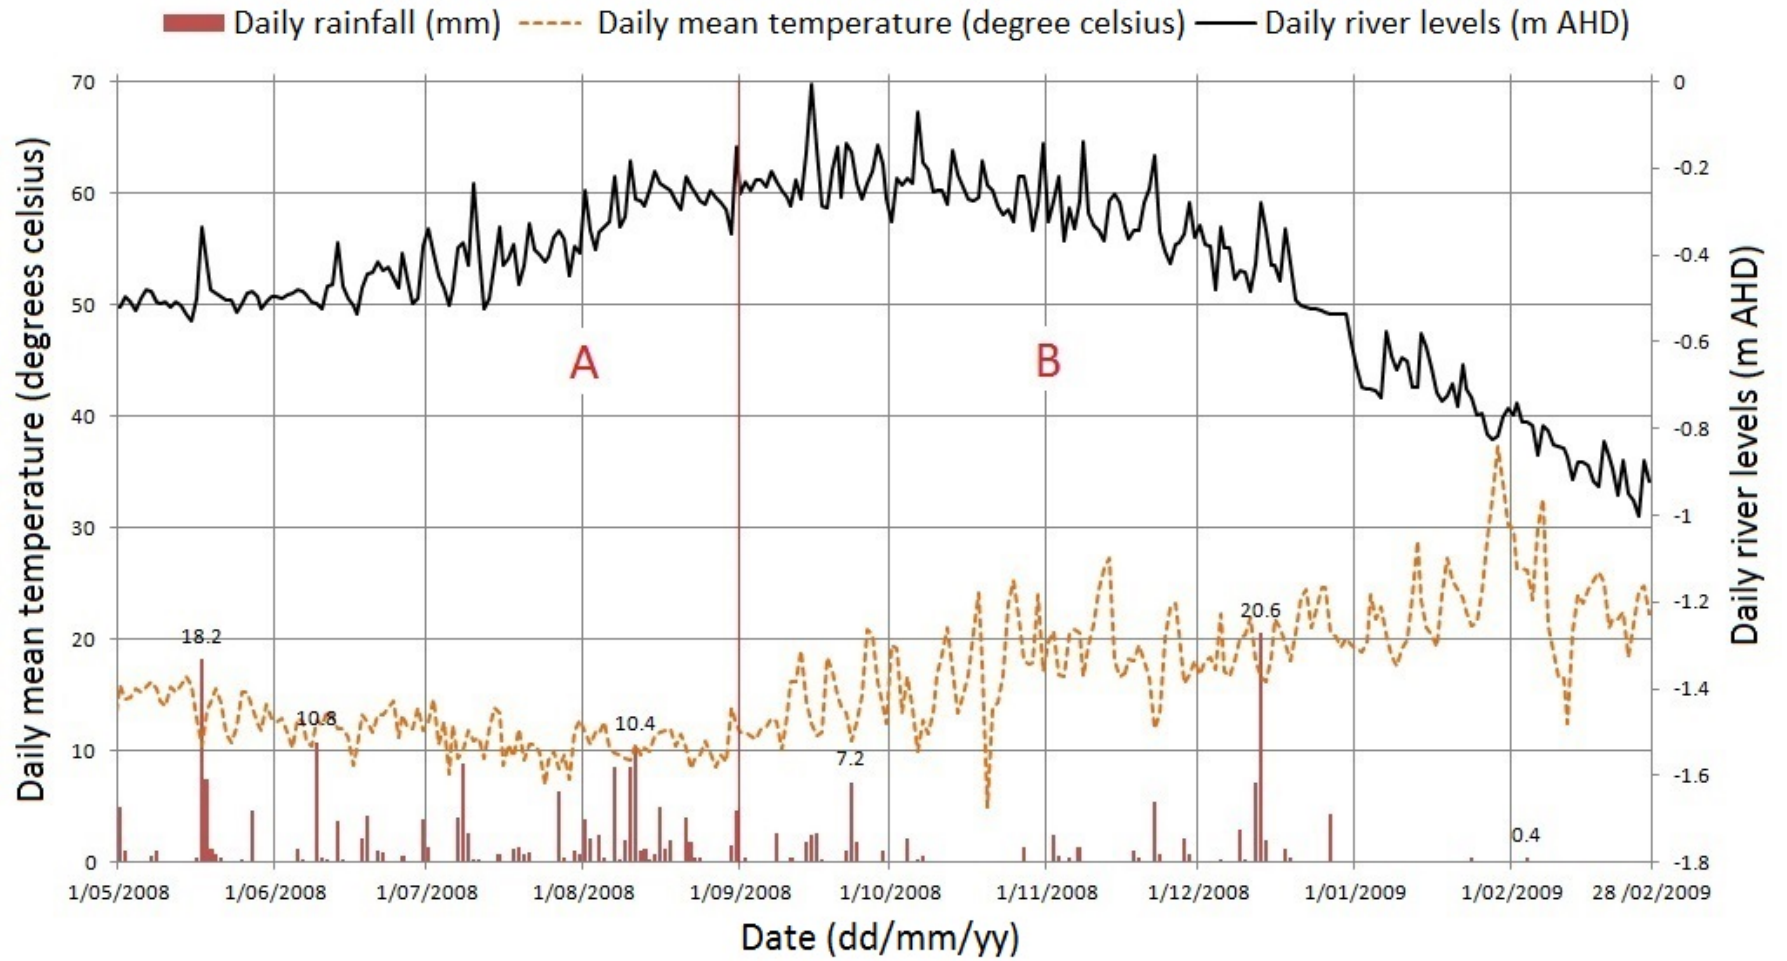
Figure 4.8 Daily river levels, daily rainfall and daily mean temperature from 1 May 2008 to 28 February 2009 at Long Island Marina.

As summarized in Figure 4.8, mean daily rainfall, as well as mean daily temperature, at the Long Island Marina site were collected from the Australian Bureau of Meteorology (Meteorology, 2014), in addition to evaporation and humidity, in order to provide climatic data for the riverbank stability modeling.

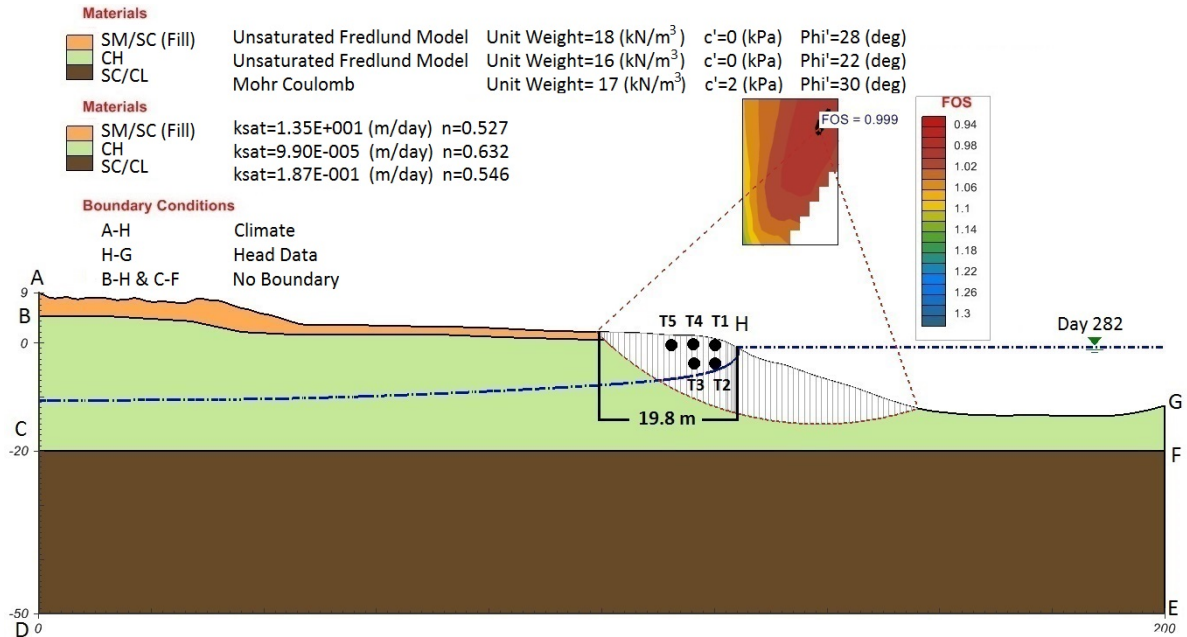
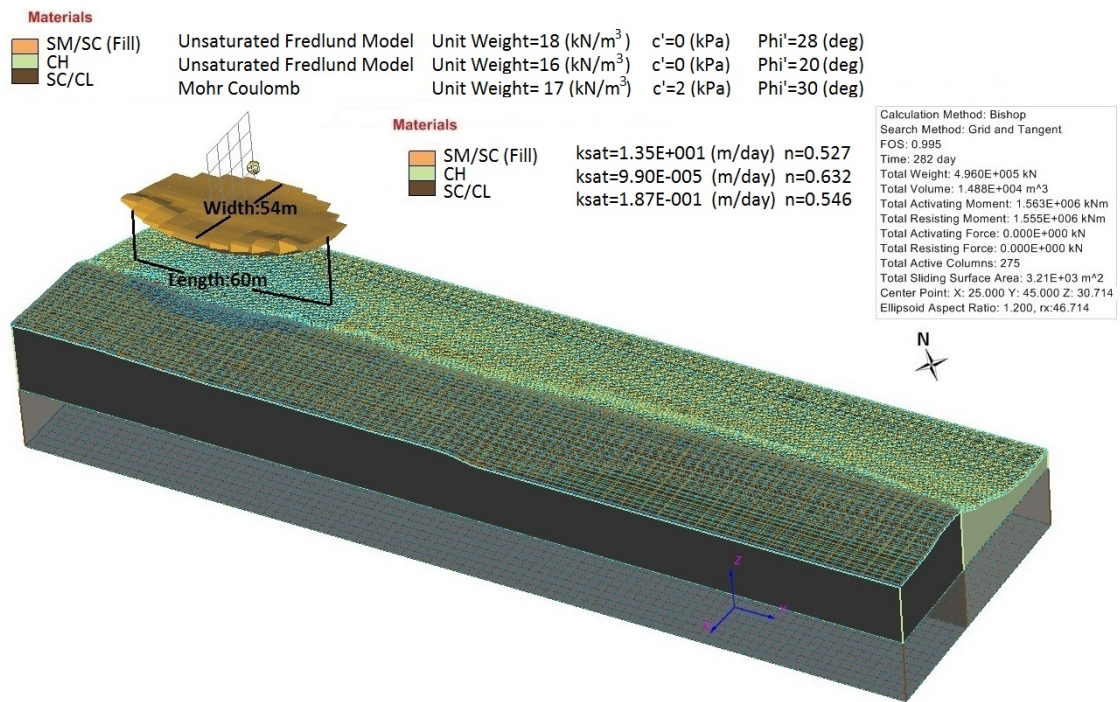
(a) 2D cross-sectional model.

(b) 3D stability model.
