**Spatial Simulation Based Riverbank Slope
Instability and Susceptibility Assessment in the
Lower River Murray**

Thesis submitted in fulfilment of the requirements for the degree
of Doctor of Philosophy

The University of Adelaide
Faculty of Engineering, Computer and Mathematical Sciences
School of Civil, Environmental and Mining Engineering

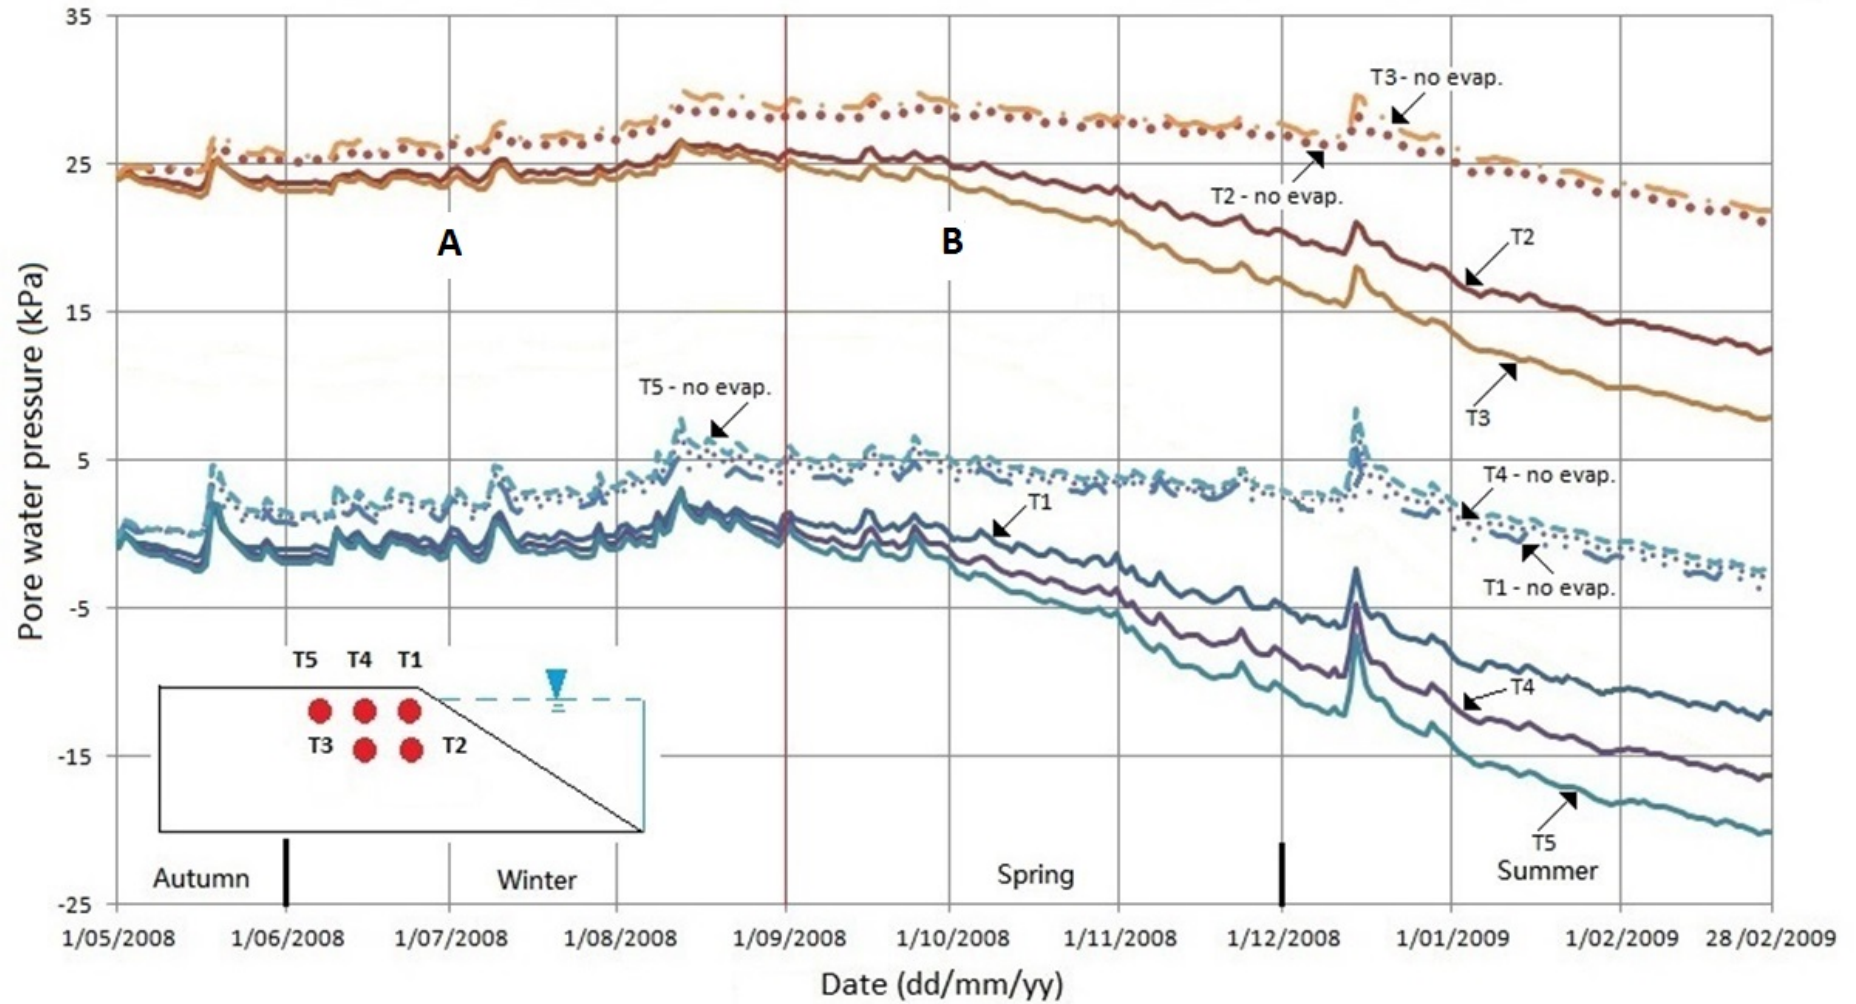
Figure 4.10 Evolution of pore water pressure at 6 selected nodes through the entire research period accounting for, and without, evaporation.

Horizontally, the daily PWP profiles exhibit a very similar trend (e.g. T1, T4 and T5 at -0.5 m AHD; and T2 and T3 at -3 m AHD) throughout the 304 day period. Specifically, at locations T1, T4 and T5, the profiles of PWP fluctuate about 0 kPa in late autumn and winter, and then diverge in spring and summer. It is interesting to note, as a consequence of river drawdown, the reduction in PWP is not equal horizontally in the 5 nodes. Compared with the soil close to the river channel (e.g. T1 and T2), the reduction in PWP (increase in suction) is slightly greater than that associated with the soil farther from the bank and at the same elevation (e.g. T5 and T3). The reason for this is the influence of evaporation. Within the riverbank, the sensitivity to climatic factors increases as the distance from the river's edge increases (Calabresi et al., 2013).

During Part A, as indicated in Figure 4.10, roughly 164.7 mm rainfall was recorded (70% of that over the entire 304 day period), the river rose by approximately 0.3 m, and the lower daily temperatures resulted in modest daily evaporation, the trend in PWP in each of the 5 nodes is generally flat. In contrast, in Part B, a moderate rainfall (81.5 mm), accompanied by relatively high daily evaporations and a significant drawdown of river level (0.9 m), contributed to a significant reduction in pore water pressure. A summary of the PWP distribution is shown in Figure 4.11, with Figure 4.11(a) showing the PWP during the day with the highest river level (Day 138, 15/09/2008) and Figure 4.11(b) illustrating the PWP during the day with the lowest river level (Day 302, 26/02/2009).

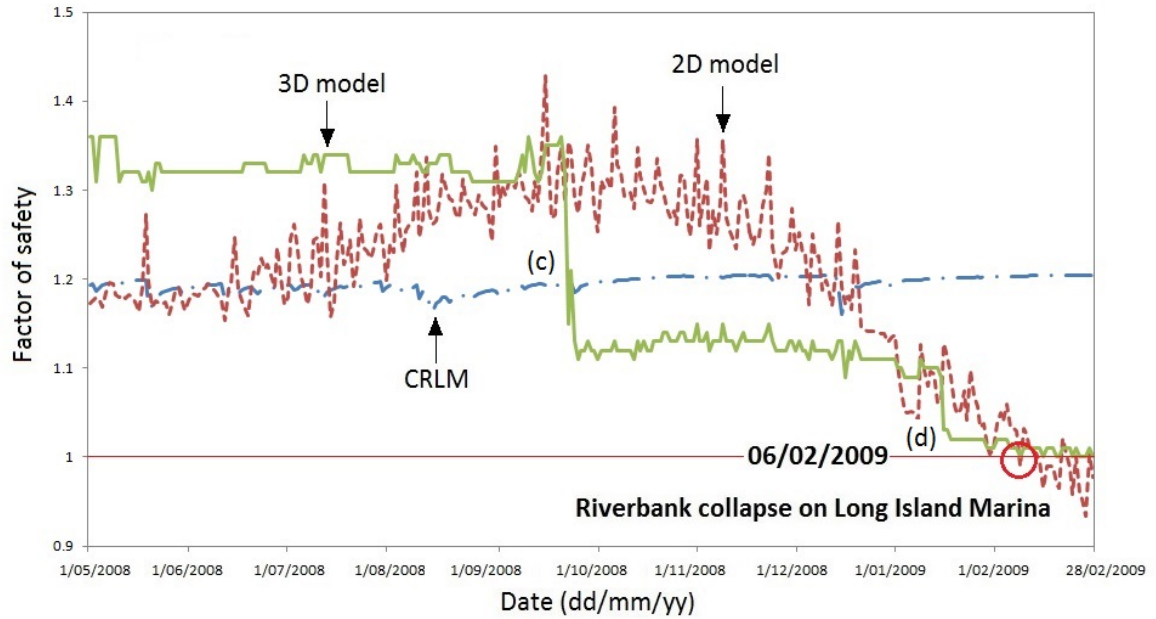
Figure 4.12 Factors of safety from the 2D, 3D and CRLM models.

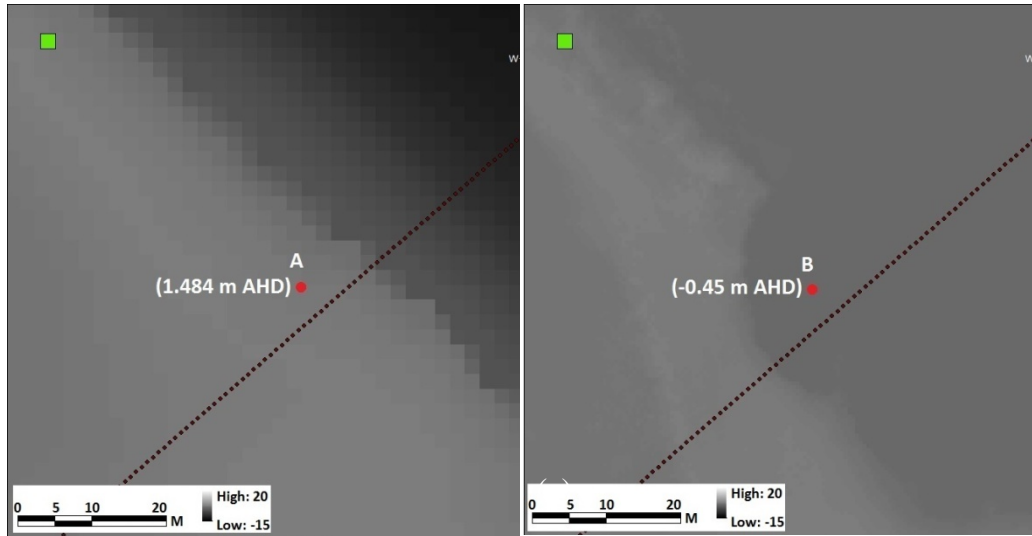
Figure 5.3: Example of adopted elevation comparison method on DEMs at Woodlane Reserve (a) 1 m resolution DEM acquired in 2008; (b) 0.2 m resolution DEM acquired in 2010).

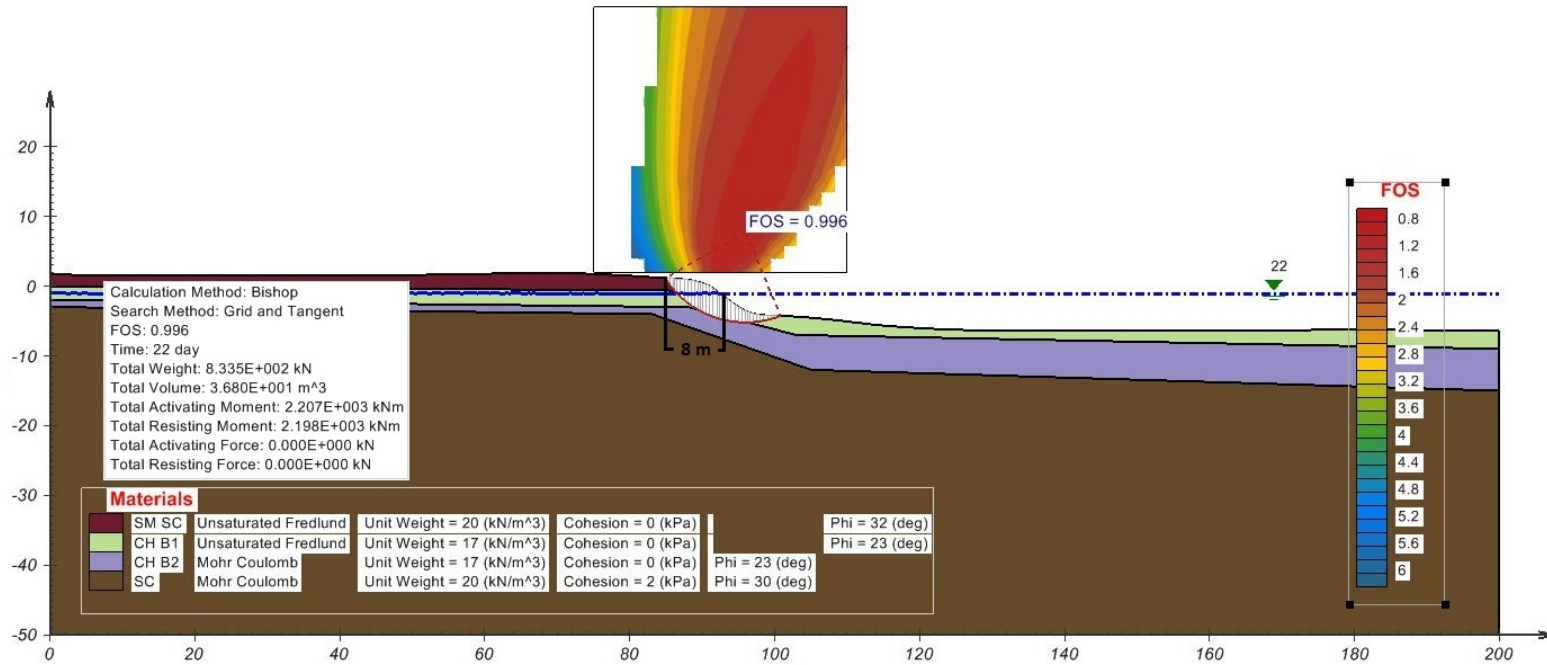
Figure 5.5: Riverbank stability analysis of the East Front Road, Mannum (EFR) site on 23 April 2009.

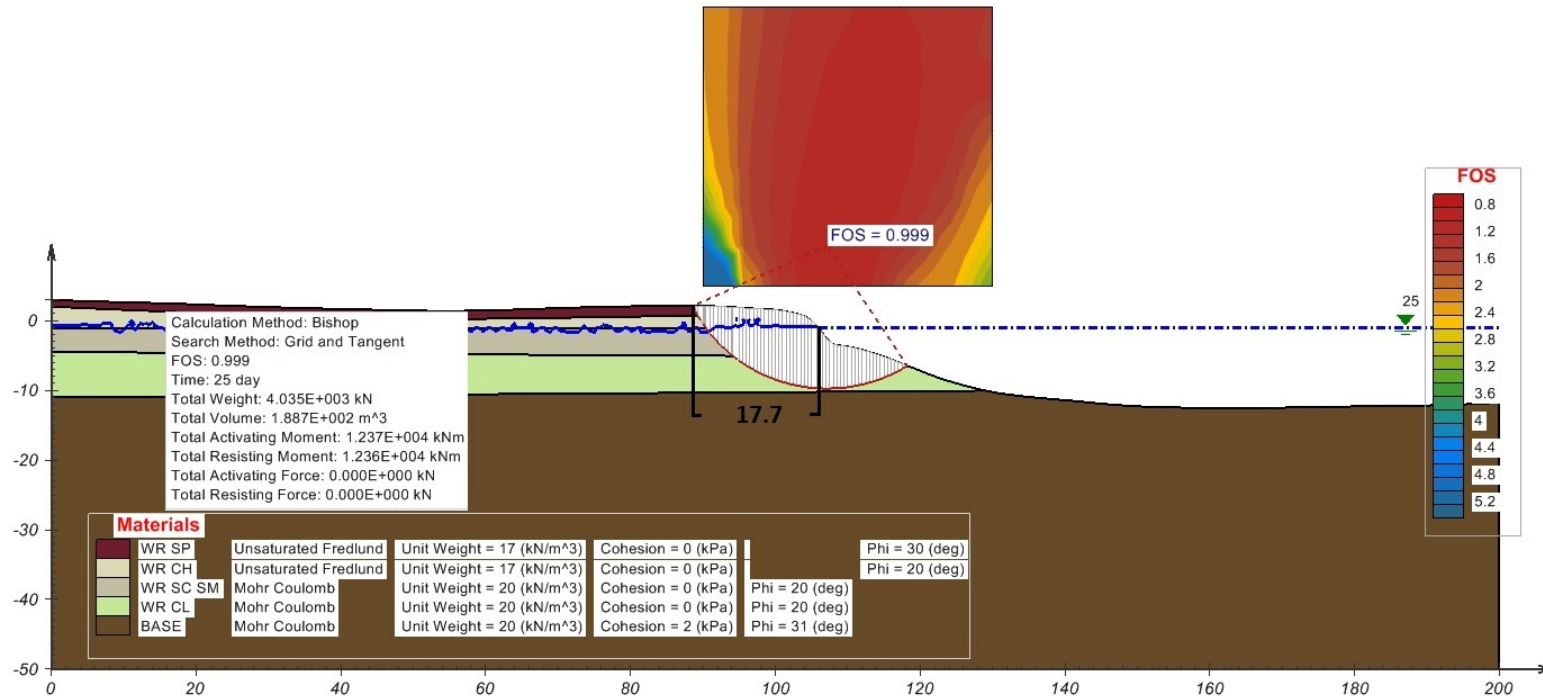
Figure 5.6: Riverbank stability analysis of the Woodlane Reserve (WR) site on 26 February 2009.

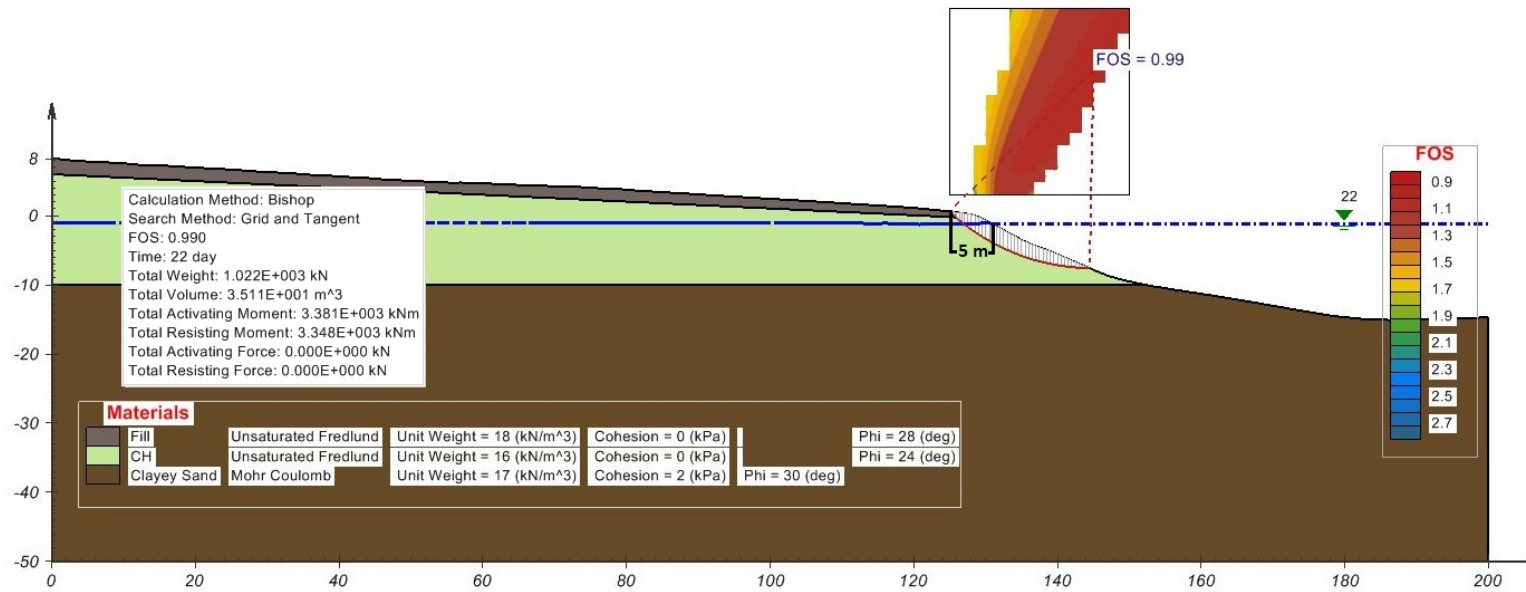
Figure 5.8: Riverbank stability analysis of the White Sands (WS) site on 23 April 2009.

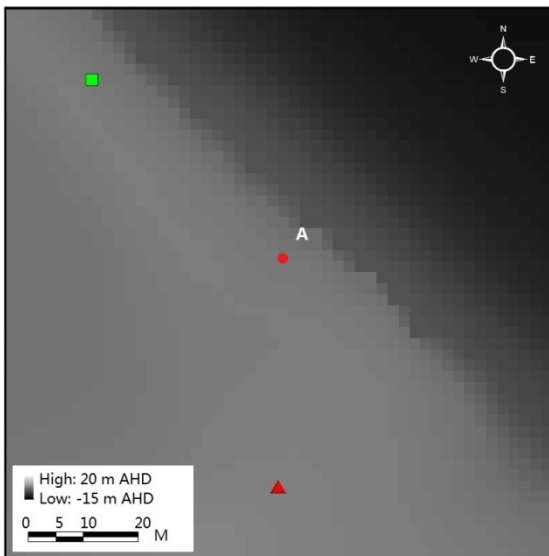
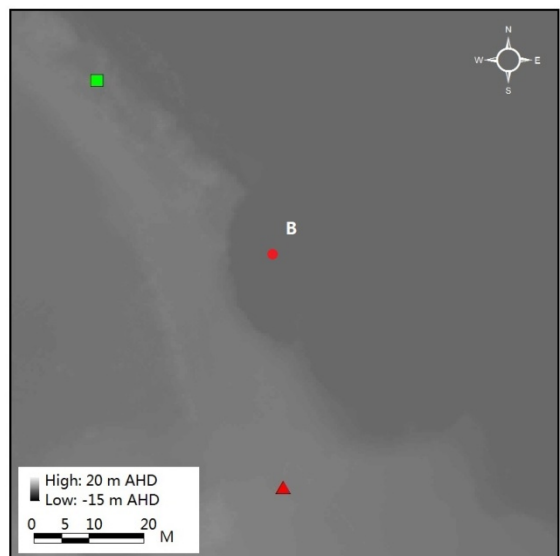
(c) 1 metre resolution DEM obtained in 2008

(d) 0.2 metre resolution DEM obtained in 2010

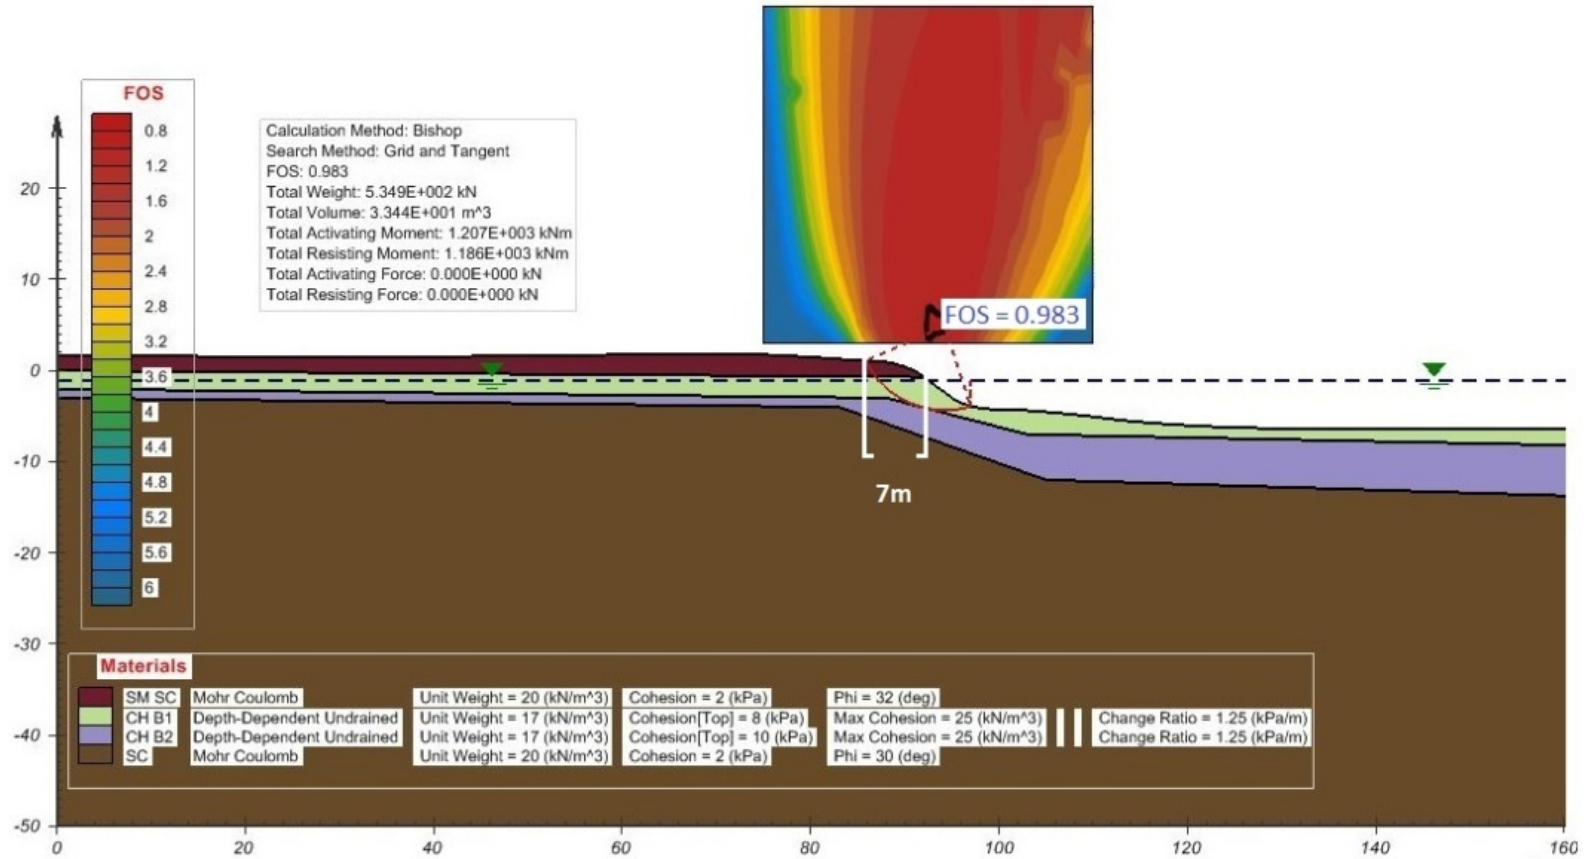
(a) Back-analysis of EFR site on 21 April 2009.

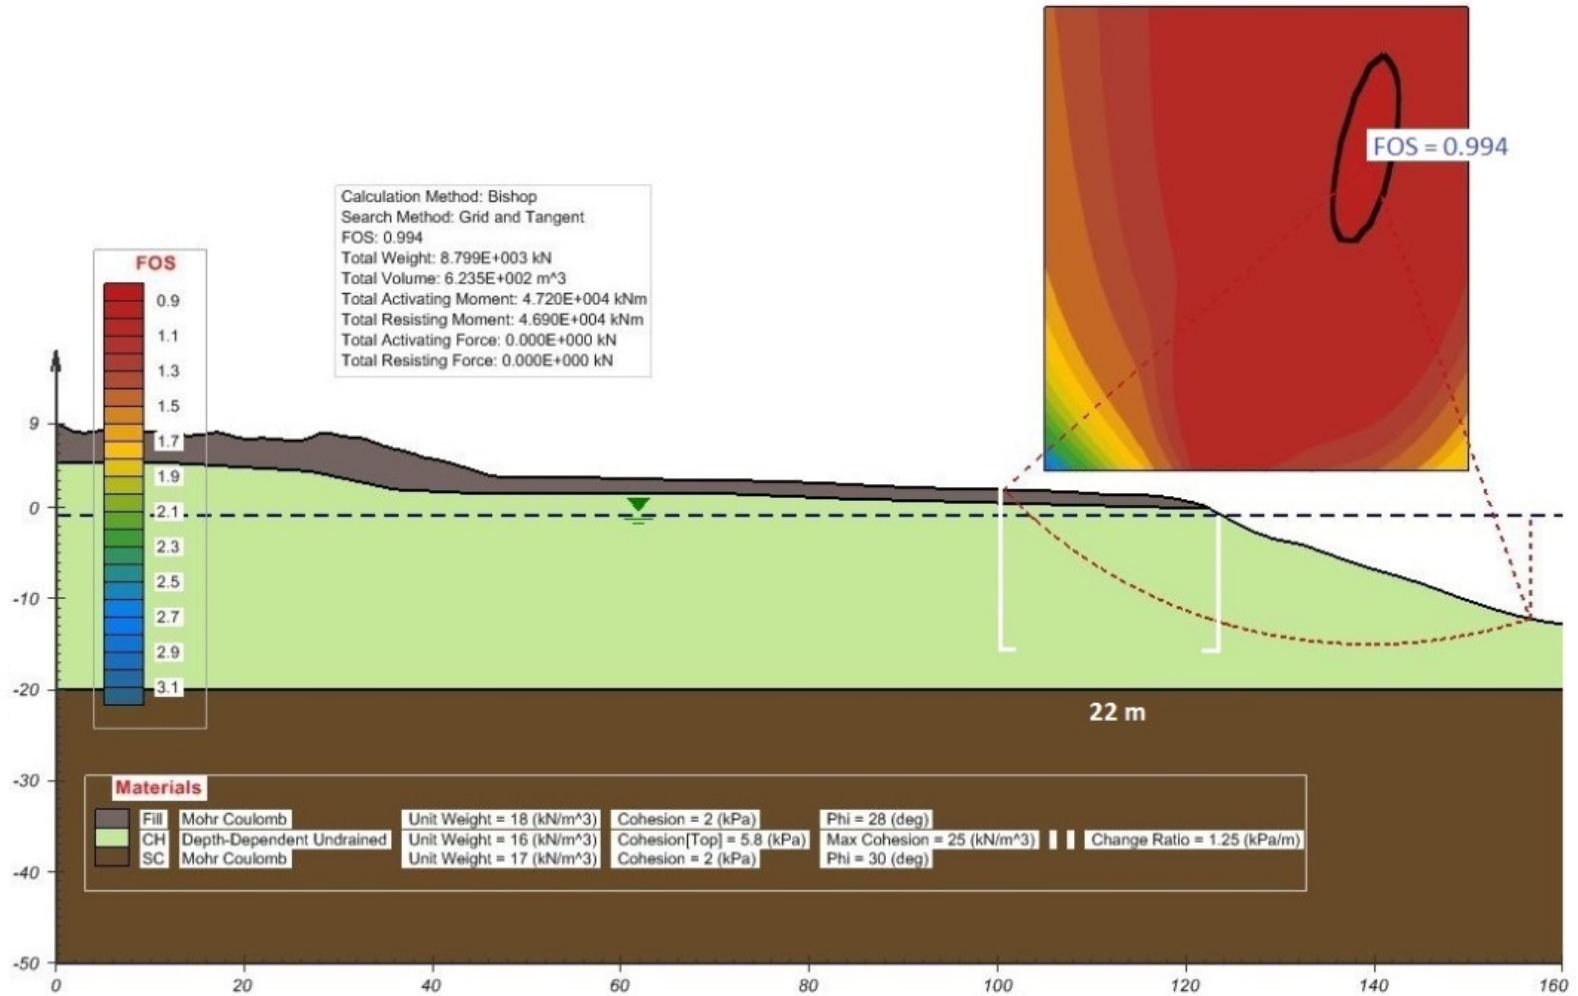
(c) Back-analysis of MB site on 6 February 2009.

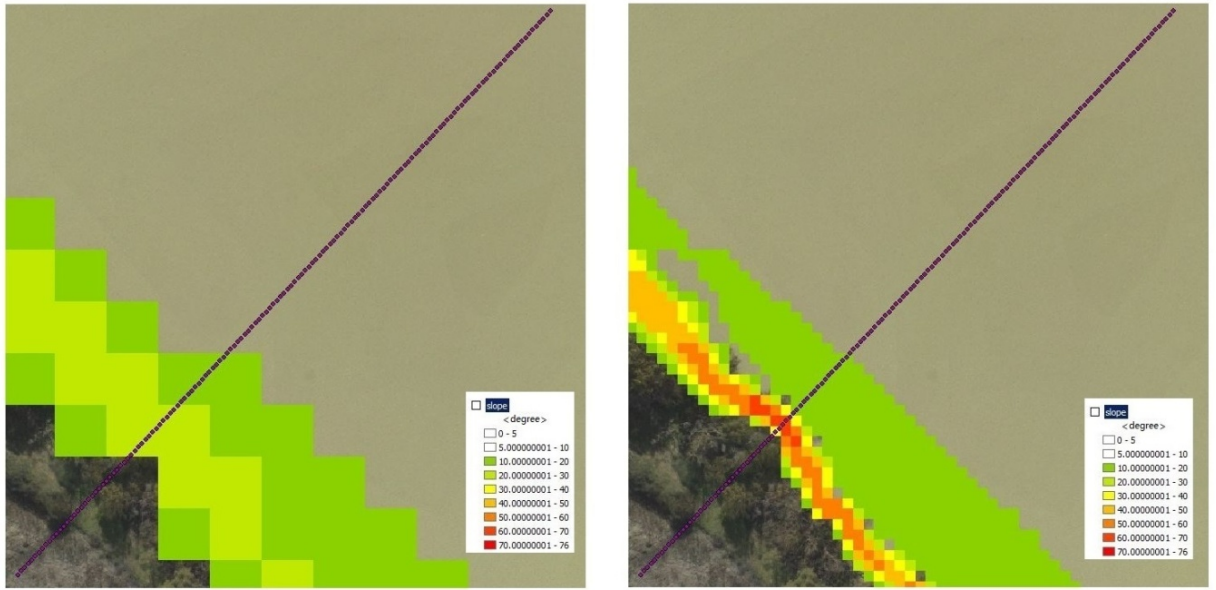
(a) Surface slope on WR1 based on 10×10 DEM. (b) Surface slope on WR1 based on 2×2 DEM.

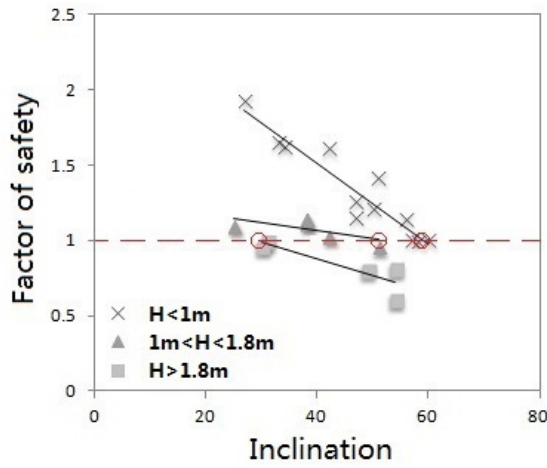
(a) Results of cross-sectional modeling in EFR.

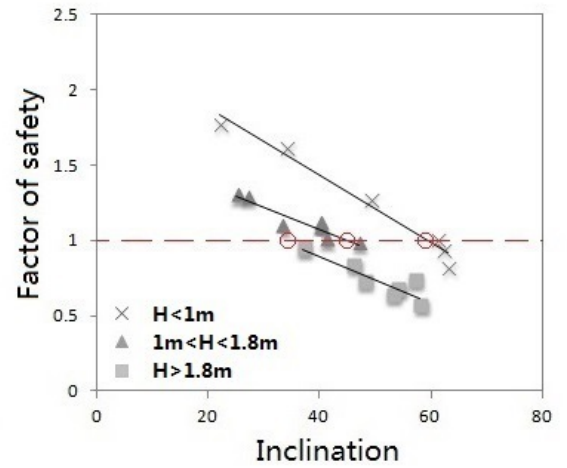
(b) Results of cross-sectional modeling in WR.

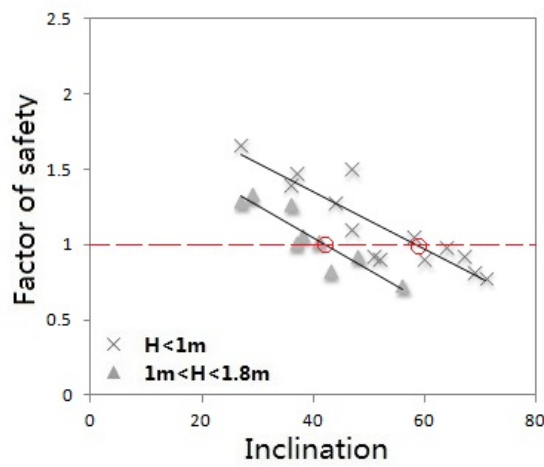
(c) Results of cross-sectional modeling in RFR.
