Master's Thesis

CHARACTERISATION OF THE
MORPHOLOGY OF INCLINED SCC
CRACKS IN AUSTRALIAN GAS
PIPELINES

LUKE ZADOW

The University of Adelaide

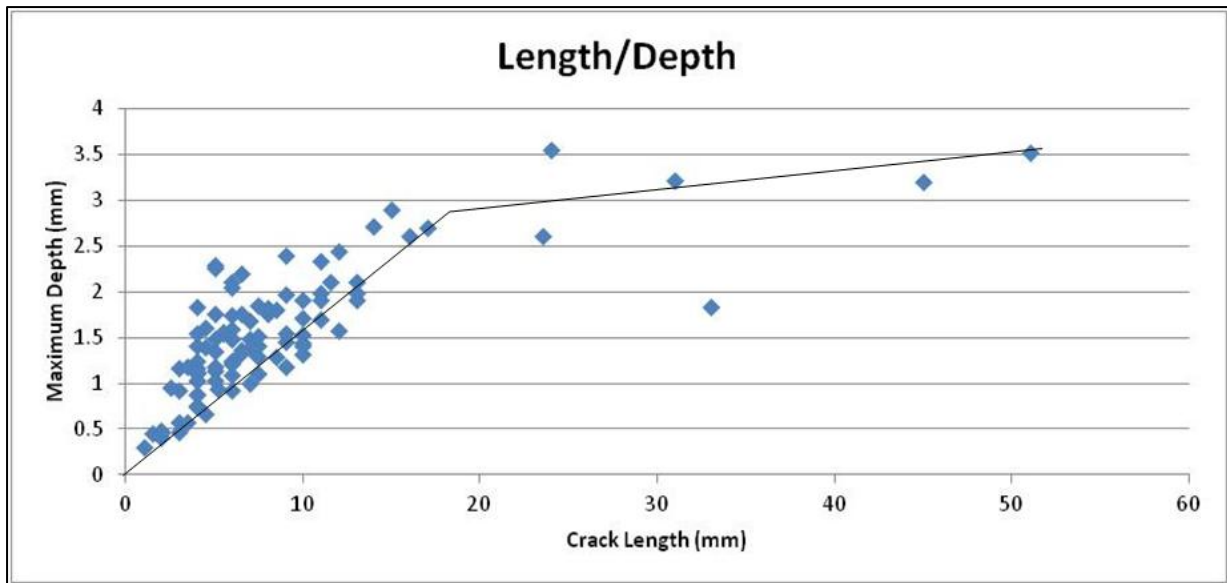
Figure 6-3: Length to depth ratio for all SCC cracks analysed.

The relationship depicted appears to have two aspect ratios. For cracks shorter than 18 mm, the aspect ratio is 0.21 and for cracks greater than 18 mm, the aspect ratio is 0.03. This change in aspect ratio corresponds to a crack depth of approximately 2.8 mm. Crack surface lengths were measured with an error of up to 1 mm on the outer pipe surface. This error was due to the rough MPI characteristics. The crack depths for each cross sectional slice were measured to an accuracy of $\pm 50 \mu\text{m}$.

The sudden change in the aspect ratio for cracks greater than 18 mm in length is attributed to smaller cracks having coalesced where there is a significant increase in the crack length but little deviation in the maximum depth. This effect of coalescence on aspect ratio has been identified in a previous work (Baker, Rochfort & Parkins 1987b) that examined the aspect ratio of merged cracks. This trend of the aspect ratio to change at 18 mm could also be influenced by the inclined angle of the cracks. Overall, for crack of length less than 18 mm, the results for the aspect ratio agree with the literature (Sutherby & Chen 2004).

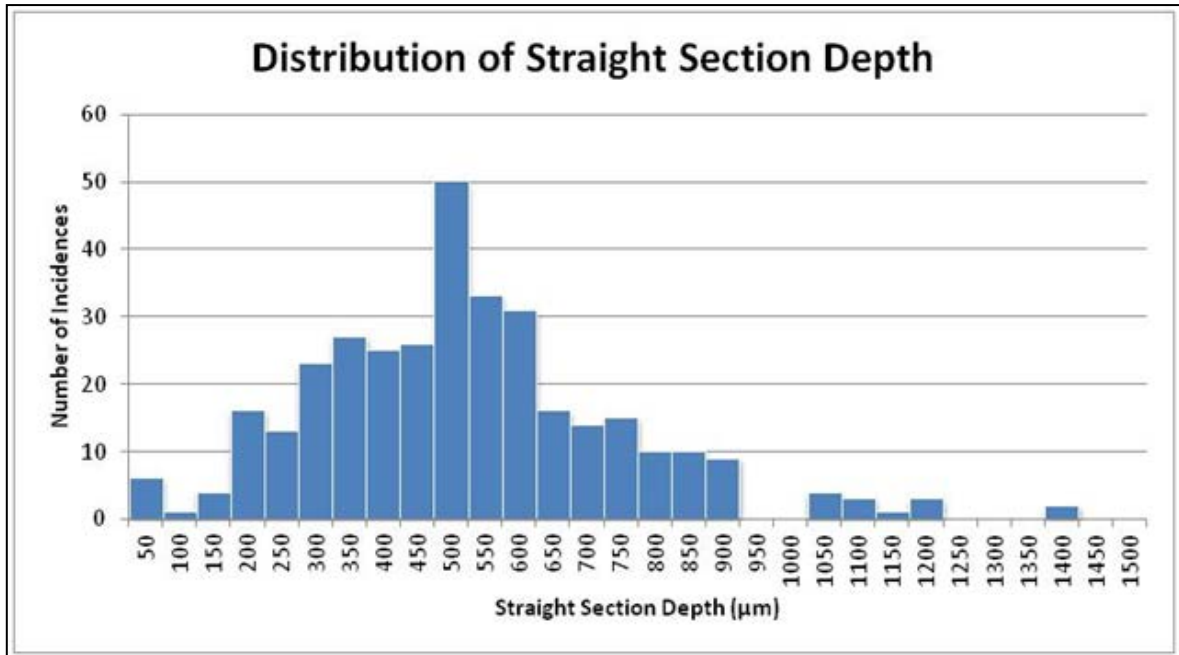
The straight section was measured for each metallographic slice of all cracks and the typical depth was found to be in the range of 200–900 μm. Figure 6-5 shows the typical range of straight sections observed. The straight section was consistently measured to an accuracy of $\pm 5 \mu\text{m}$ or better. It is also important to note the discontinuities present in the cracks shown. Many were observed in the study and were probably a result of crack interactions, however, these discontinuities also occasionally occurred around inclusions.

Figure 6-5: Straight section depth distribution for all cracks.

It is important to note that each SCC crack had different straight section depths for each cross sectional slice measured. Therefore, for this study, the straight section depth for each cross sectional slice was plotted, instead of the average straight section depth of each crack. Importantly, the variation in straight section profile for each crack did not follow a specific pattern and therefore no hypothesis on the probable straight section depth could be proposed.

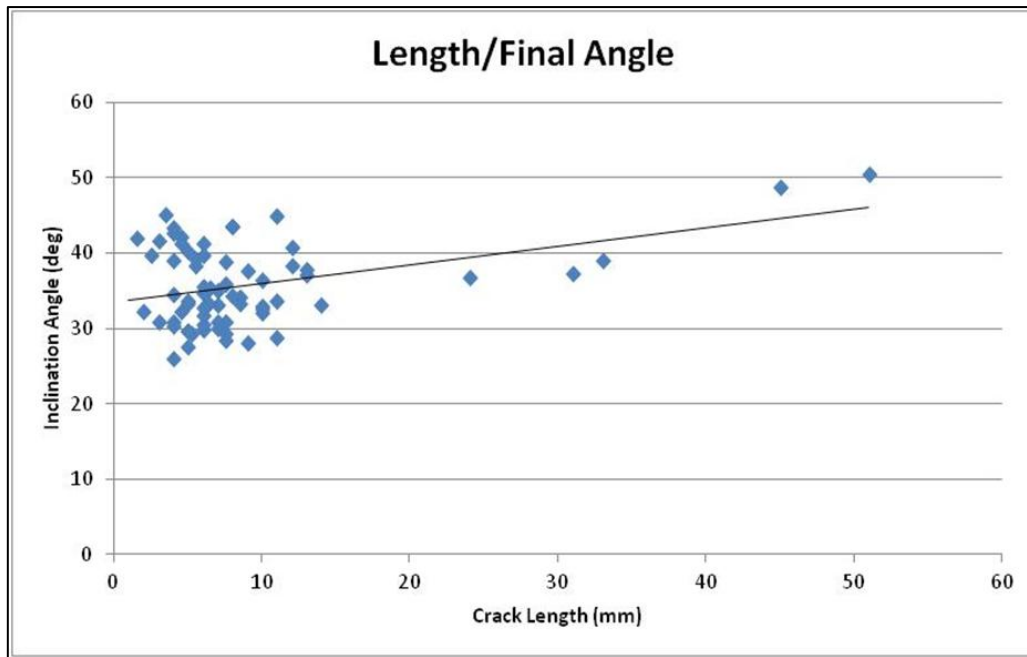
For all cracks with lengths less than 18 mm or depths less than 2.8 mm, the inclination angle was in the range 30–45 degrees from the perpendicular. The relationship measured between the crack length and inclination angle is shown in Figure 6-7. The error in the results produced in Figure 6-7 is +/- 1 degree. The graph demonstrates the average inclination angle for each inclined crack analysed with many of the cracks less than 18 mm having approximately the same angle (data points overlapping).

Figure 6-7: Relationship between crack length and inclination angle for all inclined cracks.

The range of 30–45 degrees is not inclusive of cracks greater than 18 mm in length. For the small number of results for cracks greater than this length, the trend observed was that the angle increased at the crack tip. Observation showed that the longer the crack grows across the pipe surface, the steeper the crack angle at the tip. As a result, the crack travelled considerable distances in the hoop direction. The inclination angle was observed as being between 45 and 60 degrees for cracks exceeding 18 mm in length. As a result, the rate of increase in the crack depth reduces and this was shown in Figure 6-3, where the aspect ratio changed at an approximate crack length of 18 mm.

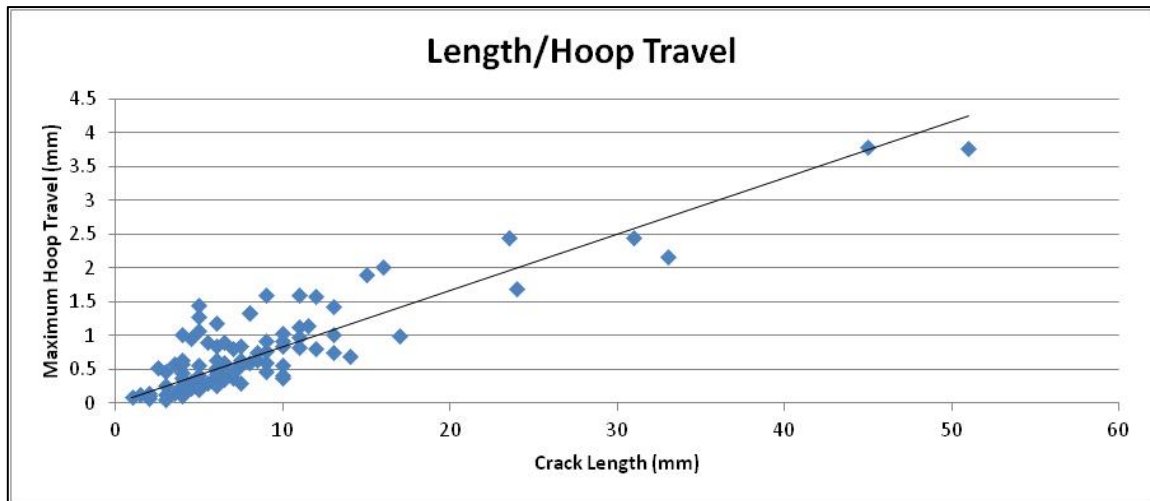
Figure 6-9: Maximum hoop travel plotted as a function of the crack surface length.

The relationship shown in Figure 6-9 leads to the definition of an ‘inclination factor’. The linear trend line in this graph is tentative and has been superimposed for discussion purposes. The inclination factor is defined as the maximum hoop travel divided by the surface crack length. This factor aids in identifying a typical or worst case situation with regard to the hoop travel for an inclined crack. The inclination factor obtained for the SCC existing in the Australian pipeline examined is 0.075.

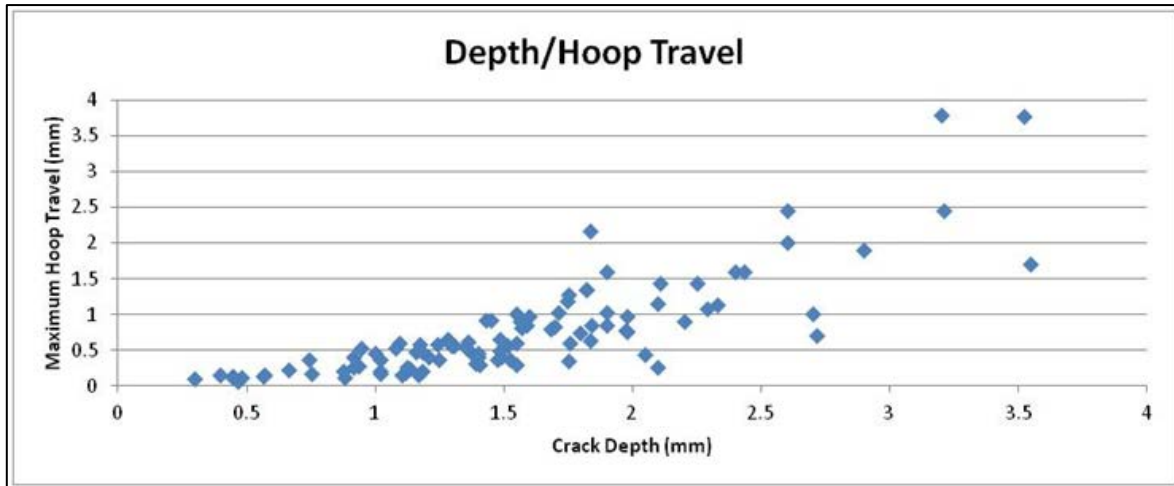
To illustrate the observed increase in angle as the depth increases, the maximum hoop travel was plotted against the maximum depth as shown in Figure 6-10. The large scatter within the few data points obtained suggests the relationship may be more complex than a linear relationship but the general trend is evident. However, more data for longer cracks is required to establish a more precise relationship.

Figure 6-10: Relationship between maximum crack depth and hoop travel.

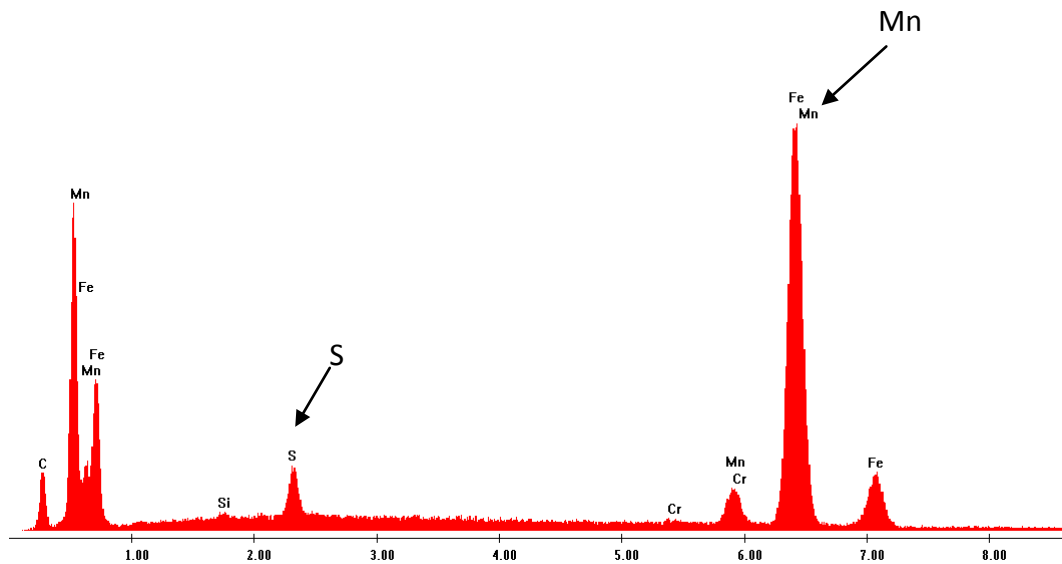
Through the analysis of many cracks in the ex-service pipeline in Australia, many instances of non-metallic inclusions (NMI's) were found. Elongated manganese sulphide inclusions were found in the banded regions of the steel as a result of the pipe rolling operation. The chemical composition of the inclusions was determined by EDAX and the normalised results are shown in Figure 6-12.

Figure 6-12: Chemical composition of the existing inclusions.

The inclusions were observed to exist at a depth typically greater than 2 mm from the pipe outer surface. As a result, cracks penetrating at least 2 mm into the pipe wall had the potential to interact with the inclusions present. Figure 6-13 illustrates a SCC crack that has interacted with an inclusion present in the pipe wall. The inclined segment of crack is shown entering the inclusion (solid arrow) and then exiting from the inclusion (dashed arrow) and continuing along the inclined crack path.

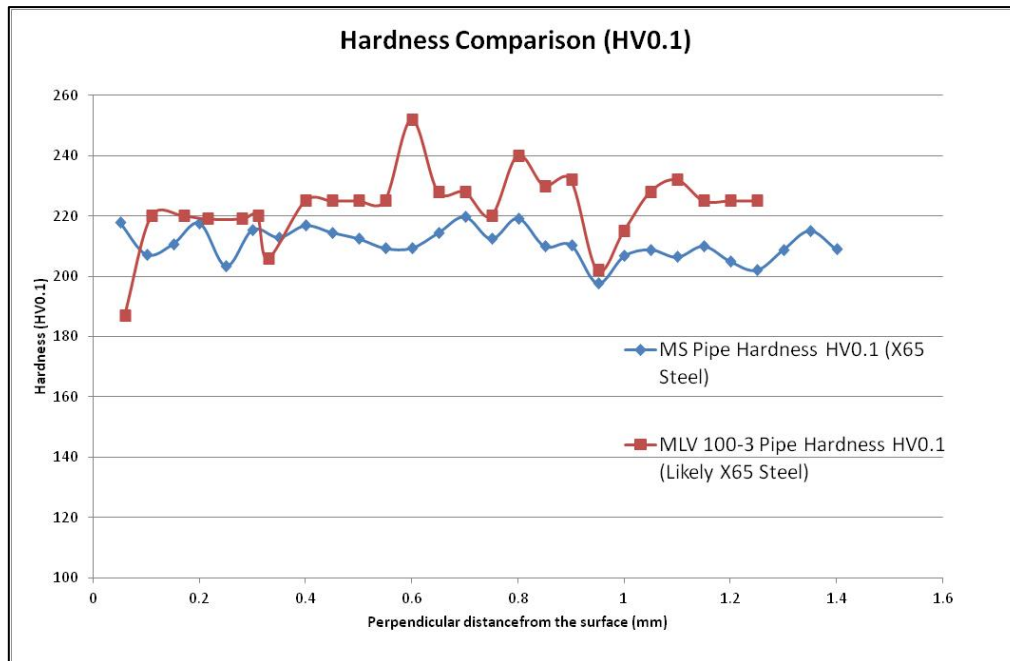
Figure 6-16: Hardness in the through-wall direction of investigated pipelines in Canada (red line) and Australia (blue line), adapted (Xie et al. 2009).

These results show variations in the hardness through the pipe wall but show no indication of any significant change at the point where the crack deviates. This means that where the deviation in the crack occurred (600 μm) there was no spike or change in the hardness profile in that zone.

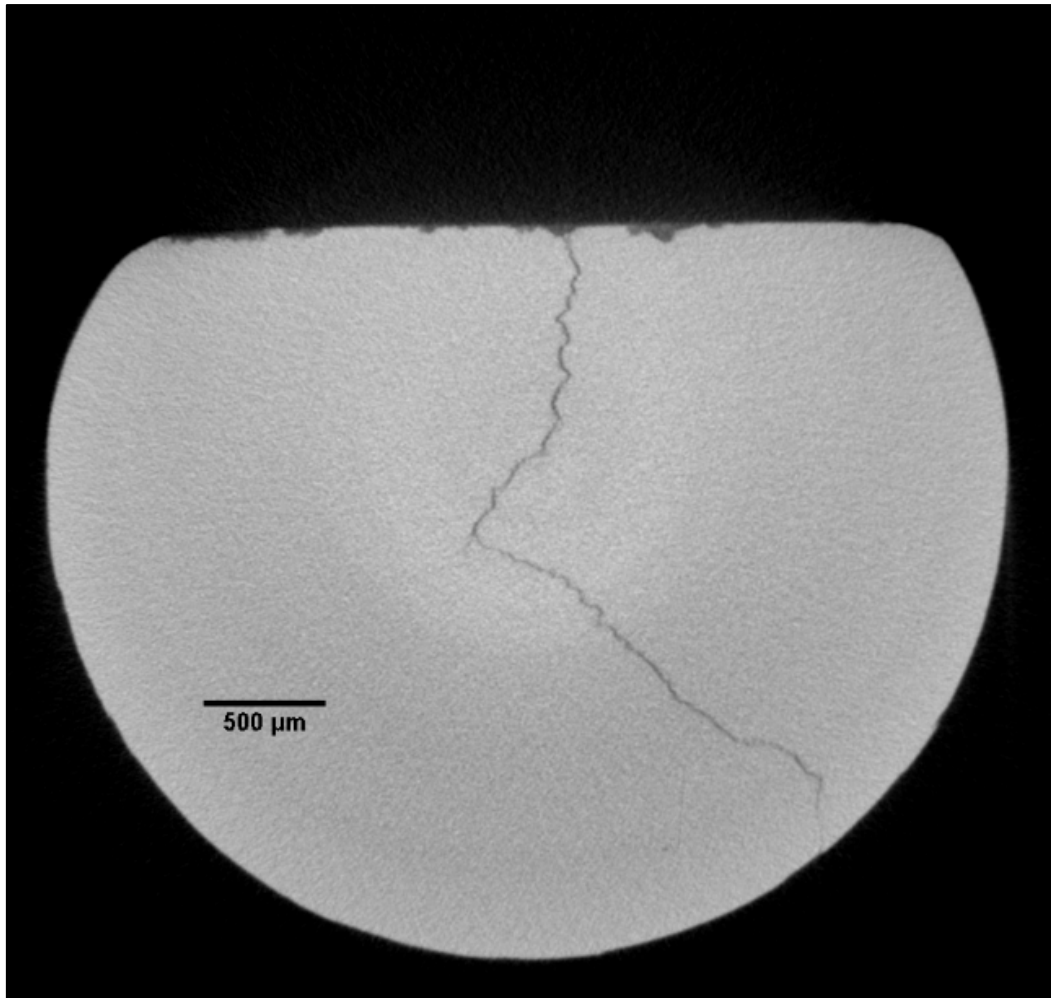
A concurrent study was initiated in conjunction with this project, aimed at sourcing equipment that had more appropriate capabilities. Figure 6-18 shows an SCC crack in a 4 mm sample using improved and more powerful equipment (Giuliani 2013).

Figure 6-18: 4 mm SCC sample using tomography (source Michael Giuliani).

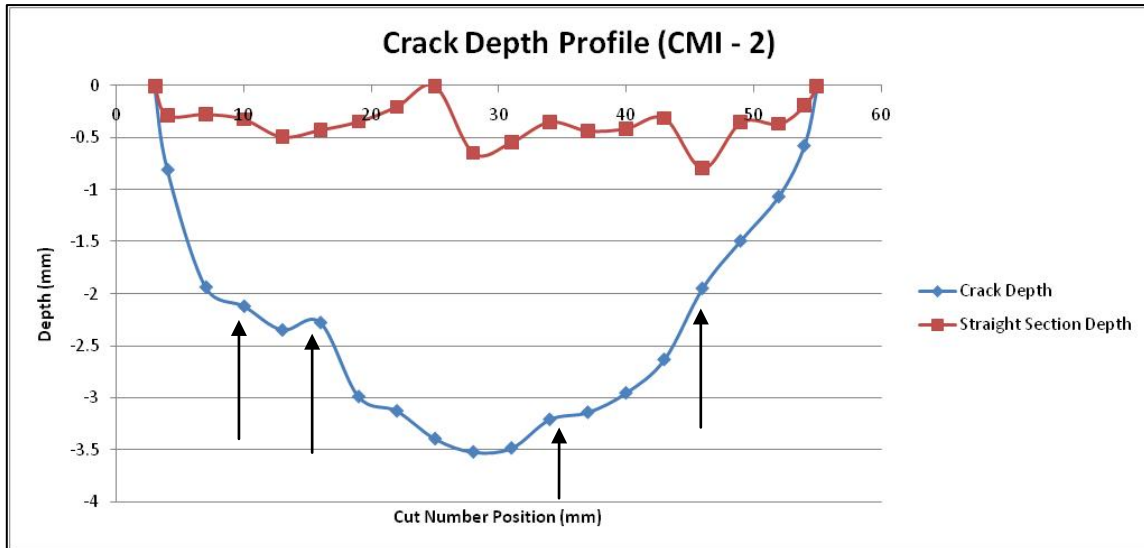
For each crack investigated in this study, an associated depth profile together with a straight section and hoop travel profile were created. Figure 8-1 shows the depth profile (blue line) plotted for an SCC crack that had a recorded length of 51 mm. On the surface, this crack had indicators that suggested it was comprised of a number of cracks that had coalesced to form one large crack. Analysing the transverse sections of the crack confirmed this assessment. The profile of the straight section has been included on the figure to demonstrate the typical change in straight section that occurs along the length of each crack characterised. In this particular case, the straight section depth ranged from 0mm to almost 800 μm in depth. It is interesting to note that a typical crack depth profile has a semi elliptical shape, this crack depth profile has many anomalous points along its path.

Figure 8-1: Crack depth and straight section depth profile for sample CMI-2.

Inconsistencies in the depth profile arrowed in Figure 8-1 suggest some form of crack interaction could be occurring. It is unlikely that these are due to microstructural features resisting the uniform growth of the crack front. This was confirmed when analysing the transverse sections of the SCC crack. Figure 8-2 is of the outer surface of the pipe and shows the crack that was analysed. The lines etched on the surface indicate the positions at which the transverse cross sections of the crack were taken and the predicted points of crack interactions identified and arrowed on the image.

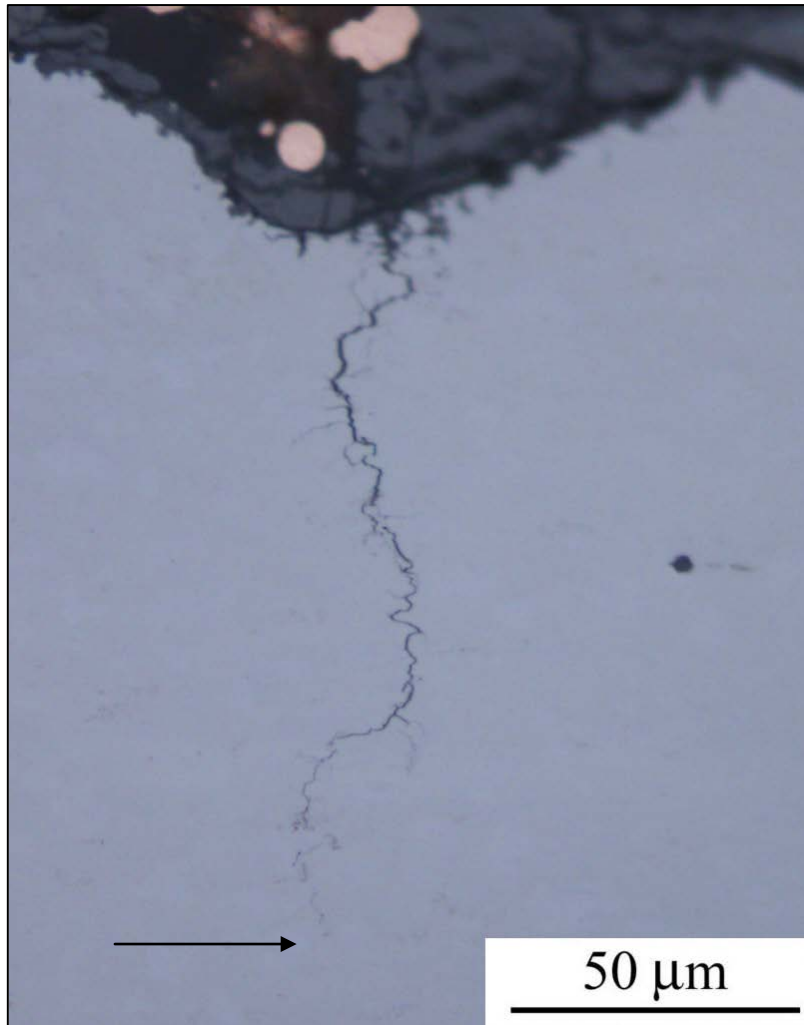
The study (Wang & Atrens 2003) concluded that if the crack tips of the ex-service samples were similar to that of the induced cracks, the pipe crack was active. To this end, an induced SCC crack was produced in the laboratory at the University of Adelaide in a sample from the same ex-service Australian pipeline examined in the current study. The crack is shown in Figure 8-5. The crack tip (arrowed) is that of an active crack.

Figure 8-5: Induced SCC crack in pipe sample (active), (courtesy of Olivier Lavigne, UoA).

The crack tip shown in Figure 8-5 was compared with a typical crack tip taken from the ex-service pipe sample shown in Figure 8-6. The crack tips in both figures show similar characteristics, being fine and having little oxidation indicating that the crack tip in the ex-service pipeline sample shown in Figure 8-6 is also active.

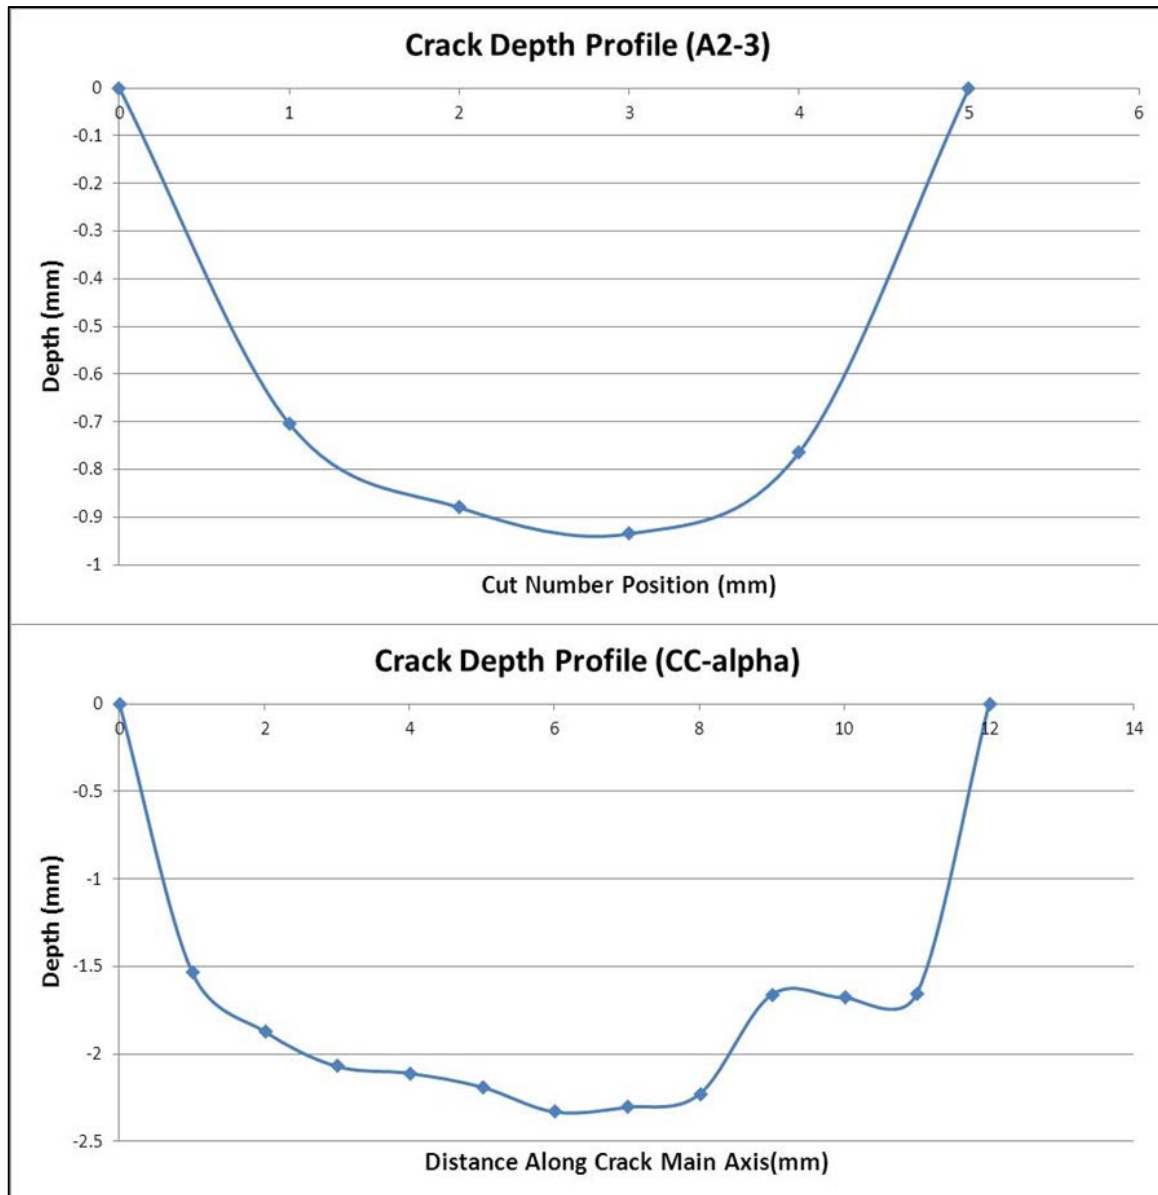
Throughout this study, definitive observations of crack interactions were not possible due to the metallographic method of crack analysis used. However, observations regarding crack interactions were made from the MPI results of the surface of the pipe before sectioning and metallographic processing. In the post-processing procedure, the crack depth profiles of all cracks and coalesced cracks were analysed. With interacting cracks, the crack depth profile would show this interaction through a variation in the crack depth. This factor explained why many of the crack depth profiles created were not a semi-elliptical shape.

Figure 8-8 shows the depth profiles of two cracks. Figure 8-8 (top) shows a smaller crack that was analysed and was clearly shown to be a single crack with no interactions taking place. As can be seen, the profile of this crack is semi-elliptical and shows a typical crack depth profile. Figure 8-8 (bottom) is made up of at least two cracks observed to be interacting on the surface of the pipe and this is evident in the depth profile.

Figure 8-8: Depth profiles of a single 5 mm crack (top) and 12 mm coalesced cracks (bottom) (purposed for profile only).
